JPL Publication 2005-2

Genesis Failure Investigation Report

JPL Failure Review Board, Avionics Sub-team

July 2004

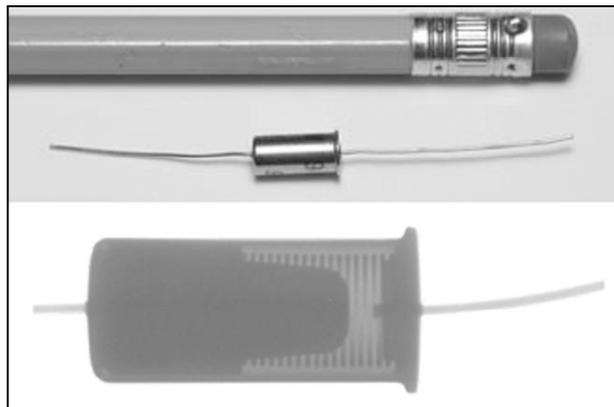
Figure 2-10. G-switch views; X-ray shows mass and spring

Shortly after the mishap, LMA engineers identified the proximate cause of the failure in less than a week. The forensic evidence indicated that the first pyro event had not occurred (i.e., the drogue chute had not deployed). The list of possible common mode failures that could affect both avionics units was small. LMA engineers quickly identified the improper orientation of the G-switch as a simple common fault in both redundant avionics units that could explain the entire failure. Examination of the as-built relay module indicated that this was indeed what had happened.

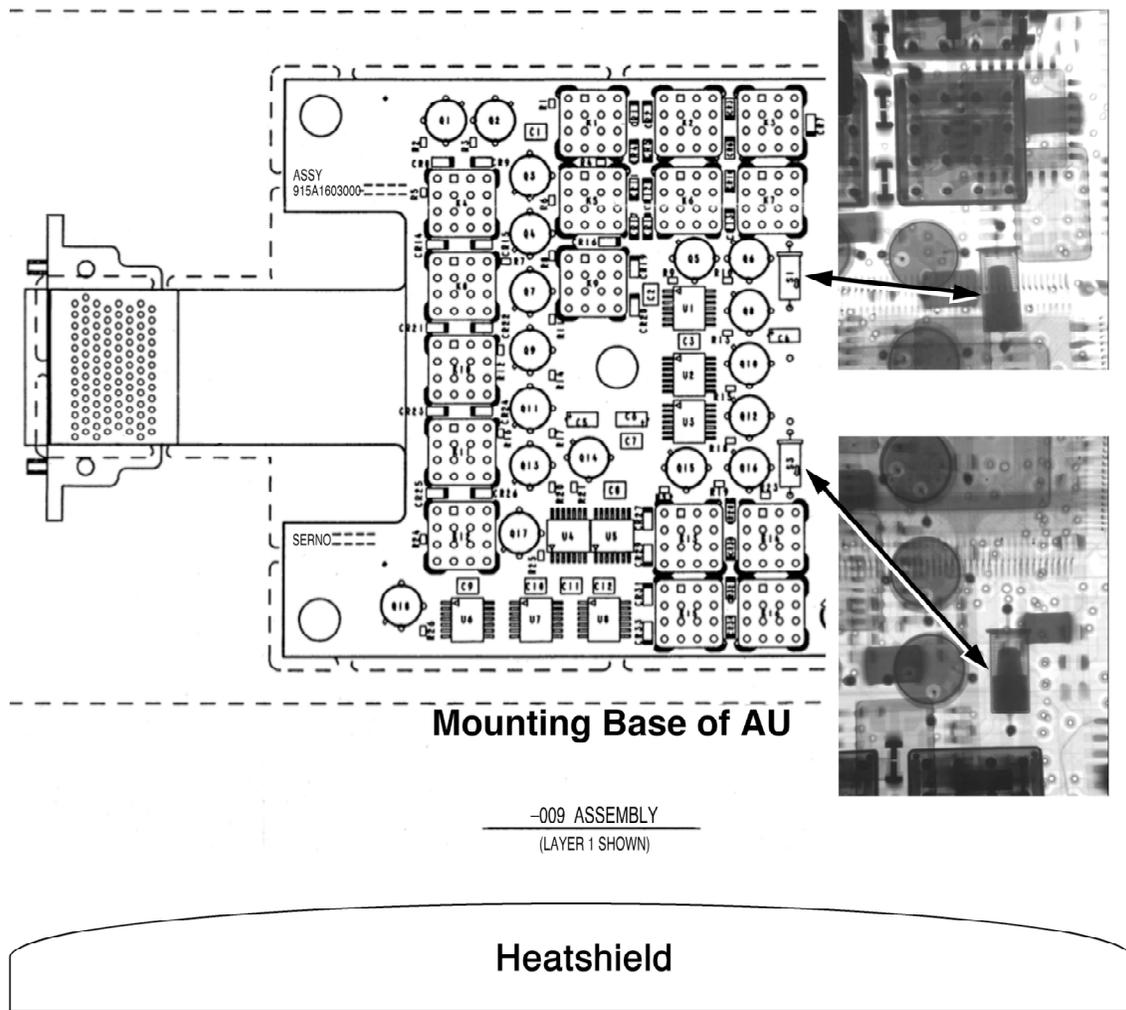
Figure 2-13. X-Ray of board indicating that installation of G-switches matches board layout drawing

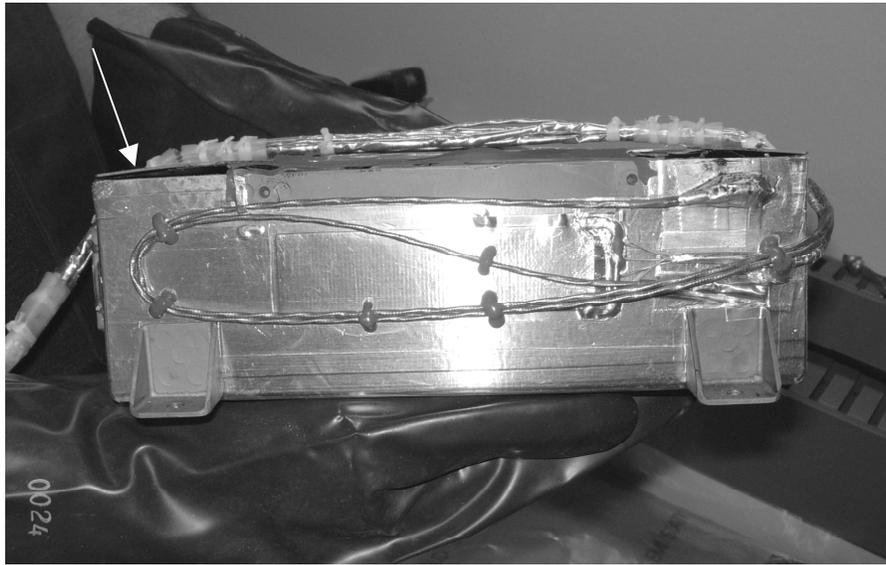
With the exception of a bowed top cover and some discoloration/staining on the top cover and black Kapton (Figures B-3, B-4), the battery surprisingly escaped severe damage from the hard landing. Physical dimensions of the battery were measured and were found to be comparable to pre-flight measurements, with the exception of height. This discrepancy is due to the bowing of the top cover.

Figure B-3. Battery showing bowed cover

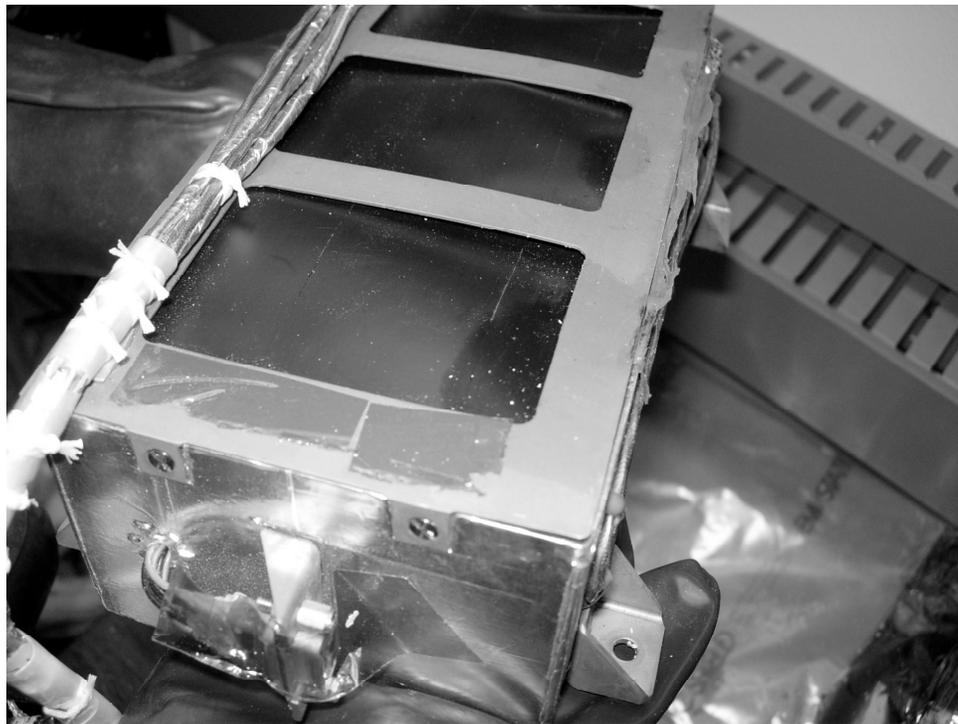
Figure B-4. Battery showing stained glass

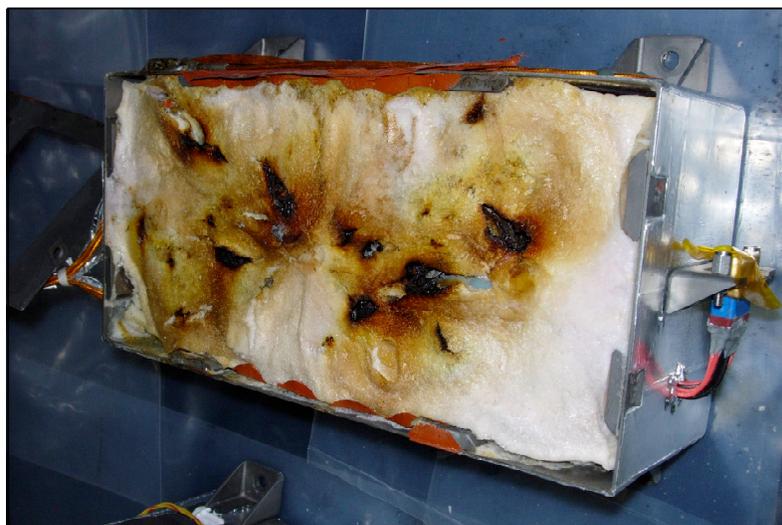
The ATLO battery (i.e., one that had not been exposed to a flight environment) was opened first for comparison purposes. Figure B-6 shows the top of the ATLO battery underneath the cover and Kapton layers. The Eccofoam insulation looks pristine and has a pinkish color. By contrast, when the SRC battery top cover was removed, there was significant discoloration of the Eccofoam insulation, indicating exposure to excessively high temperatures (Figure B-7). The worst discoloration, almost black, was localized over the nickel cell interconnect tabs. This condition is consistent with high-rate discharge over a significant duration.

Figure B-7. SRC battery Eccofoam insulation

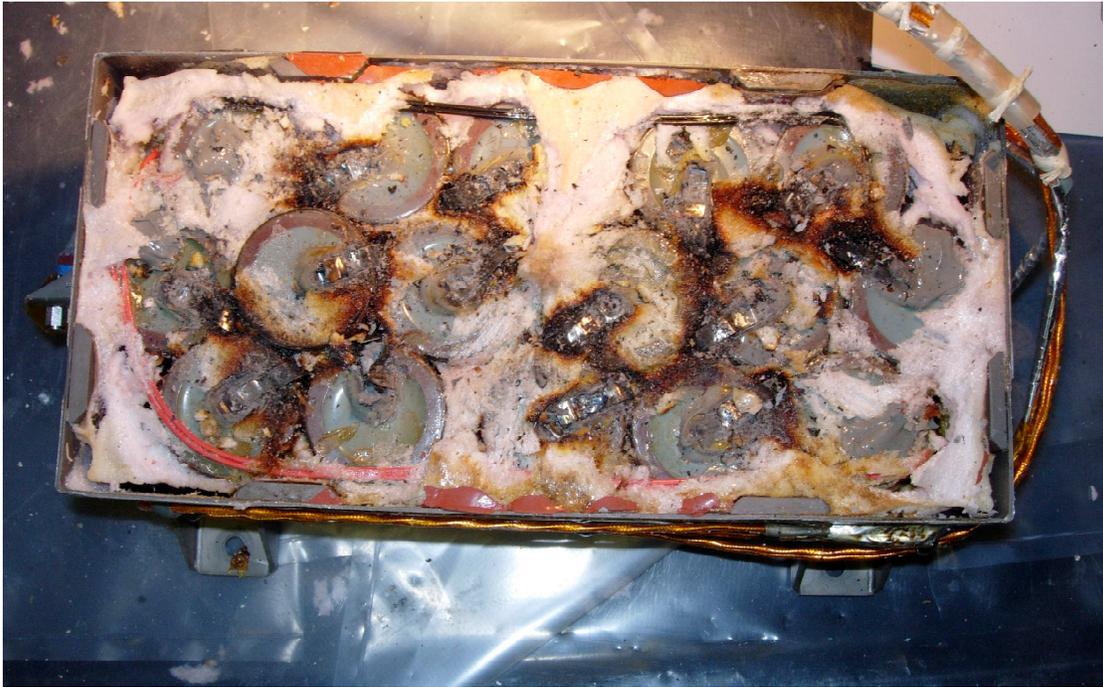
Pieces of the pyrolyzed foam were removed and revealed significant corrosion over the top of cells (Figure B-8). A piece of foam was tested to see how high a temperature would be required to pyrolyze it to a condition similar to the foam in the SRC battery. The foam started discoloration at 140°C and showed significant discoloration at 200°C.

Figure B-8. SRC battery cell tops

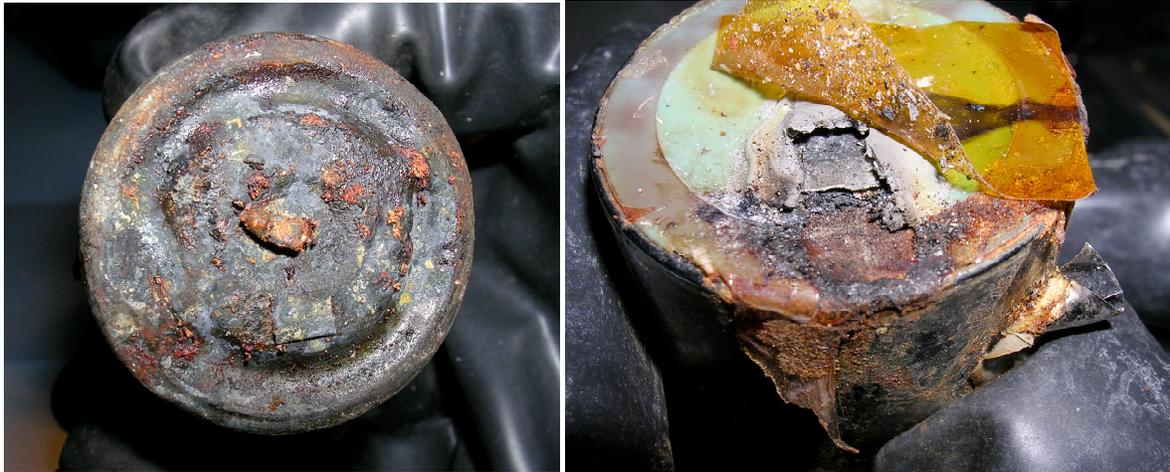
The cells were removed from the battery housing after all the interconnect tabs were cut. The cells showed significant corrosion at the bottoms, where the vent points were located, and also displayed significant heat damage underneath the cell interconnect tabs. Typical cell bottom and cell top photos are shown as Figures B-9 and B-10, respectively. Close inspection of the cells revealed that all cells had vented.

Figure B-9 (above left). Picture taken of a typical cell bottom (Cell 3A) after removal, illustrating the excessive corrosion evident due to the release of SO_2

Figure B-10 (above right). Picture taken of a typical cell top (Cell 3A) after removal, illustrating charred area underneath cell tab; Kapton tape placed on cell top to provide cell orientation details

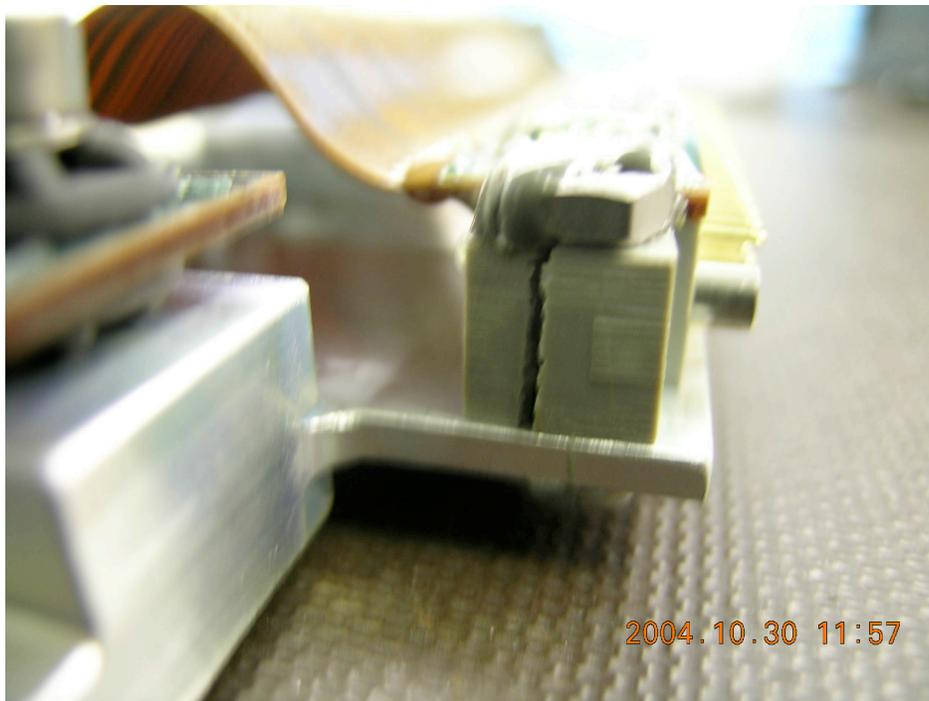
Figure G-2. Cracked P1 Connector on Relay Card SN 001

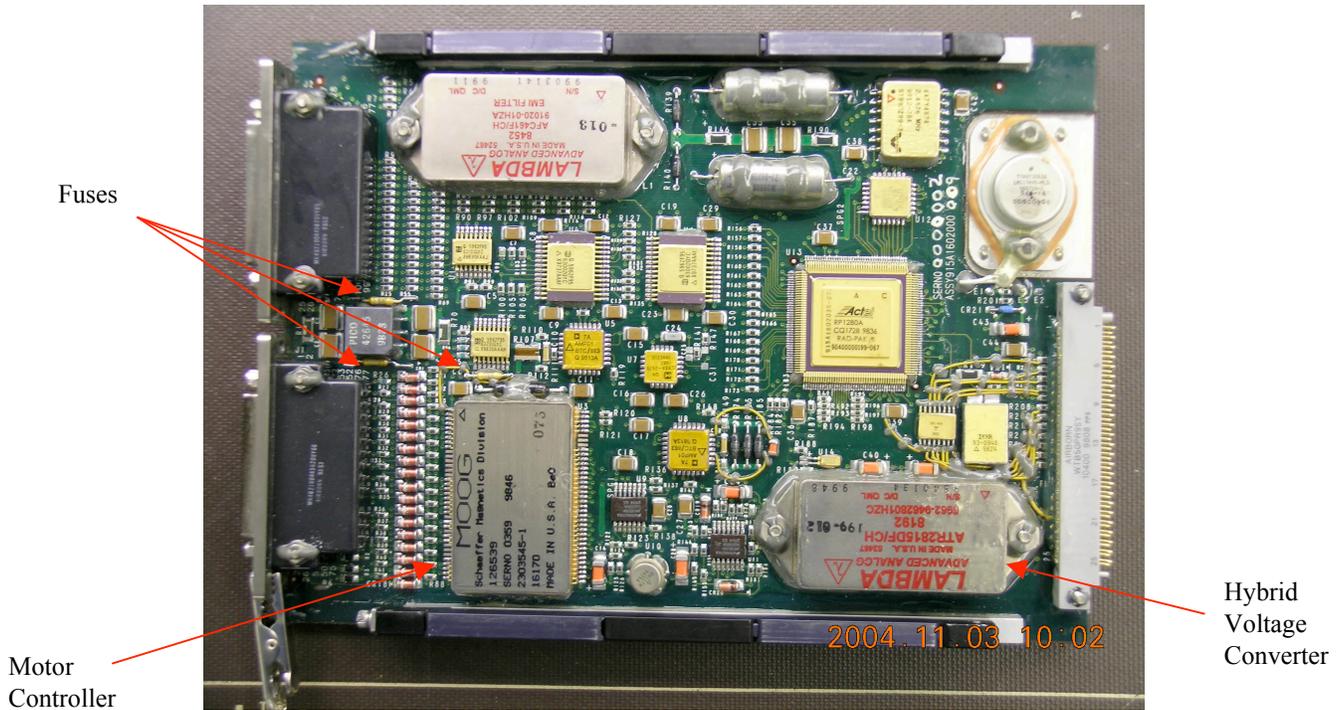
Figure G-4. Avionics Box A MDE Card SN 002

MDE Card S/N 002. The MDE card was in very good condition (Figure G-4). A slight deformation of the board was observed, less than the EST. The two 5-A 28-V spacecraft power fuses appeared normal with no visible evidence of damage or overstress. Continuity tests verified the integrity of the fuses. The hybrid DC/DC secondary voltage converter appeared normal with no evidence of damage or overstress.

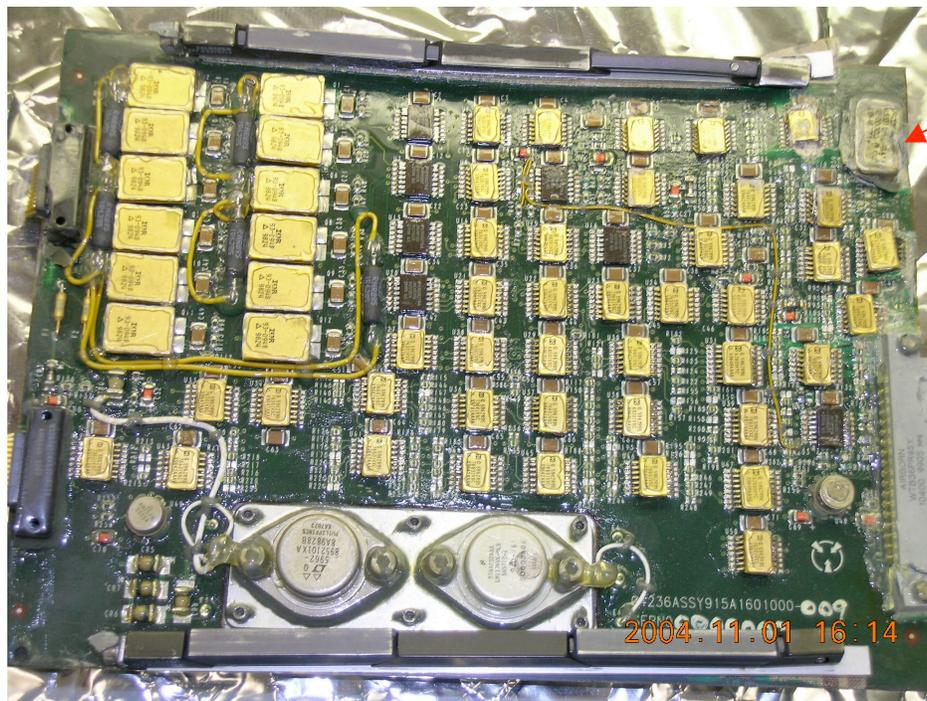
Figure G-6. Avionics Box B EST Card SN 002

Note physical damage in this corner.

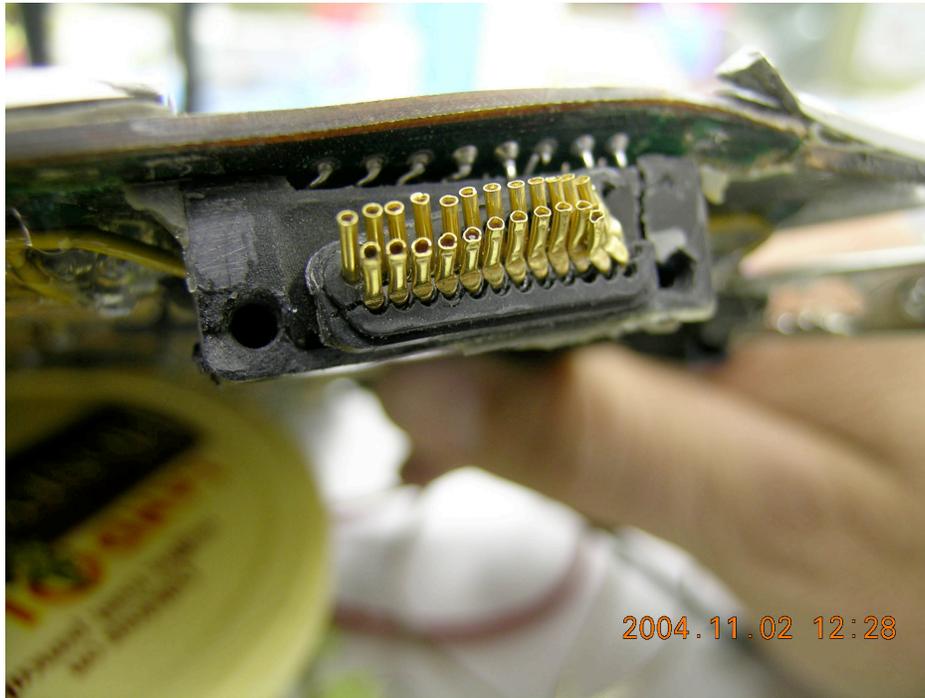
Pyro output continuity testing could not be performed because of connector damage.

Figure G-8. EST SN 002 J2 Connector

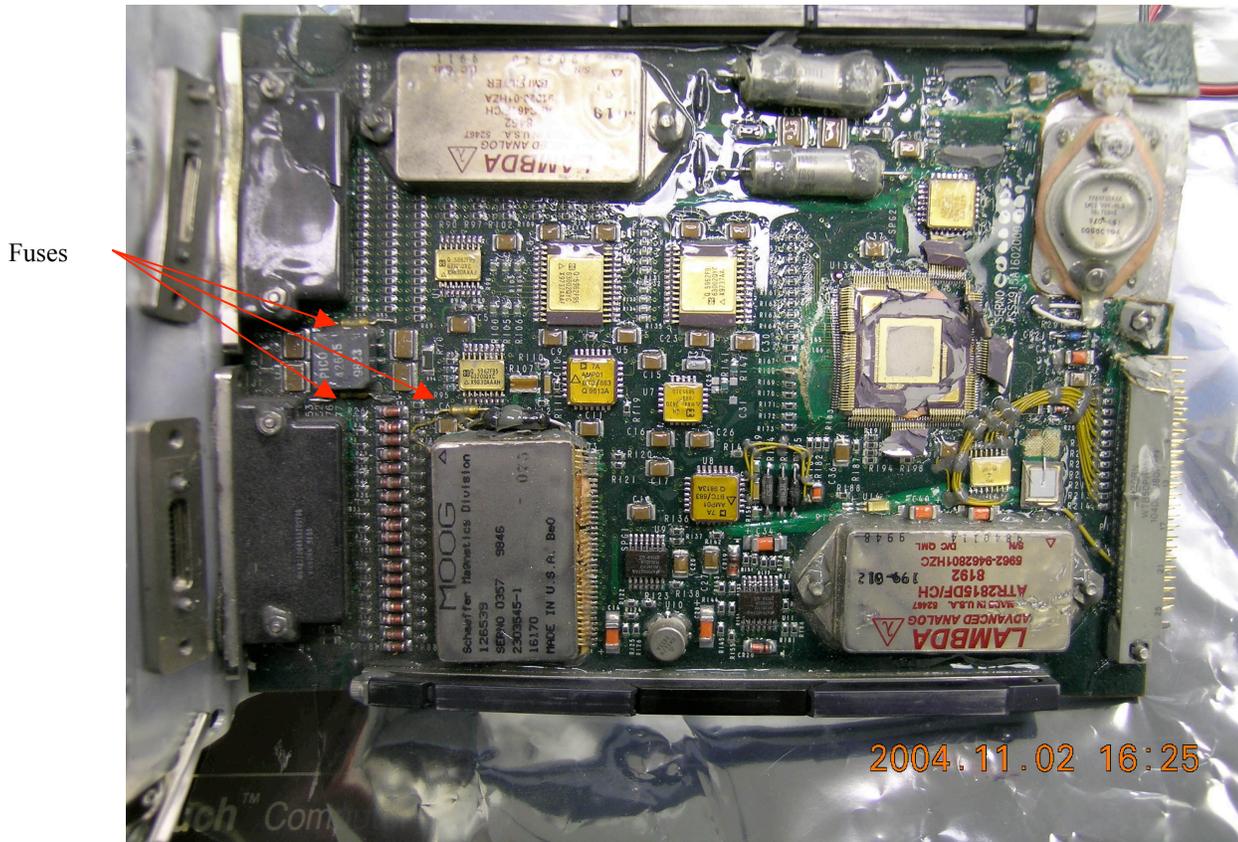
Figure 9. Avionics Box B MDE Card SN 003

MDE Card S/N 003. The MDE card was in bad condition, with extensive damage to the components and board near the P1 connector (Figure G-9). However, the two 5-A 28-V spacecraft power fuses escaped damage and appeared normal, with no visible evidence of damage or overstress. Continuity tests verified the integrity of the fuses.
