NATIONAL TRANSPORTATION SAFETY BOARD

MATERIALS LABORATORY FACTUAL REPORT

Report No. 04-133

Place : Dugway, Utah
Date : September 8, 2004
Vehicle : Genesis Spacecraft
NTSB No. : ENG04SA028
Investigator : Clint Crookshanks, AS-40

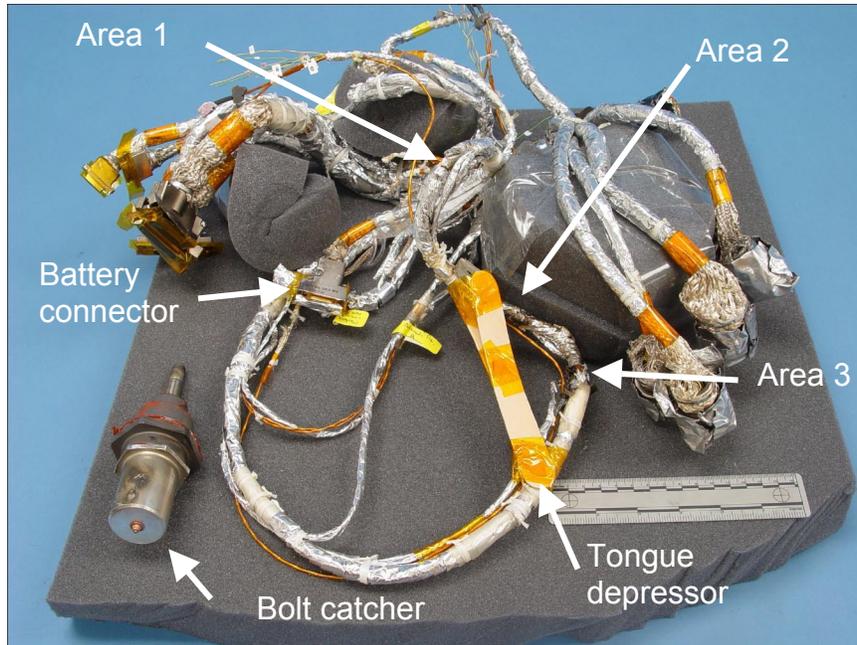
An overall view of the submitted wiring harness and bolt catcher is shown in figure 1 as the components were received in the NTSB Materials Laboratory. The harness is shown as packaged, supported by a dark gray foam. Damage areas are indicated by arrows "Area 1", "Area 2" and "Area 3". Damage Areas 2 and 3 were further supported with wood tongue depressors taped to the harness. Another view of damage Areas 1, 2, and 3 after removing the packing material is shown in figure 2.

Figure 1. Overall view of the as-received wiring harness and bolt catcher. Wrap disturbance at areas 1 to 3 are indicated. Also, a splice consisting of wood tongue depressors for stabilization during shipping is indicated.

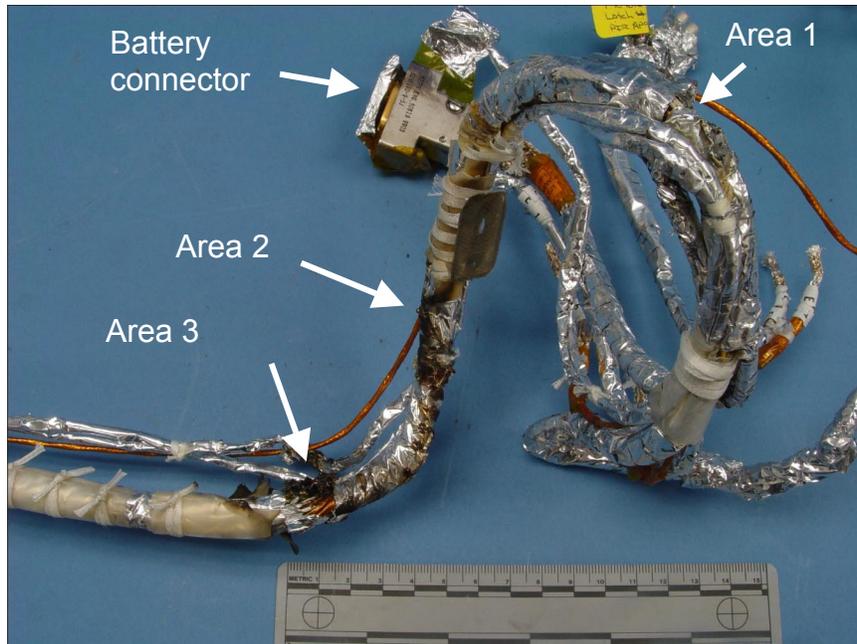
Figure 2. Another view of the harness at areas 1 to 3 with the packaging material removed.

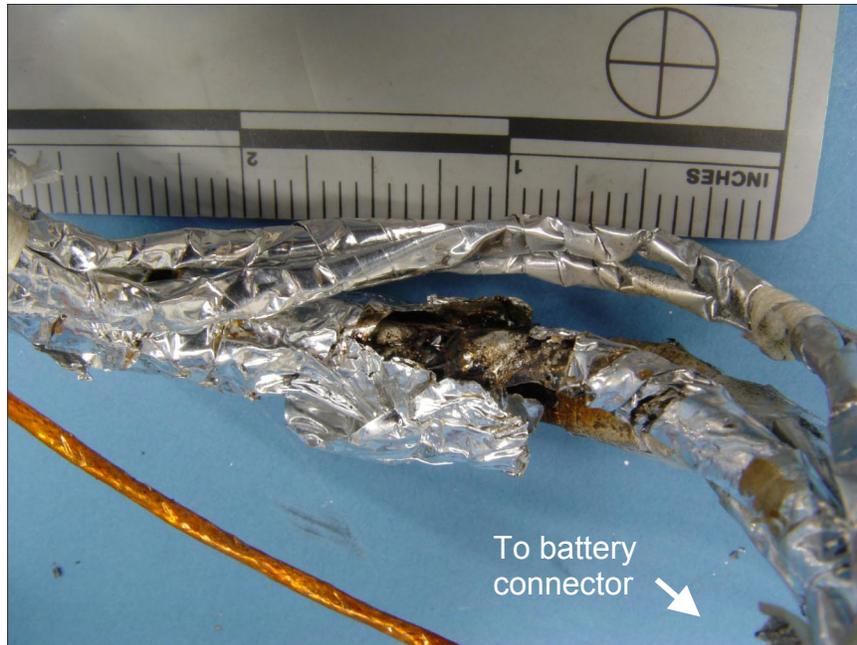
Closer views of the damage at Area 1 are shown in figures 3 and 4. The aluminized Mylar wrap was fractured and gaped open, revealing internal wires and cables. Charring, deformed power cable wrapping material, and missing power cable strand insulators were observed, indicative of heat damage. Bare wires of the power cable were visible as indicated in figure 4.

Figure 3. Another view of the wrap disturbance at Area 1.

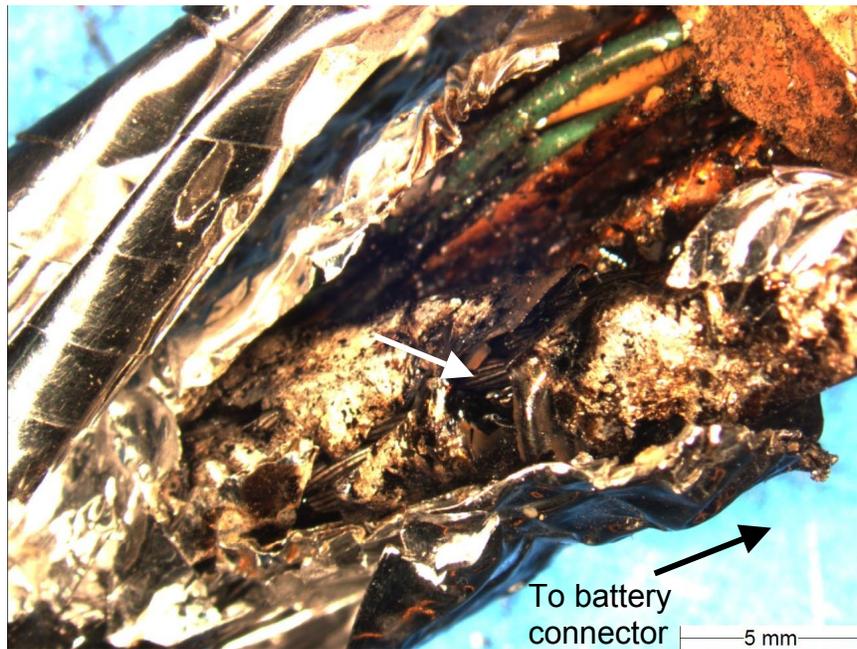
Figure 4. A closer view of Area 1. An unlabeled arrow indicates exposed power cable strands with missing insulation.

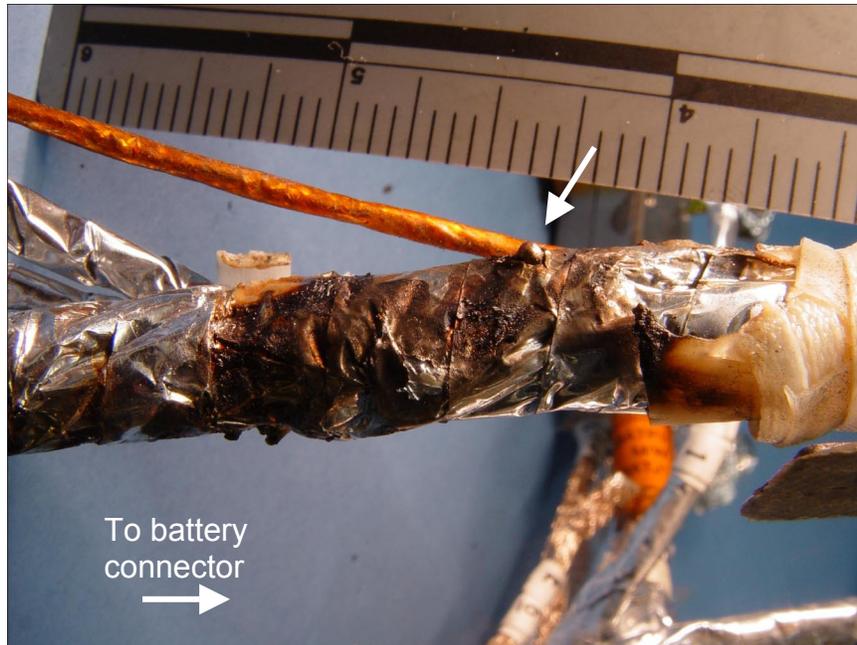
A view of the damage at Area 2 is shown in figure 5. The aluminized Mylar wrap was charred black in this area. The shrink tubing on the exterior of the aluminized Mylar wrap (shown at the right in figure 5) was blackened and melted adjacent to this. A power cable wire melt bead was observed penetrating through the aluminized Mylar wrap as indicated by the arrow in figure 5.

Figure 5. Close view of the damage at Area 2. An unlabeled arrow indicates where a melt bead penetrated the aluminized Mylar wrap.

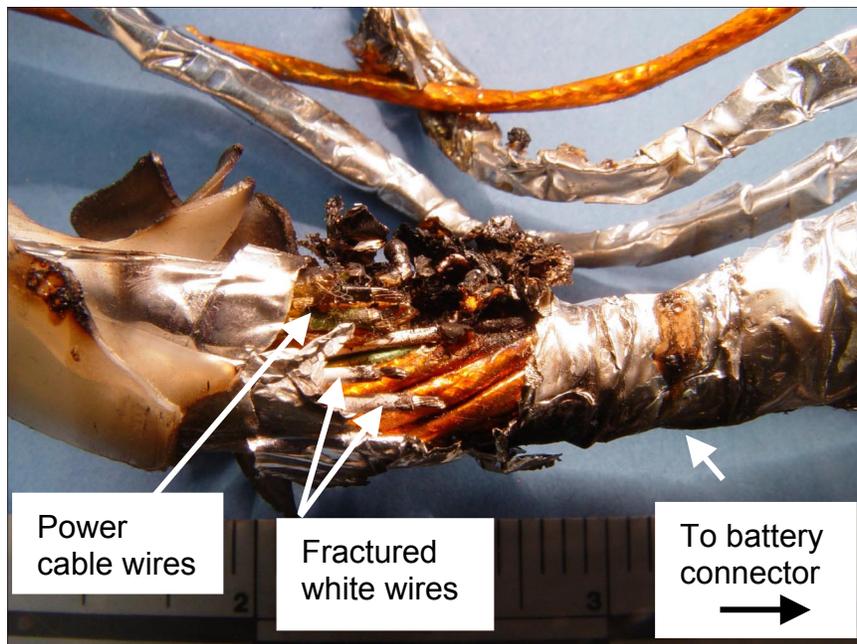
The regions of most severe damage in Area 3 were on approximately opposite sides of the harness and are shown in figures 6 and 7. The end of the damage area further from the battery connector is shown in figure 6, and the end closer to the battery connector is shown in figure 7. The aluminized Mylar wrap at the end further from the battery connector was fractured and gaped open as shown in figure 6. All eight of the power cable strands were either fractured or melted at this location. In addition, two adjacent strands with white insulators were fractured. Black deposits, charred insulators, and melted strands were observed in the area, consistent with exposure to heat. The shrink tubing on the exterior of the aluminized Mylar wrap adjacent to the area (shown at the left in figure 6) was blackened, partially melted, and opened back away from the damage at Area 3. At the end of Area 3 closer to the battery connector as shown in figure 7, the aluminized Mylar was gaped open, exposing the power cable. The insulators for the power cable were charred consistent with exposure to heat.

Figure 6. Close view of the damage at area 3. The unlabeled arrow indicates the direction of viewing for figure 7.

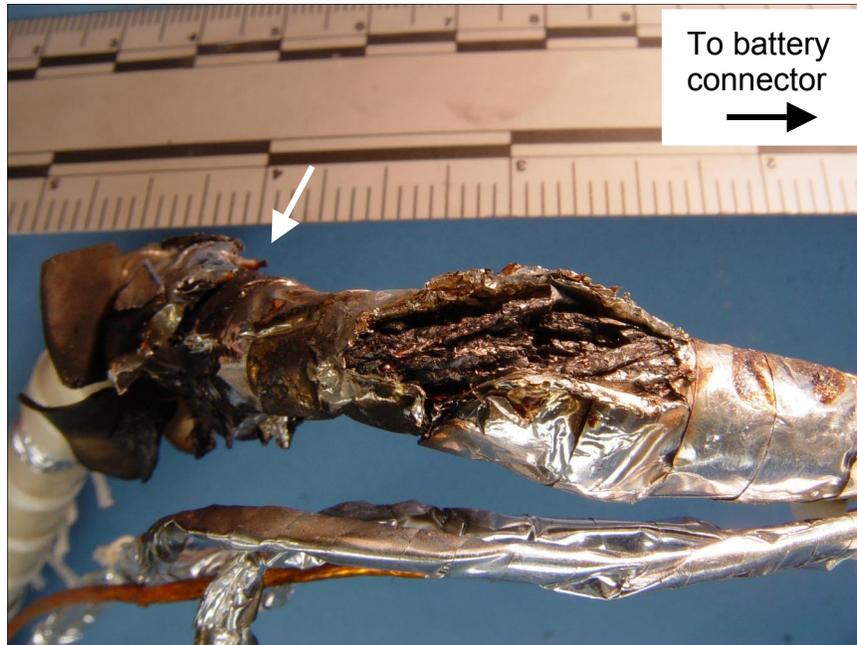
Figure 7. Damage at area 3 adjacent to the damage shown in figure 6 located closer to the battery connector. The unlabeled arrow indicates the direction of viewing for figure 6.

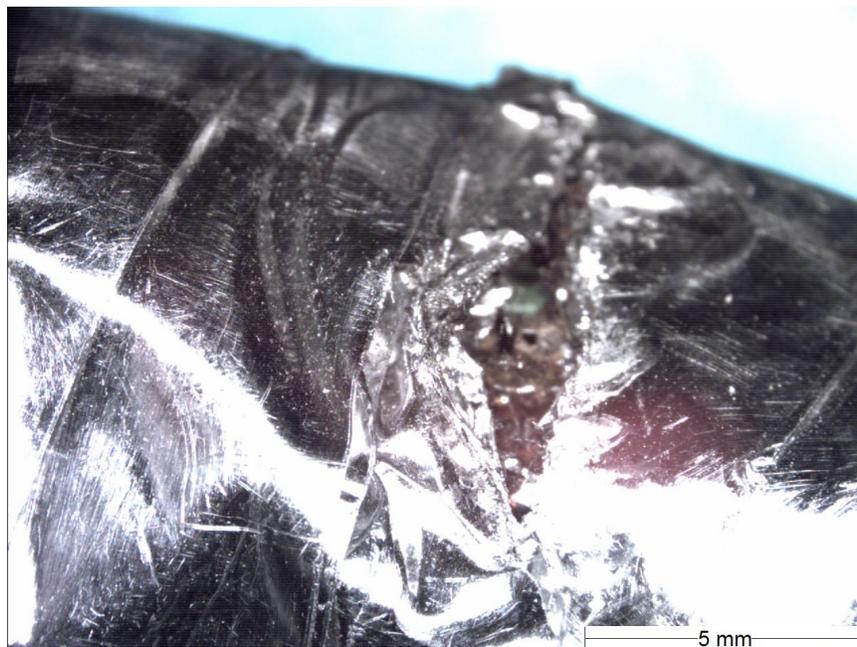
A close view of the damage at Area 4 is shown in figure 8. The aluminized Mylar was fractured and gaped slightly open. None of the underlying strand insulators for the power cable were penetrated, and no heat damage was observed. An irregular-shaped piece of white debris measuring 100 micrometers across was observed in this area. The

piece was examined in a scanning electron microscope using energy dispersive x-ray spectroscopy (EDS), and the resulting spectrum showed high peaks of gallium and zinc.

Figure 8. View of the damage at area 4.

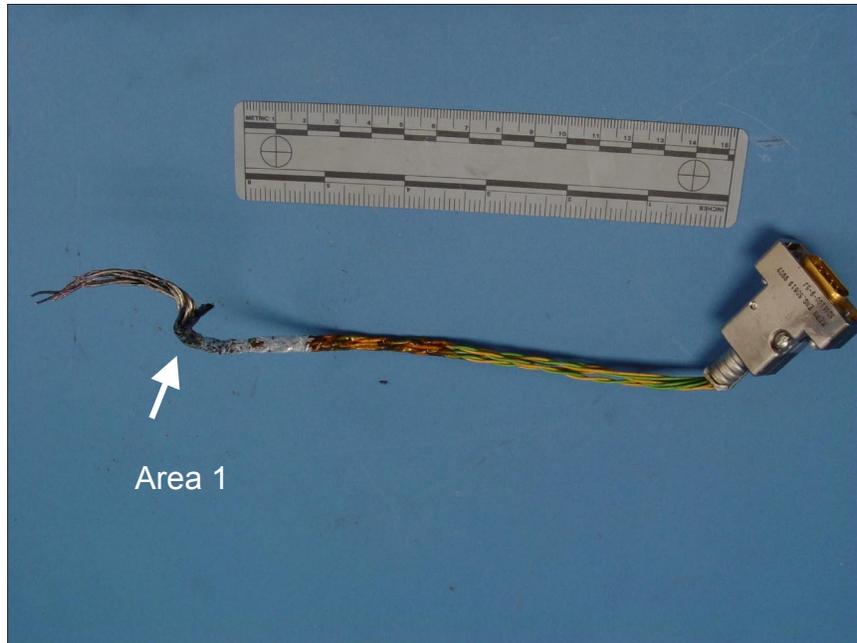
The aluminized Mylar and aluminized Kapton were removed from the power cable where possible. As these wraps were removed near Area 1, a portion of the power cable with the battery connector separated from the remainder of the harness. The separated piece is shown in figure 9.

Figure 9. View of the battery connector and power cable after removal of the outer aluminized Mylar wrap. The cable strands were melted and fractured in the vicinity of Area 1.

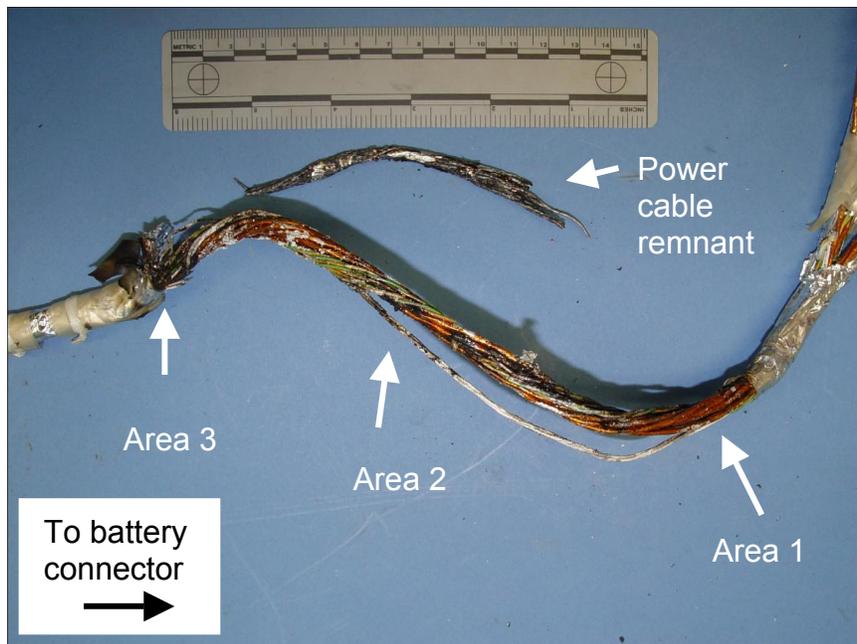
As the aluminized Mylar was removed further, charred and separated remnants of the power cable were exposed in the section between Areas 1 and 3. A view of the harness in this area with the largest of the exposed power cable remnants is shown in figure 10.

The aluminized Mylar in the section shown in figure 10 showed evidence of charring and heating and tore more easily than in other sections. Also, the shrink tubing in this area was stiffer than the tubing in other areas.

Figure 10. View of the harness between Areas 1 and 3 after removal of the outer aluminized Mylar wrap.

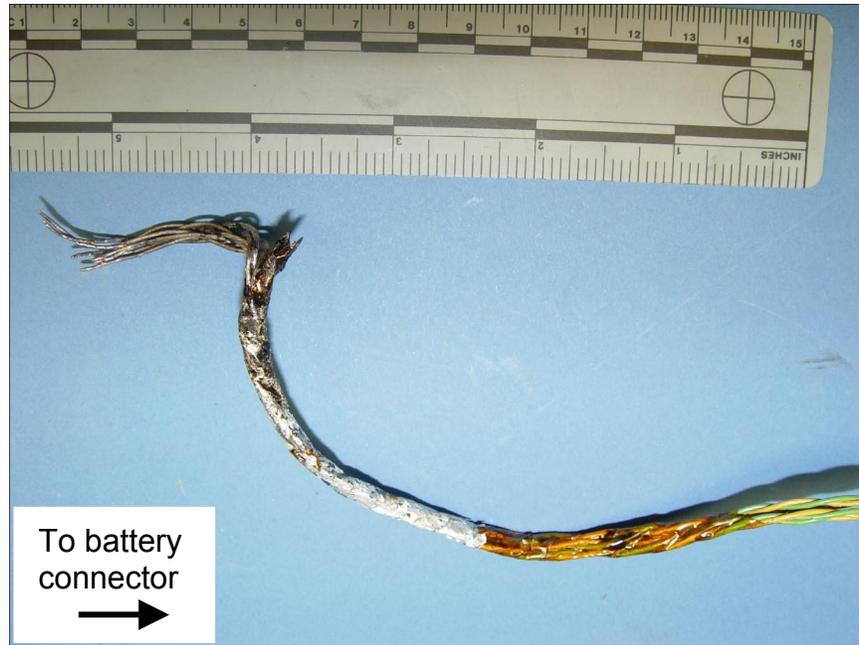
A view of the damaged end of the power cable piece attached to the battery connector is shown in figure 11. No heat damage was noted directly adjacent to the battery connector and up to a distance of about 3.3 inches from the connector. Starting at a distance of 3.3 inches from the base of the battery connector, the Kapton film around the power cable strands was shrunk onto the strands. Starting at a distance of 5.4 inches from the base of the battery connector, the aluminized Kapton was fused to the underlying Kapton film. Starting at a distance of 8.3 inches from the base of the battery connector, the power cable strand insulators were mostly missing, and bare wires were exposed. The strands on this piece of the power cable were fractured or melted 9.8 to 10.3 inches from the base of the battery connector. A closer view of the ends of the power cable piece at this location is shown in figure 12. Several of the fractured and melted ends are shown in figure 13 as viewed using scanning electron microscopy (SEM). As shown in figures 12 and 13, the power cable strand ends were rounded, individual wires within a strand were fused, and irregular thinning was observed consistent with melting. Where fractured, significant thinning of the strand was observed adjacent to the fracture, consistent with fracture at high temperature.

Figure 11. Closer view of the damaged end of the power cable piece shown in figure 9.

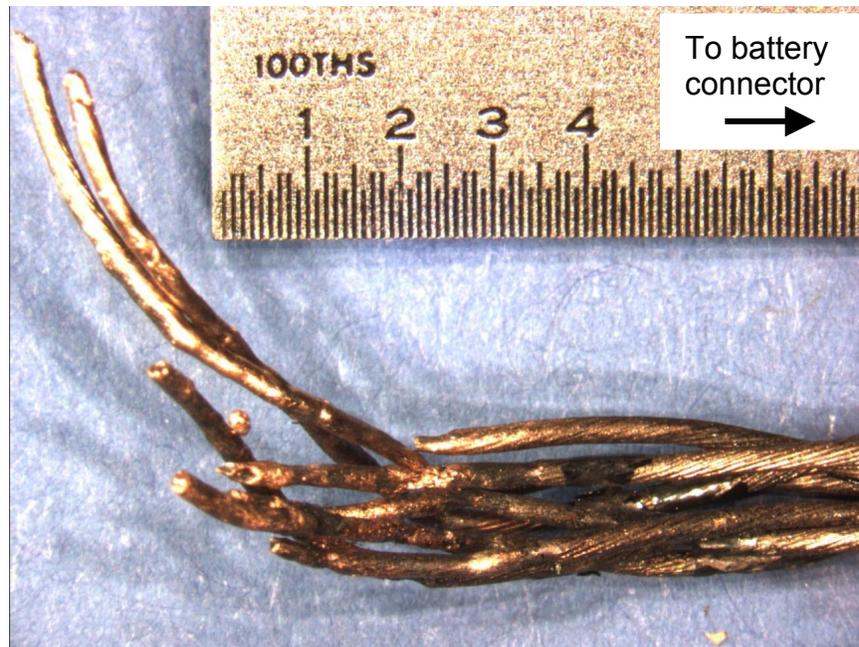
Figure 12. Closer view of the melted and fractured strands of the power cable piece shown in figure 11.

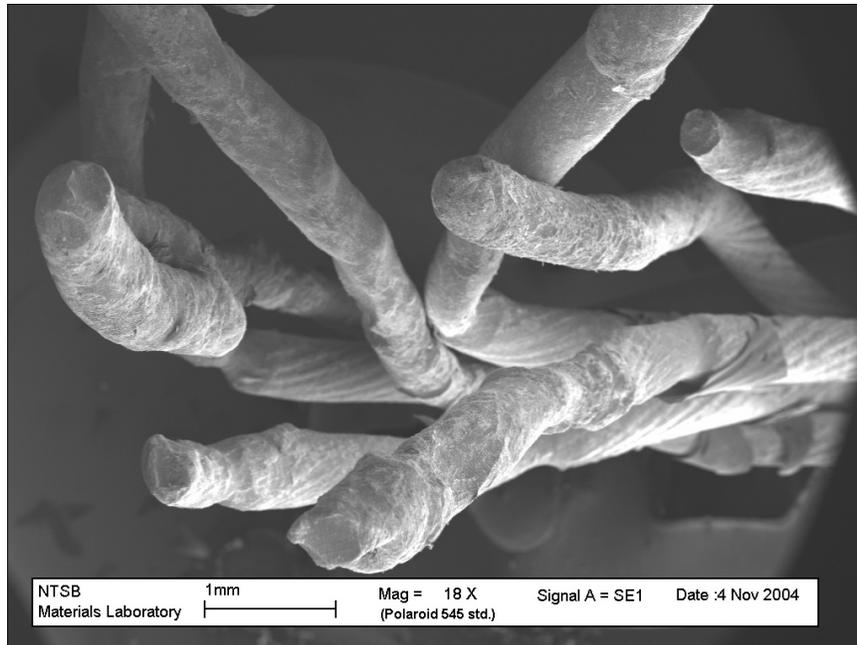
Figure 13. Strands from the power cable near Area 1 as viewed using SEM.

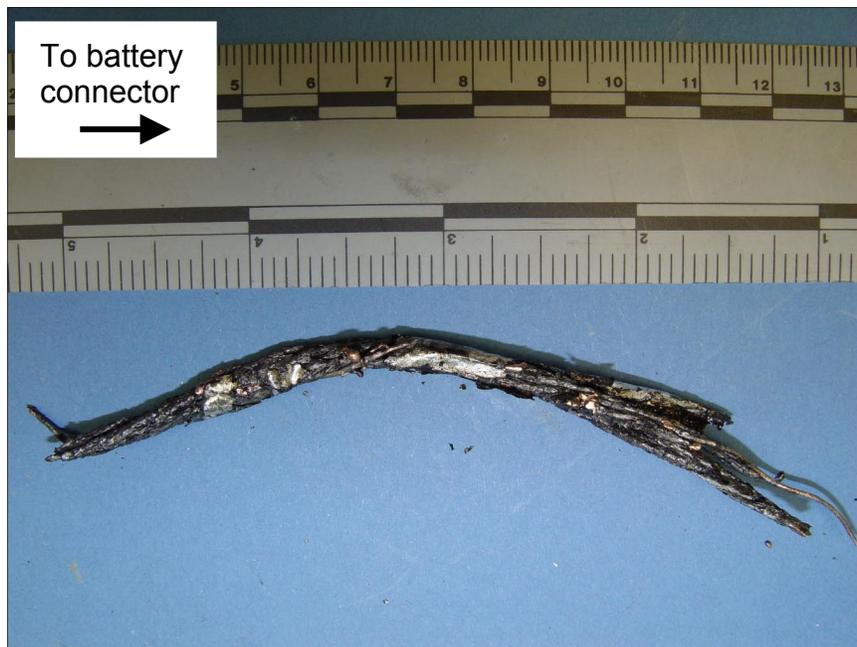
the power cable in this area remained relatively intact as shown in figure 14. This section was held together by the aluminized mylar wrap.

Figure 14. Closer view of the power cable remnant from between areas 1 and 3 (also shown in figure 10).

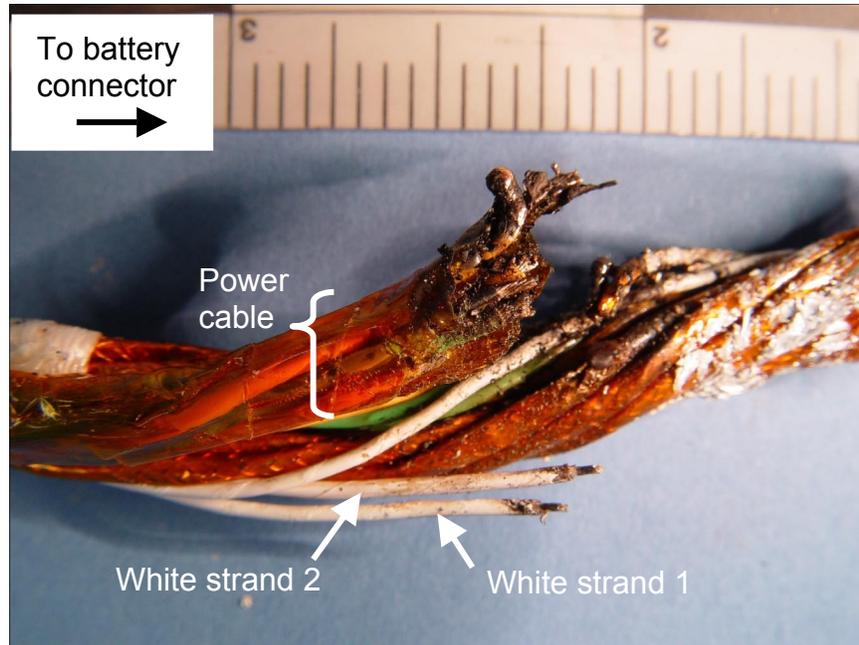
A view of the harness at Area 3 after removal of the shrink tubing, aluminized Mylar, and aluminized Kapton is shown in figure 14. The power cable Kapton film showed charring and heat damage within 0.2 to 0.3 inches of the fractured or melted ends of the power cable strands. Also, two of the adjacent strands with white insulation showed heat damage and slight charring within 0.2 inches of their fractured ends. Black fibrous deposits also were observed throughout the area, visible in many of the close views of strands in this section.

Figure 15. Close view of the damage at area 3 after removal of the outer aluminized Mylar wrap.

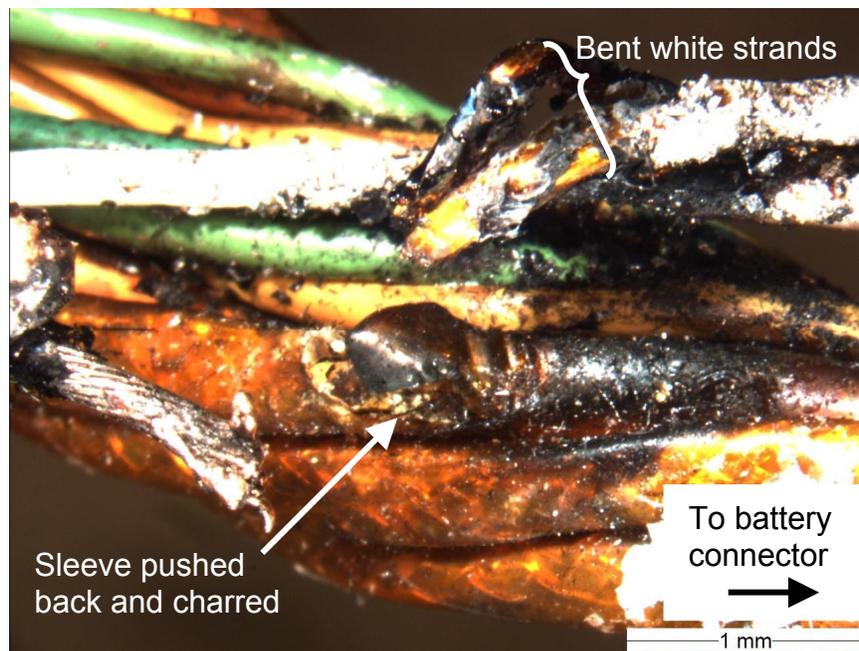
A closer view of the damage in Area 3 is shown in figure 16. As indicated in figure 16, the Kapton sleeve for a strand adjacent to the power cable was fractured and pushed back in the direction of the battery connector, consistent with contact with another object. The Kapton sleeve also was charred, consistent with exposure to heat, and the charring was not continuous across the mating sides of the fracture, indicating the charring occurred after the fracture. The fractured ends of two white strands indicated in figure 16 were bent inward, also consistent with contact with another object. These fractured strands mated with the two white strands labeled in figure 15.

Figure 16. Close view of the damage in area 3 showing the bent mating ends of white strands 1 and 2. Damage to the Kapton sleeve of an adjacent strand also is indicated in the figure.

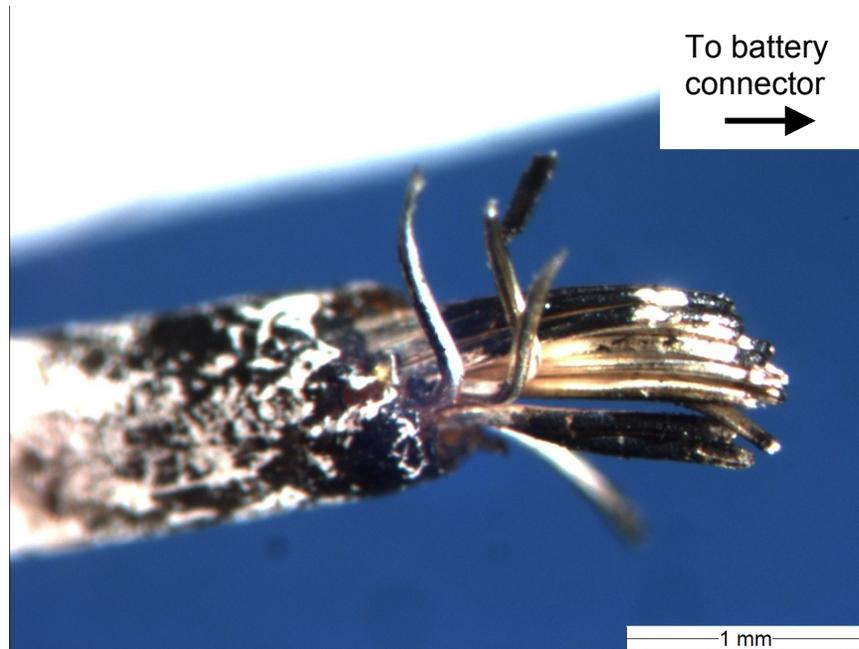
The fractured ends of white strands 1 and 2 are shown in figures 17 to 20. Approximately 0.06 inch of bare wire was exposed on each strand. The fractured ends of the strands were bent and flattened, and individual wires were sheared consistent with contact with another object. On white strand 1, several wires were inadvertently bent outward during disassembly of the aluminized Mylar and aluminized Kapton. On both strands, the adjacent insulator was charred. Black deposits were observed on the strand. In areas where the deposits were not present, the wires had a light brown color. Using energy dispersive x-ray spectroscopy (EDS), a typical spectrum of the white strand insulator material was obtained and is shown in figure 21. The spectrum showed a high peak of fluorine and much smaller peaks of titanium and carbon. A typical EDS spectrum for the black deposits on the bare end of white strand 2 is shown in figure 22. The deposits had a high peak of carbon with smaller peaks of oxygen, fluorine, and silicon. A silver peak also was observed, consistent with the coating on the underlying wire material.

Figure 17. Close view of white strand 1 in Area 3. Several strands were bent during the wrap removal process.

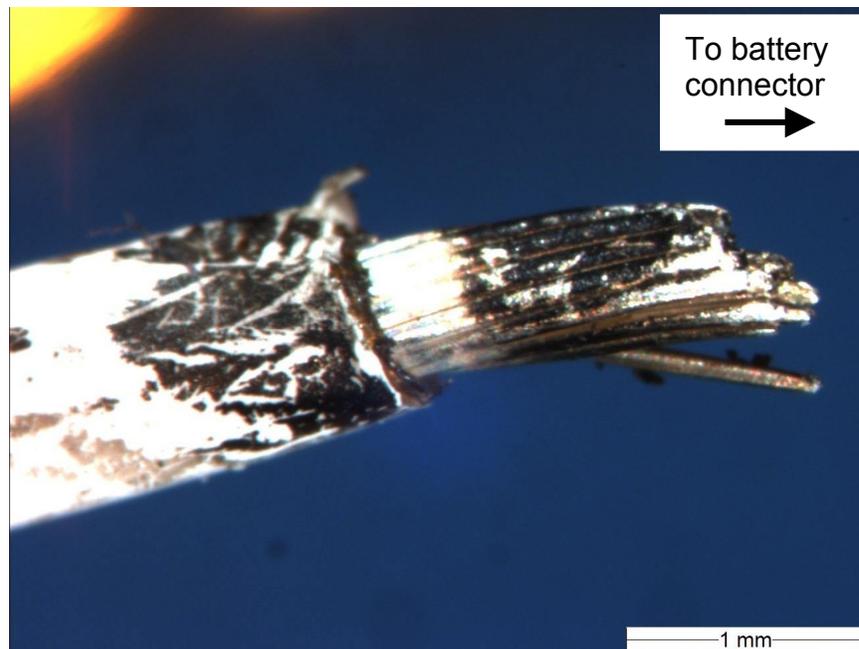
Figure 18. Close view of white strand 2 in Area 3.

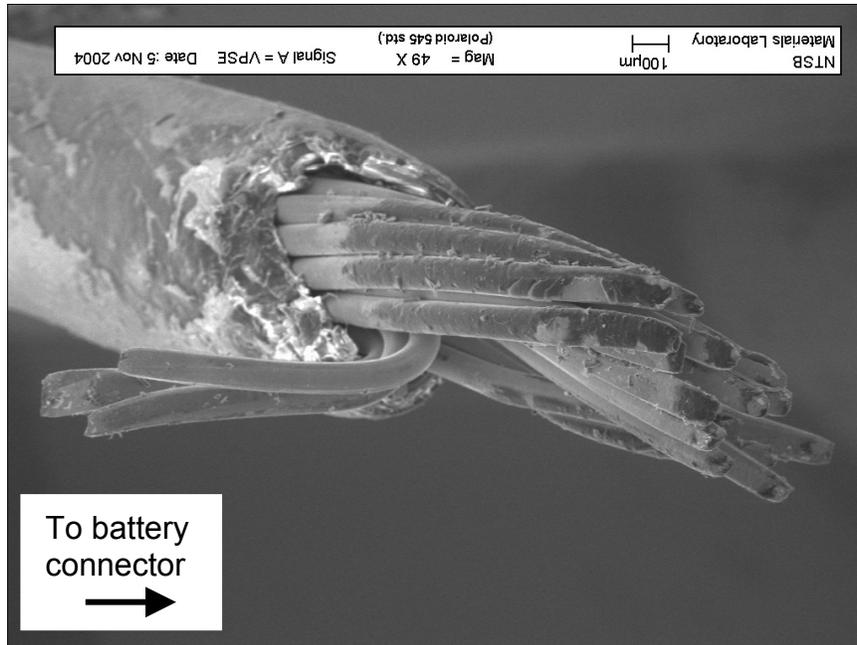
Figure 19. SEM view of white strand 1 at Area 3.

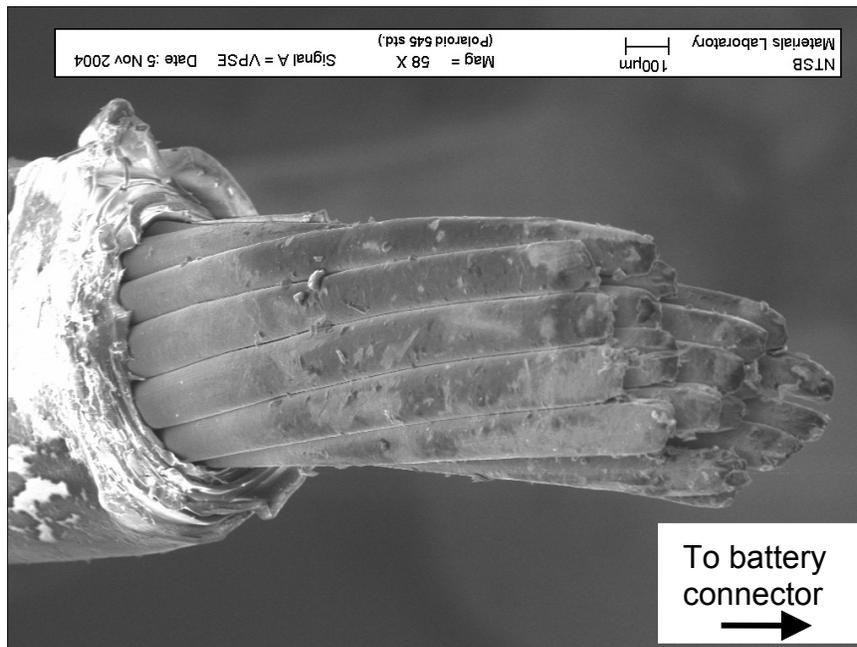
Figure 20. SEM view of white strand 2 at Area 3.

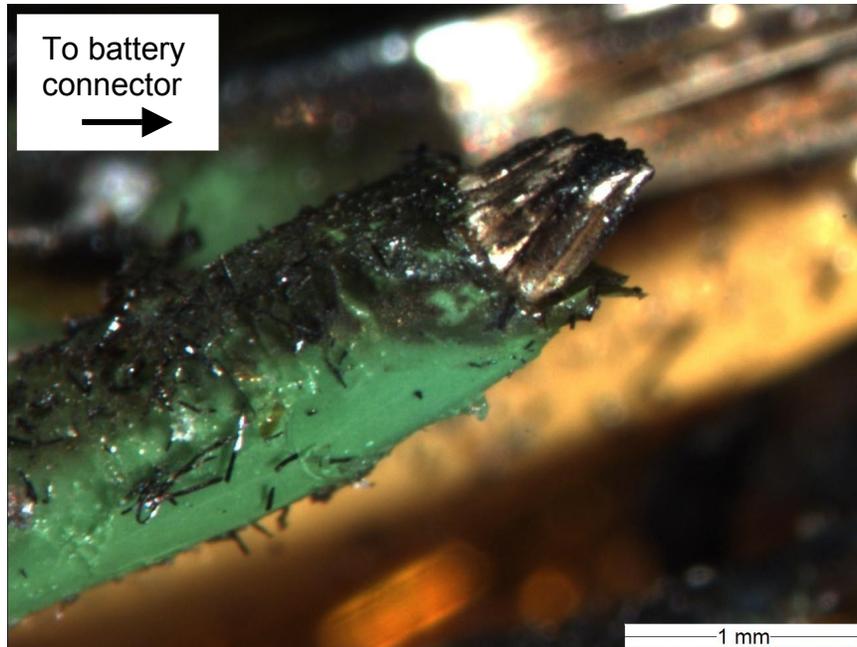
Views of power cable strand 1 are shown in figures 23 and 24. The fractured end of the strand came to a chisel-like point, and each strand was sheared consistent with contact with another object. The exposed strand had black deposits, and the adjacent insulator

was charred. Black fibrous deposits also were observed in the area. The insulator and several wires of this strand also were fractured at a location 0.24 inch from the fractured end of the strand (not visible in figures 23 and 24). The fractured wires were deformed consistent with contact with another object.

Figure 23. Close view of power cable strand 1 in Area 3.

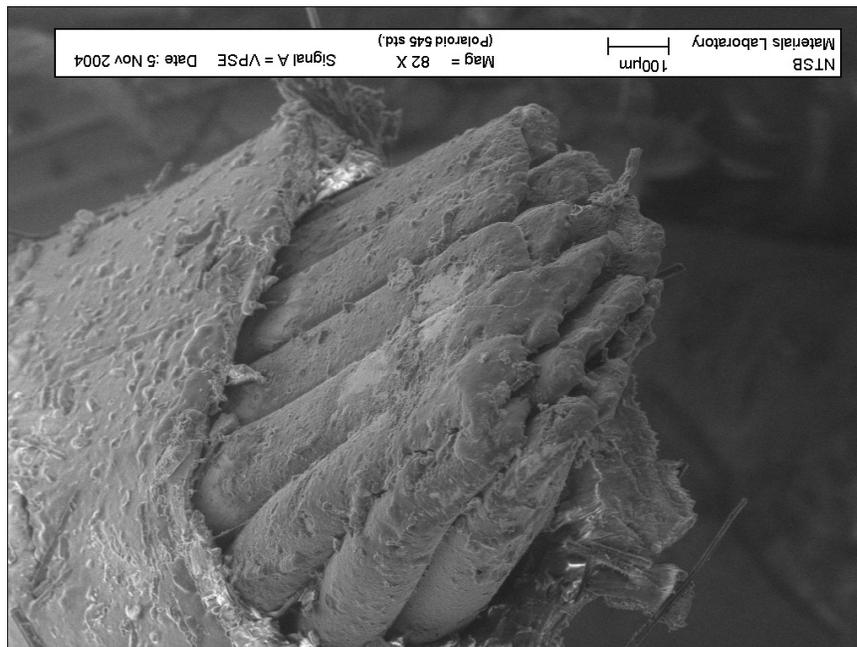
Figure 24. SEM view of power cable strand 1 at Area 3.

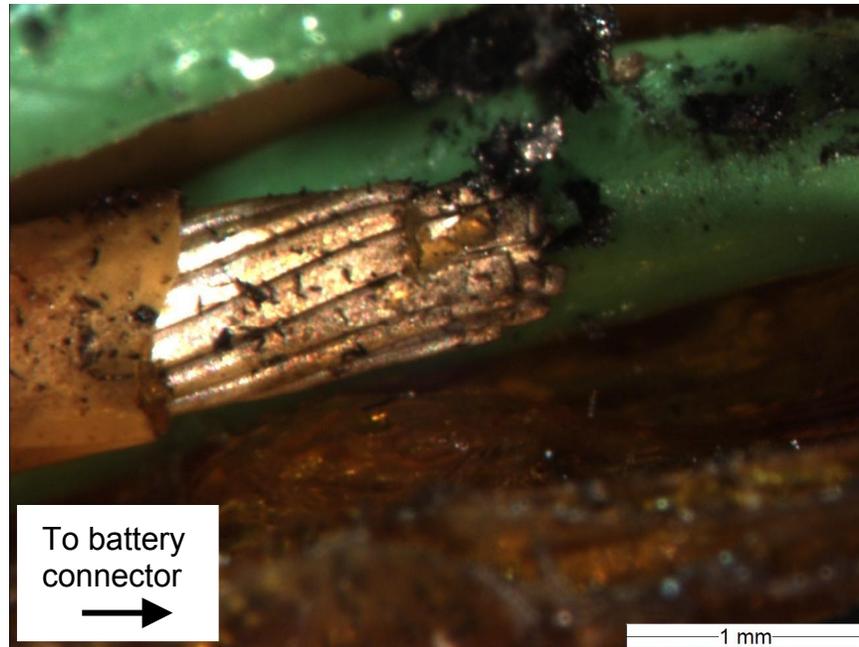
Power cable strand 2 is shown in figure 25. This fracture was located furthest from the battery connector among the eight power cable strand fractures. The individual wires of strand 2 had a chisel-like fracture consistent with an overstress fracture in tension. The end of the strand appeared light brown, darker than the exposed strand adjacent to the insulator. No insulator charring was observed on this strand at this location.

Figure 25. Close view of power cable strand 2 in area 3.

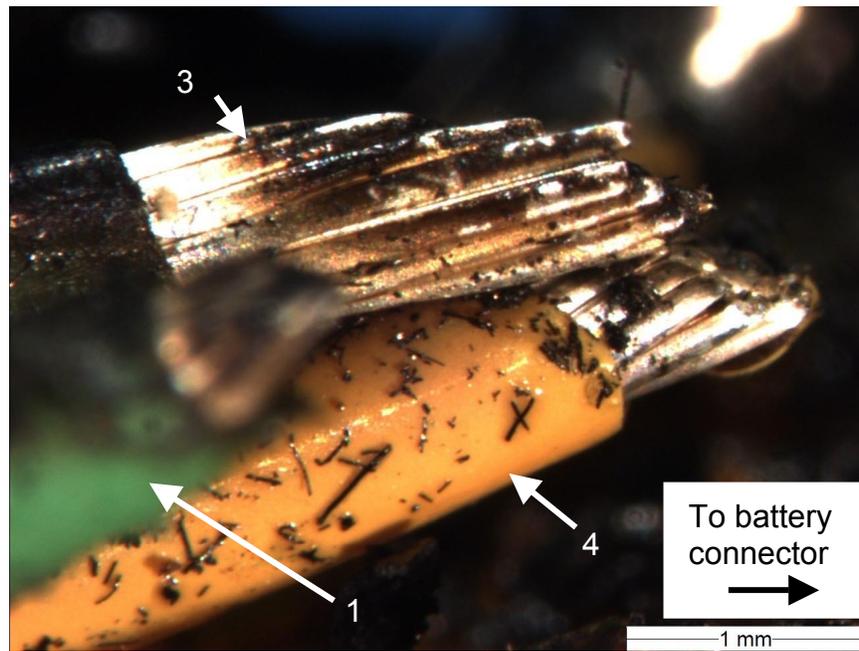
Views of power cable strand 3 are shown in figures 26 and 27. The strand was fractured with some wires sheared and others showing necking consistent with overstress fracture in tension. The ends of the exposed bare strand had black deposits, and in areas where the black deposits were not present, the ends appeared light brown. The strand had a more shiny silver appearance adjacent to the insulator. The insulator adjacent to the bare strand was charred. Black fibrous deposits also were observed in the area.

Views of power cable strand 4 are shown in figures 26 and 28. The strand end was bent and individual wires were sheared, consistent with contact with another object. Some charring was observed on the insulator adjacent to the bare strand, and where the insulator was charred, the exposed strand was tinted slightly brown mixed with some black deposits.

Figure 26. Close view of power cable strands 3 and 4 in Area 3.

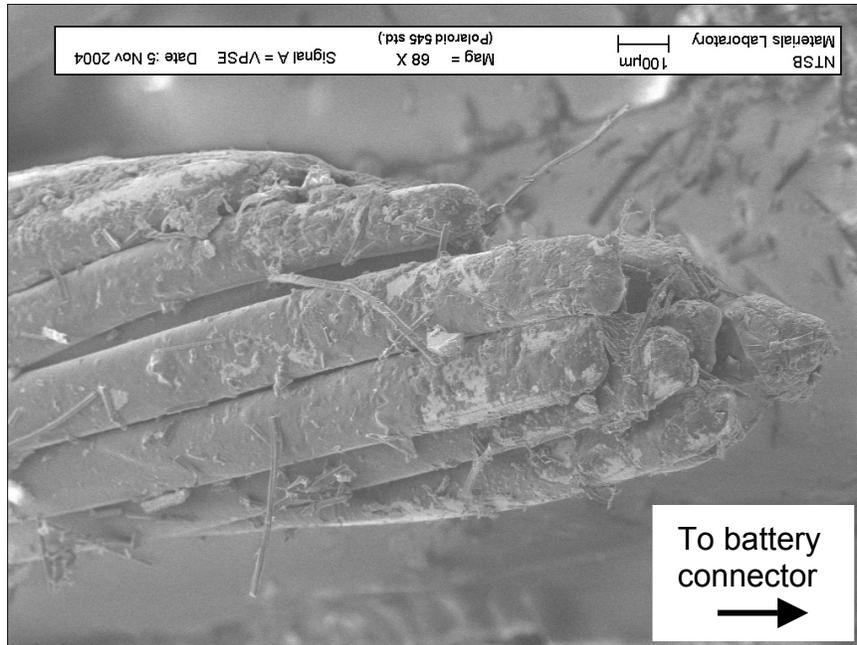
Figure 27. SEM view of power cable strand 3 at Area 3.

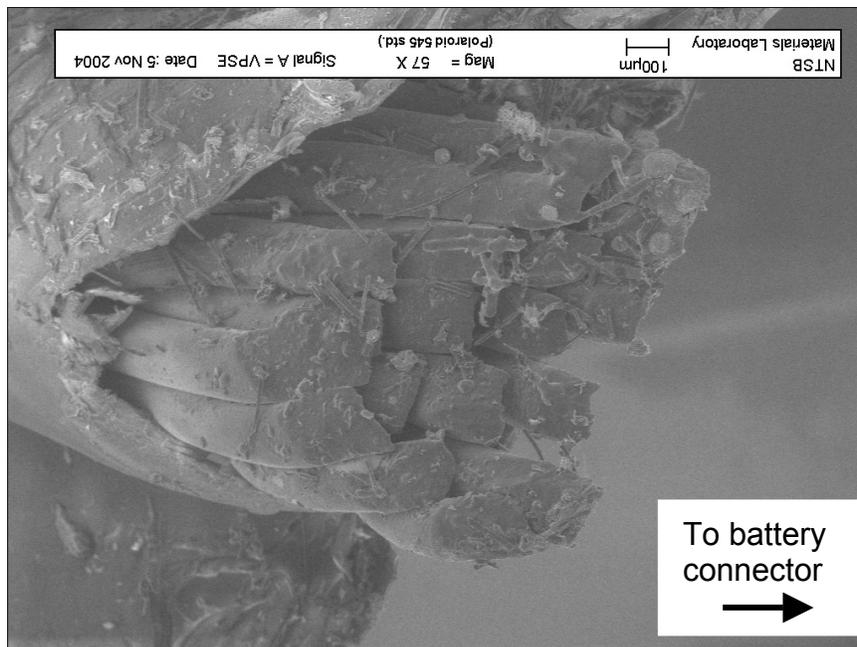
Figure 28. SEM view of power cable strand 4 at Area 3.

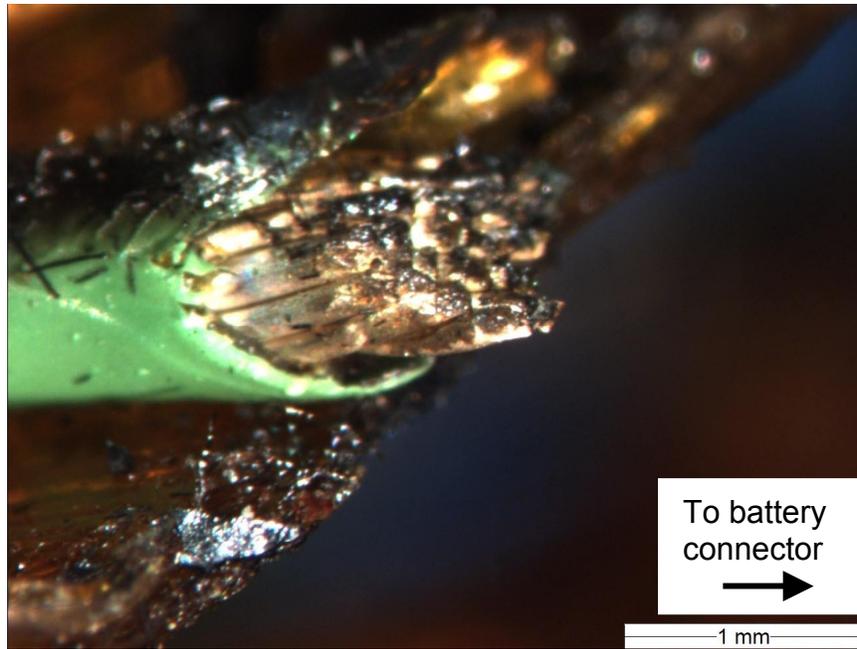
Views of power cable strand 5 are shown in figures 29 and 30. The strand end was bent and individual wires were sheared, consistent with contact with another object. Black deposits were observed on the fractured ends, and where deposits were not present, the strands had a light brown color. The insulator adjacent to the exposed bare strand was charred. Black fibrous deposits also were observed in the area.

Figure 29. View of power cable strand 5 in Area 3.

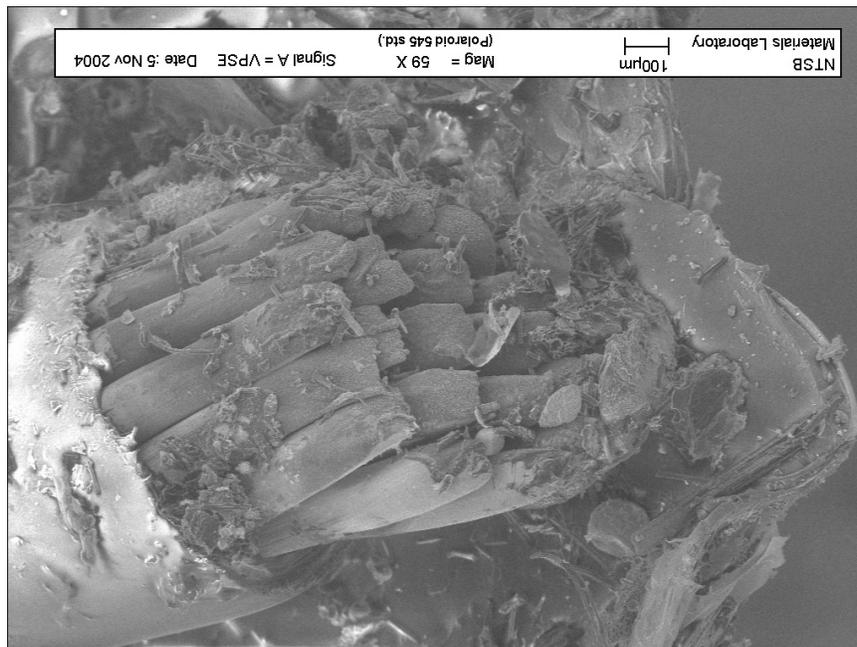
Figure 30. SEM view of power cable strand 5 at Area 3.

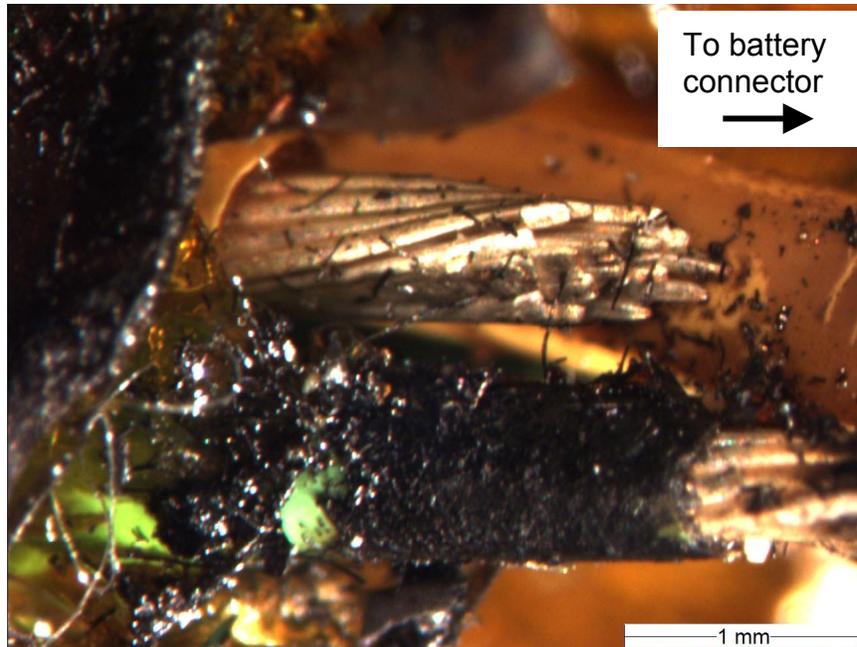
Views of power cable strand 6 are shown in figures 31 and 32. The wires of the strand end were flattened, bent, and sheared, consistent with contact with another object. The insulator adjacent to the bare strand was discolored slightly brown.

Figure 31. Close view of power cable strand 6 in Area 3.

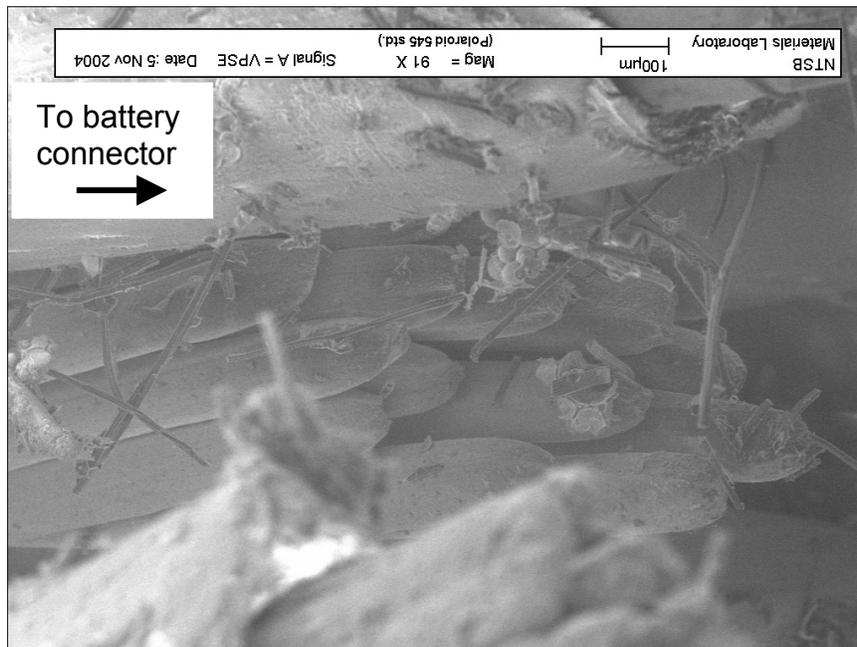
Figure 32. SEM view of power cable strand 6 at Area 3.

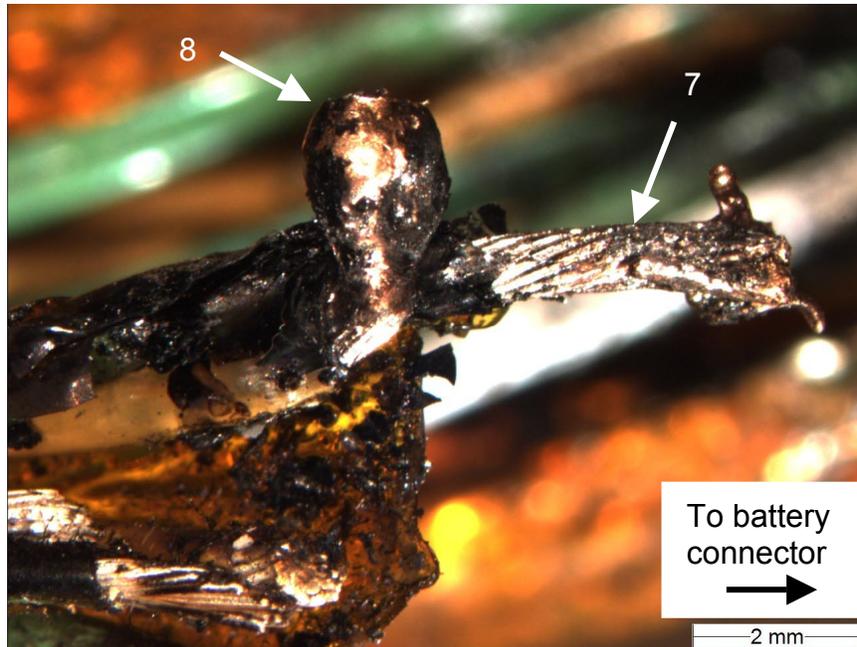
Views of power cable strand 7 are shown in figures 33 and 34. Several wires at the end of this strand were melted into a ball and the ball was oriented at an angle relative to the strand. Several other wires were melted together with an irregular melt shape. The insulator adjacent to the bare strand was charred.

Views of the power cable strand 8 are shown in figures 33 and 35. Individual wires were fused into a single melt ball and the melt ball was oriented at an angle relative to the strand in approximately the same direction as the melt ball of strand 7. The insulator adjacent to the bare strand was charred.

Figure 33. Close view of power cable strands 7 and 8 in Area 3.

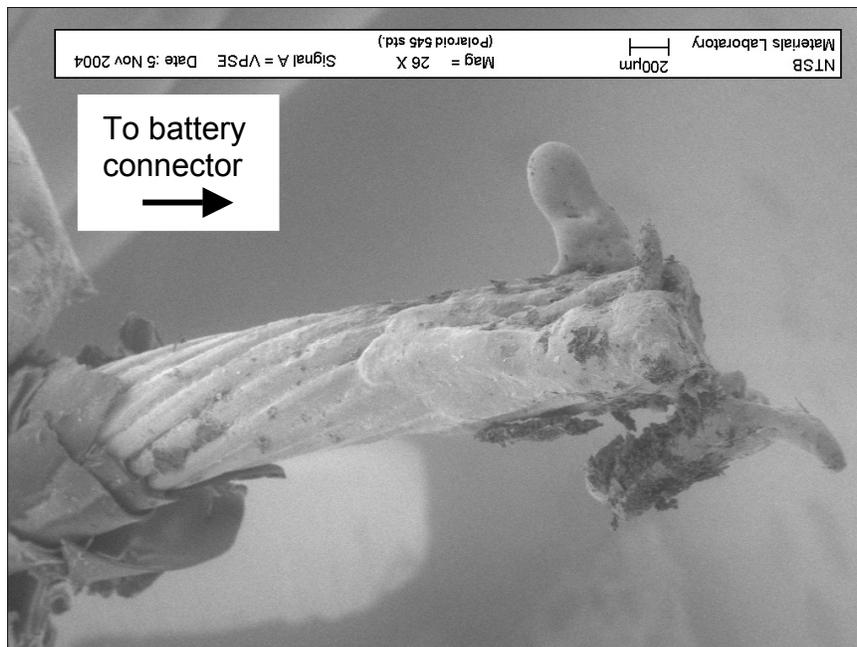
Figure 34. SEM view of power cable strand 7 at Area 3.

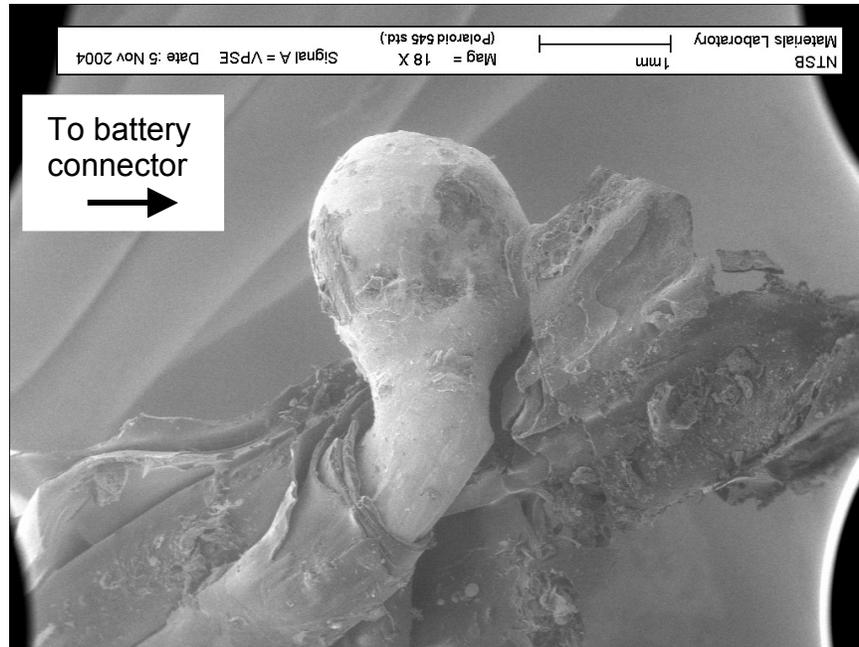
Figure 35. SEM view of power cable strand 8 at Area 3.

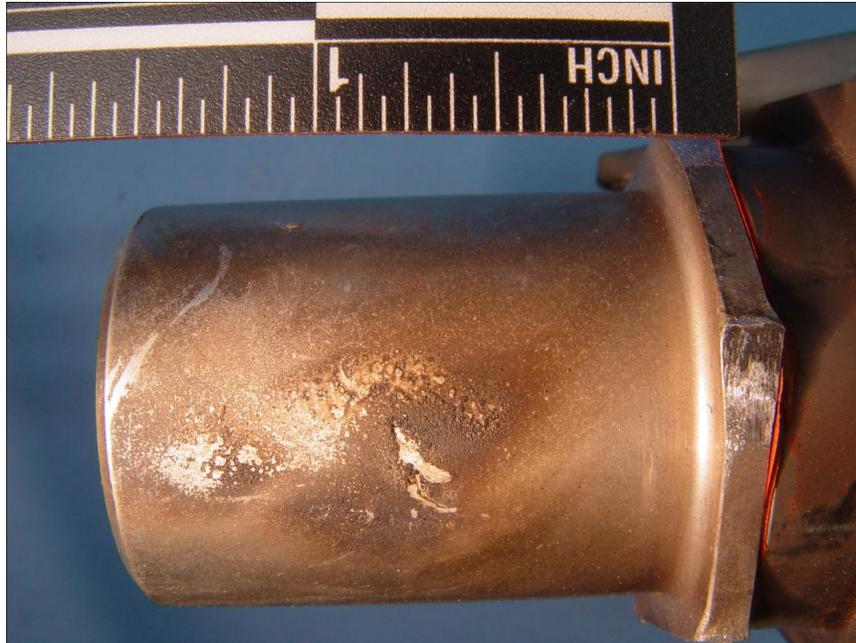
An area of the bolt catcher had black deposits on its surface. A close view of this area of the bolt catcher is shown in figure 39. The flats at the base of the bolt catcher were damaged consistent with wrench contact, which occurred during disassembly of the bolt catcher after recovery.

Figure 39. Close view of deposits on the bolt catcher.
