NATIONAL TRANSPORTATION SAFETY BOARD

MATERIALS LABORATORY FACTUAL REPORT

Report No. 04-133

Place : Dugway, Utah
Date : September 8, 2004
Vehicle : Genesis Spacecraft
NTSB No. : ENG04SA028
Investigator : Clint Crookshanks, AS-40

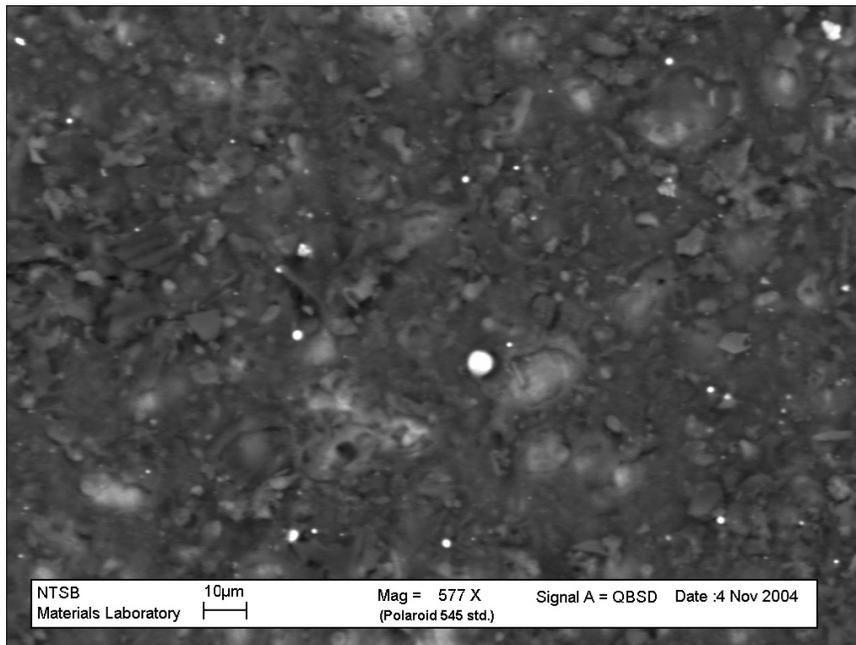
The deposits on the bolt catcher were examined using SEM and EDS. An SEM view using backscattered electrons is shown in figure 40. The deposits appeared mostly darker than the underlying bolt catcher material, but some areas appeared brighter. Most of the brighter areas were round with diameters ranging from less than a micrometer to several micrometers.

Figure 40. SEM view of deposits on the bolt catcher as viewed using backscattered electrons.
