**MAY 24, 1999**

# **WIRE ANOMALY INVESTIGATION REPORT**

**This report documents the results of the JPL Team investigation into the loss of the WIRE Science Mission**

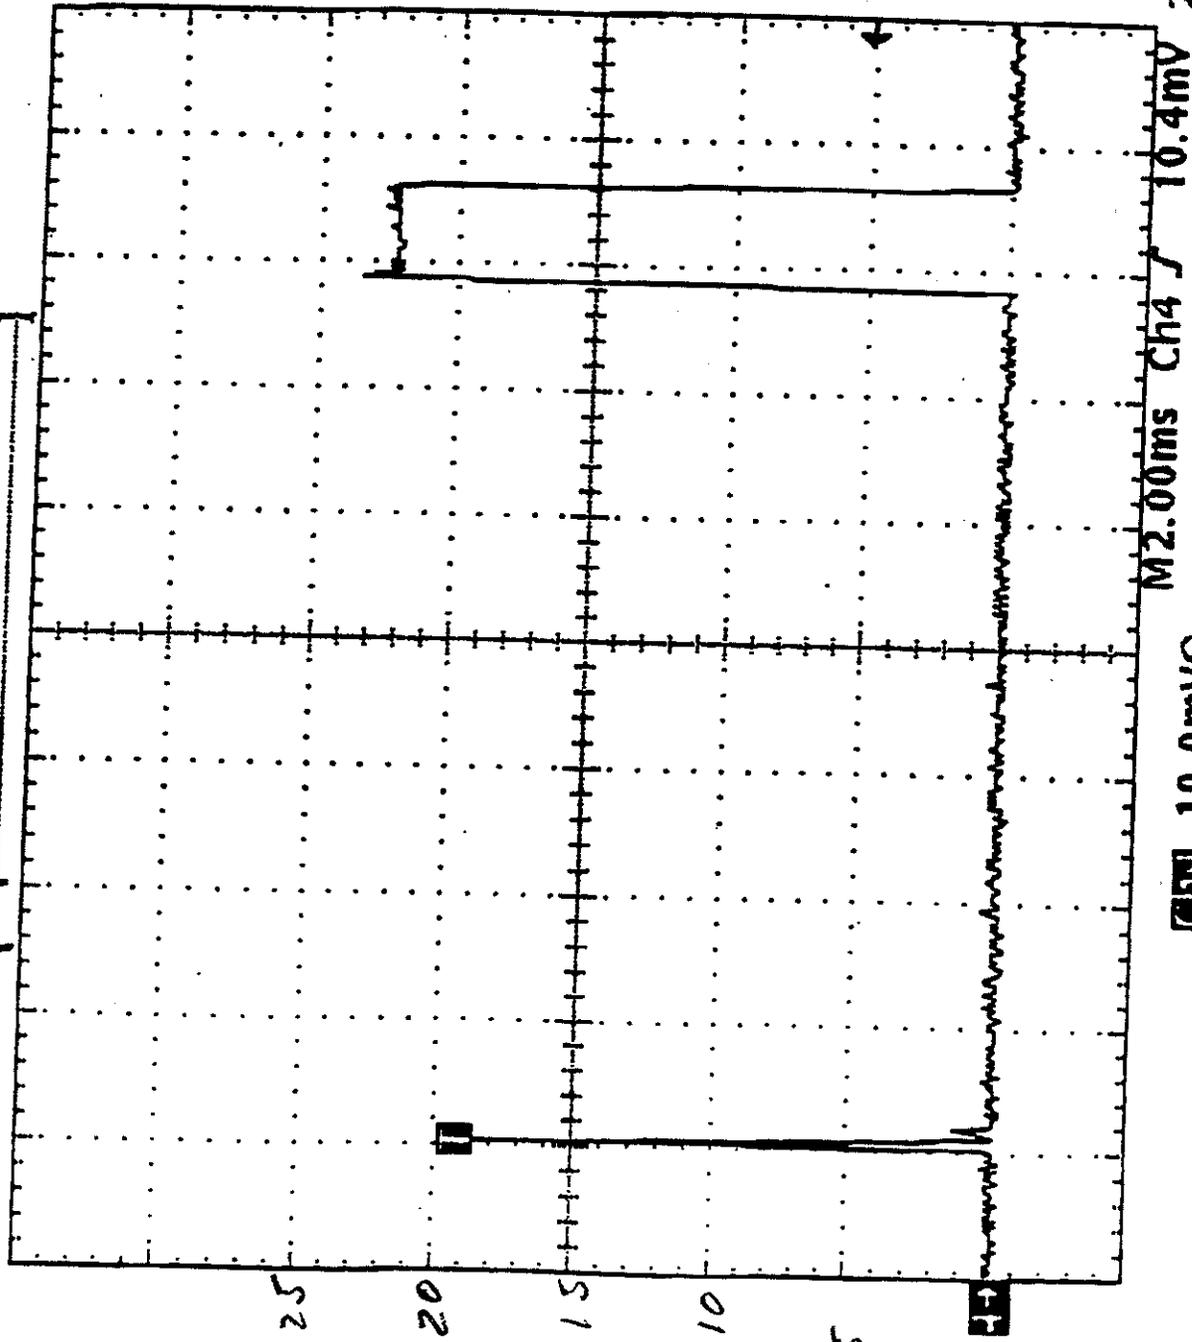
- The pyro design did not appropriately consider power turn-on transient effects (See Figures 6 and 7).
- Fault containment was not adequately considered.
- Detailed reviews were not held for the pyro electronics.
- No end-to-end pyro functional test was performed in full flight configuration with the flight mission sequence and effective pyro device simulation.
- Testing to find anomalous pyro box operational behavior was ineffective due to the deficiencies of test configurations and instrumentation.

5A/DIV  
A SIDE POWER  
INPUT - ETU  
PYRO BOX

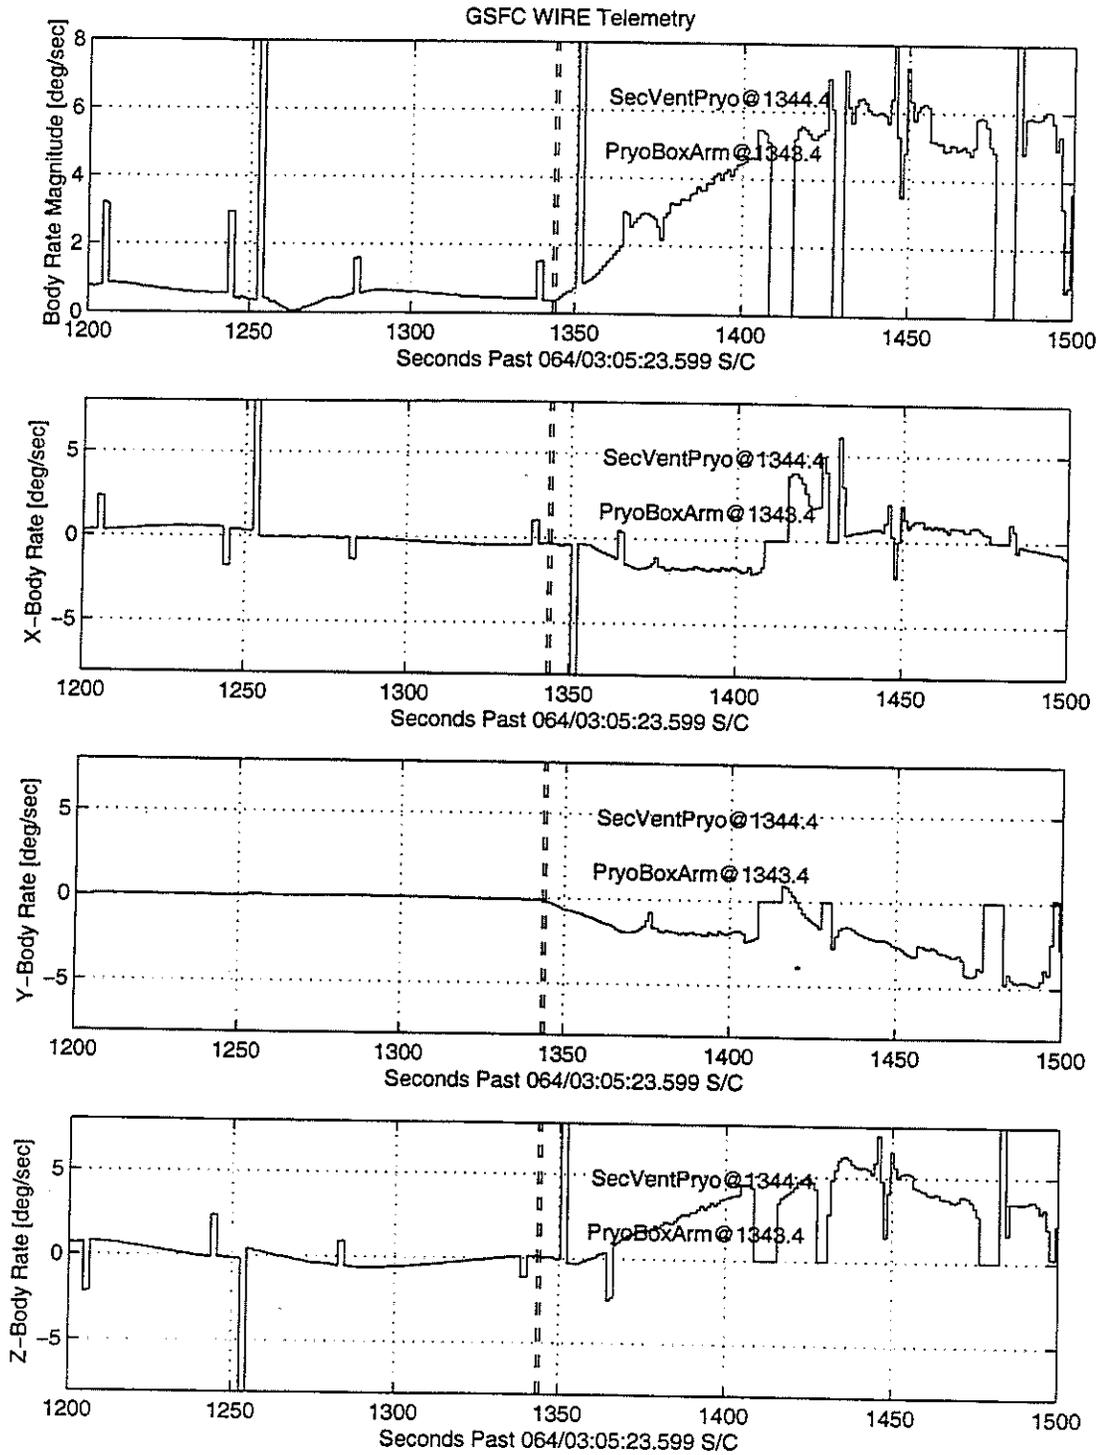
Figure 4.B.6 GSFC Derived S/C Rates

Figure 4.B.6 and Figure 4.B.7 show the derived S/C rates just before and just after the turn on of the pyro electronics box and the firing of the secondary vent pyro. Note that these events took place only 1 second apart.

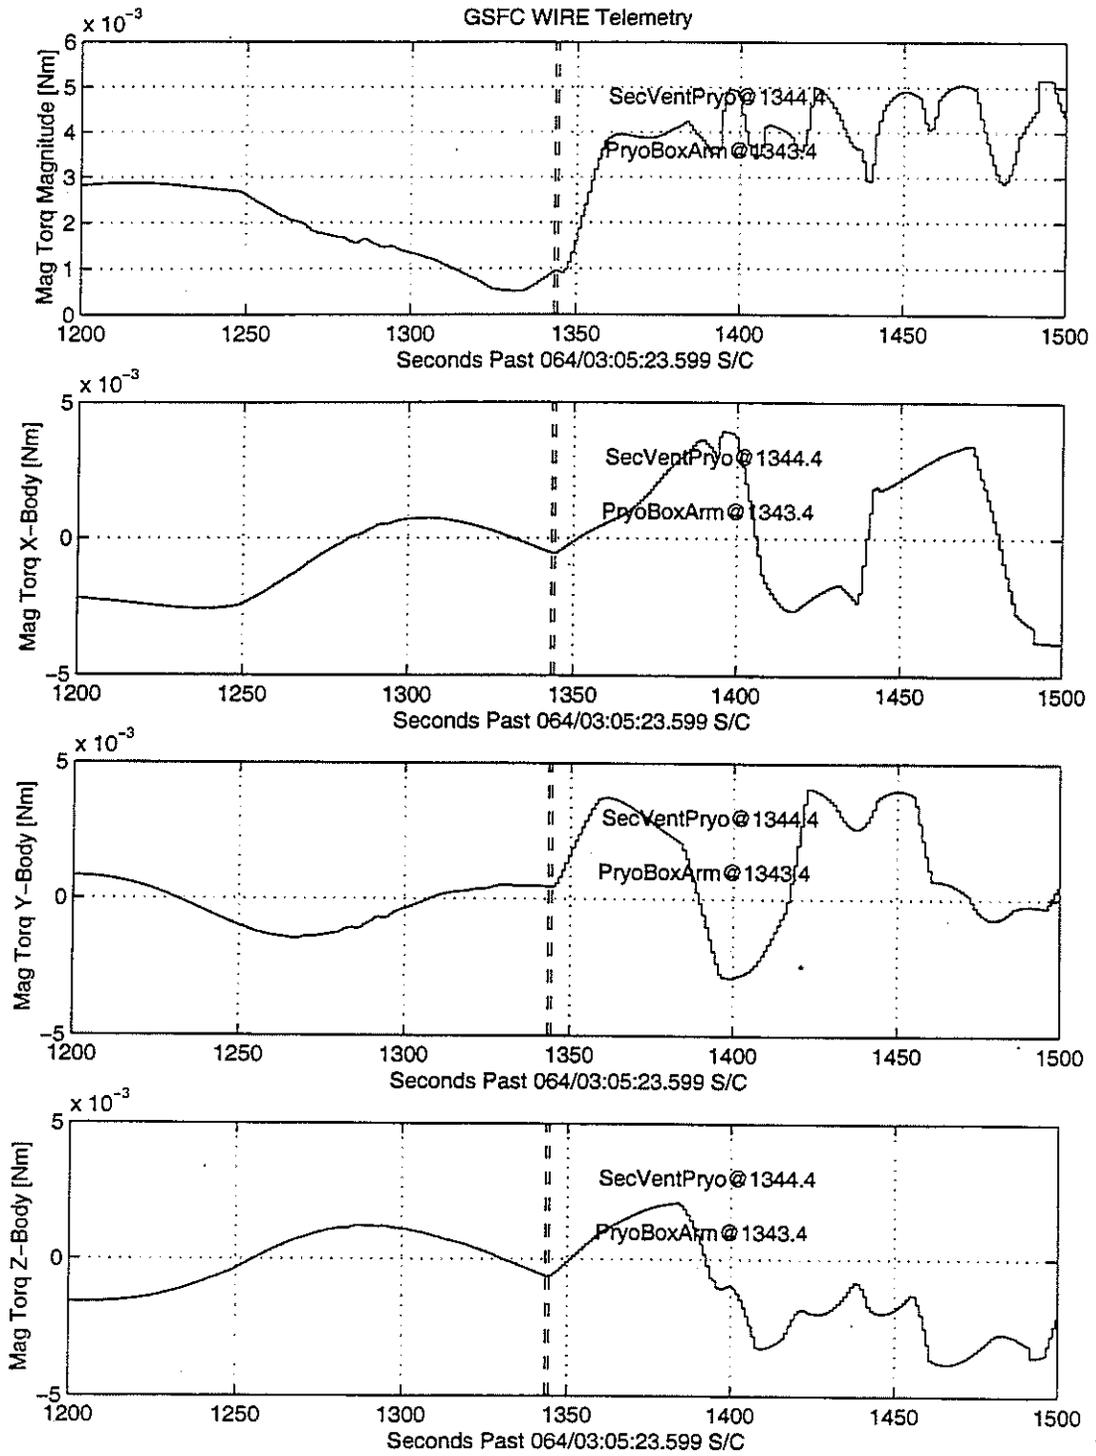
Figure 4.B.7 Magnetic Torque Rods Applied Torques

The rate increases over a period of a few minutes to a level that is large enough to cause the magnetorquers to saturate while opposing the rates. This is expected behavior. What happens next was not expected.

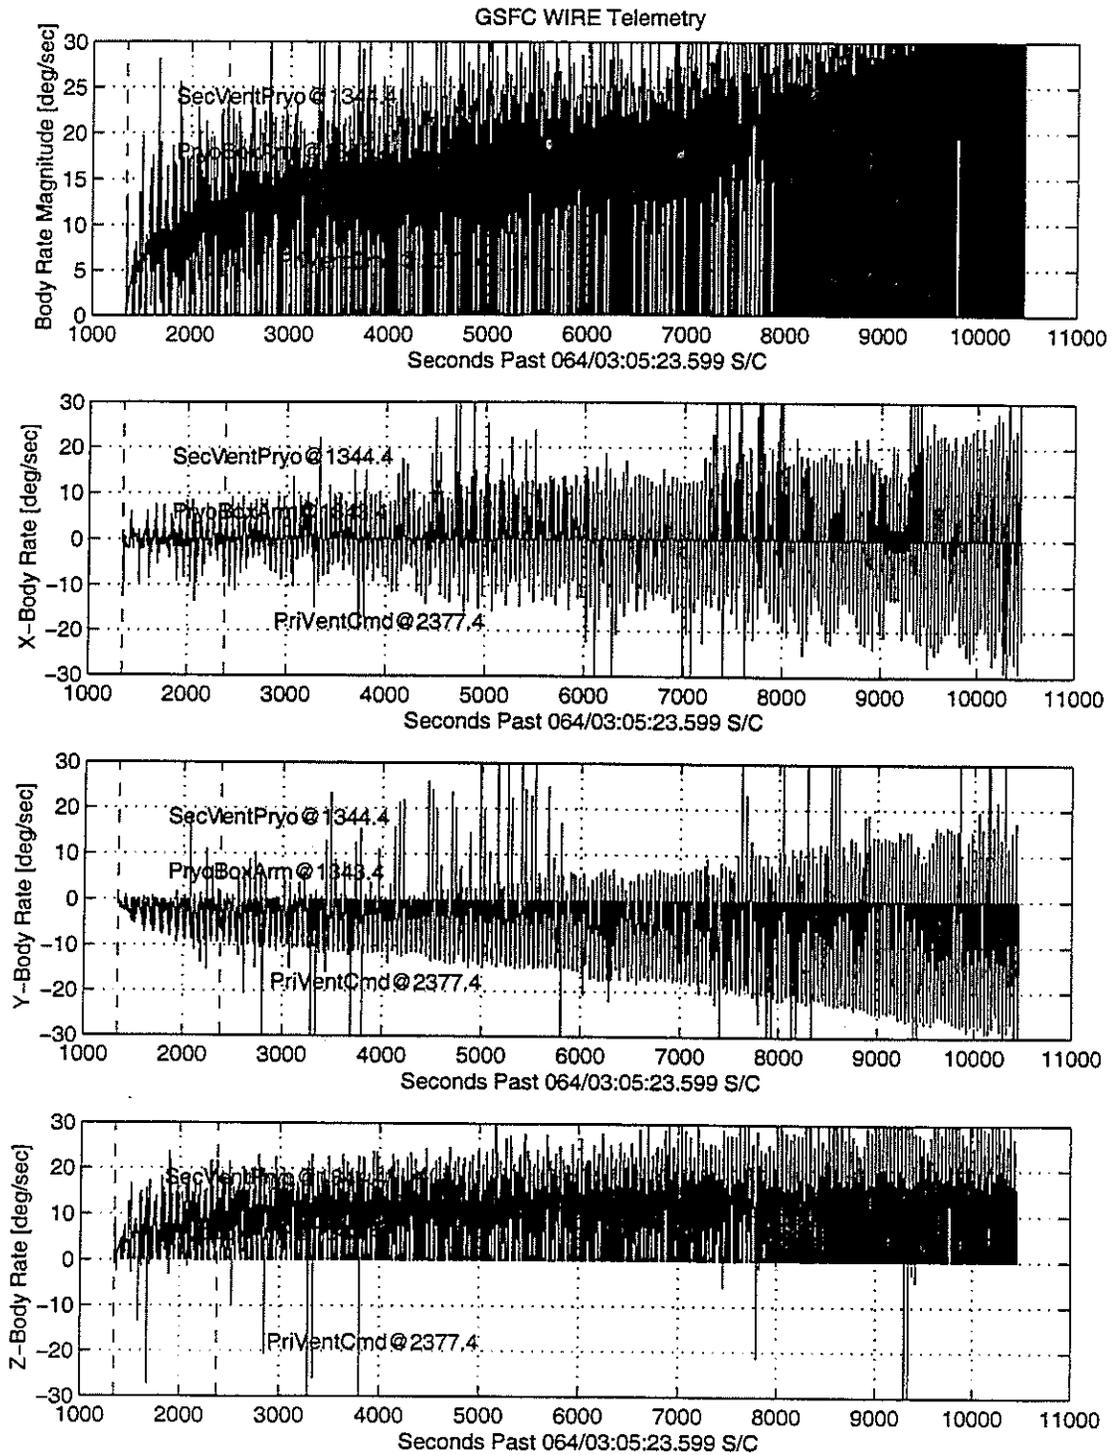
Figure 4.B.8 GSFC Derived S/C Angular Rates

After the initial rate increase subsided, S/C rates kept increasing but at a substantially lower rate of increase than at the "event". This was not nominal behavior. It was expected that the magnetorquers would once again reduce S/C rates to near zero over about an hour's time span. Instead, S/C rates kept rising. This is evidenced in the derived rate data shown in Figure 4.B.8.

Note that the derived data is extremely noisy, but the z-axis spin-up is apparent. The S/C momentum (Figure 4.B.9) shows this more clearly via filtering. Also, a straight line fit to the filtered data shows that a net positive torque of about 0.0015 Nm seems to be spinning the S/C up.

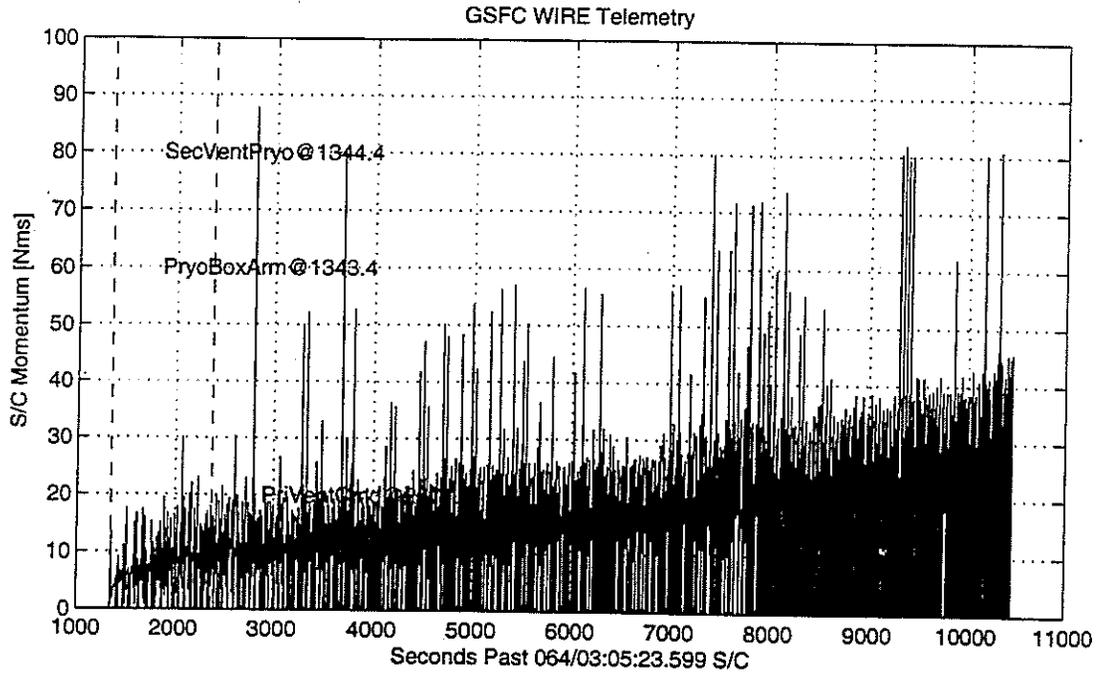
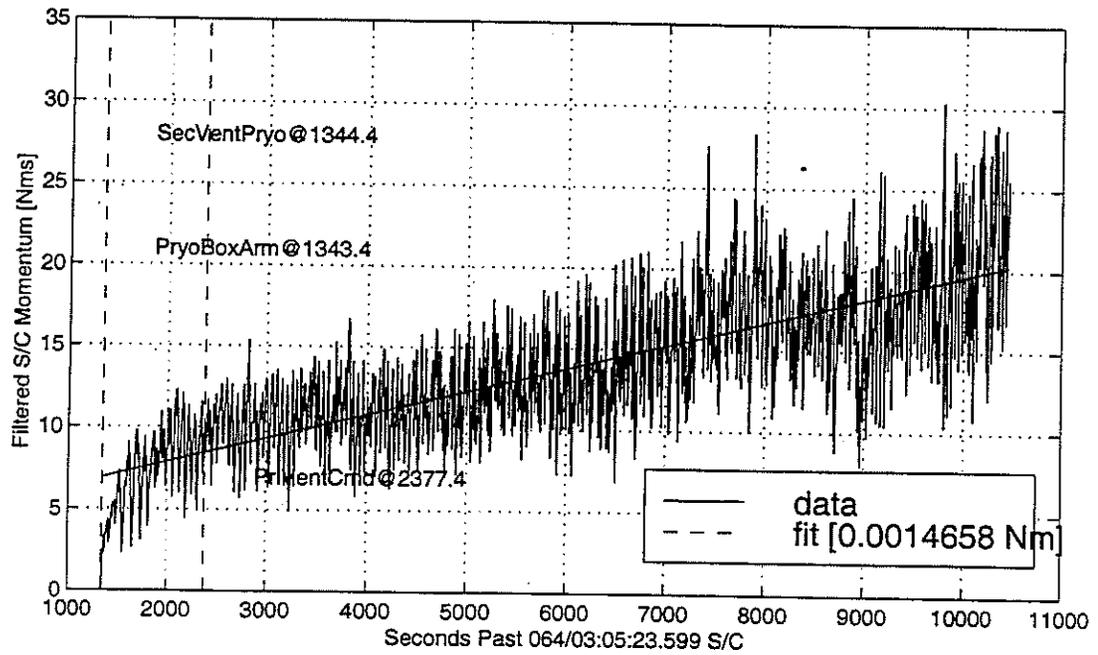
Figure 4.B.9 Derived S/C Momentum (Raw and Filtered)

Although the flight team at GSFC performed several operational and software changes in an attempt to bring the S/C under control over this time period, the S/C spin-up continued for approximately 15 hours. The final spin rate of the S/C was about 60 rpm.

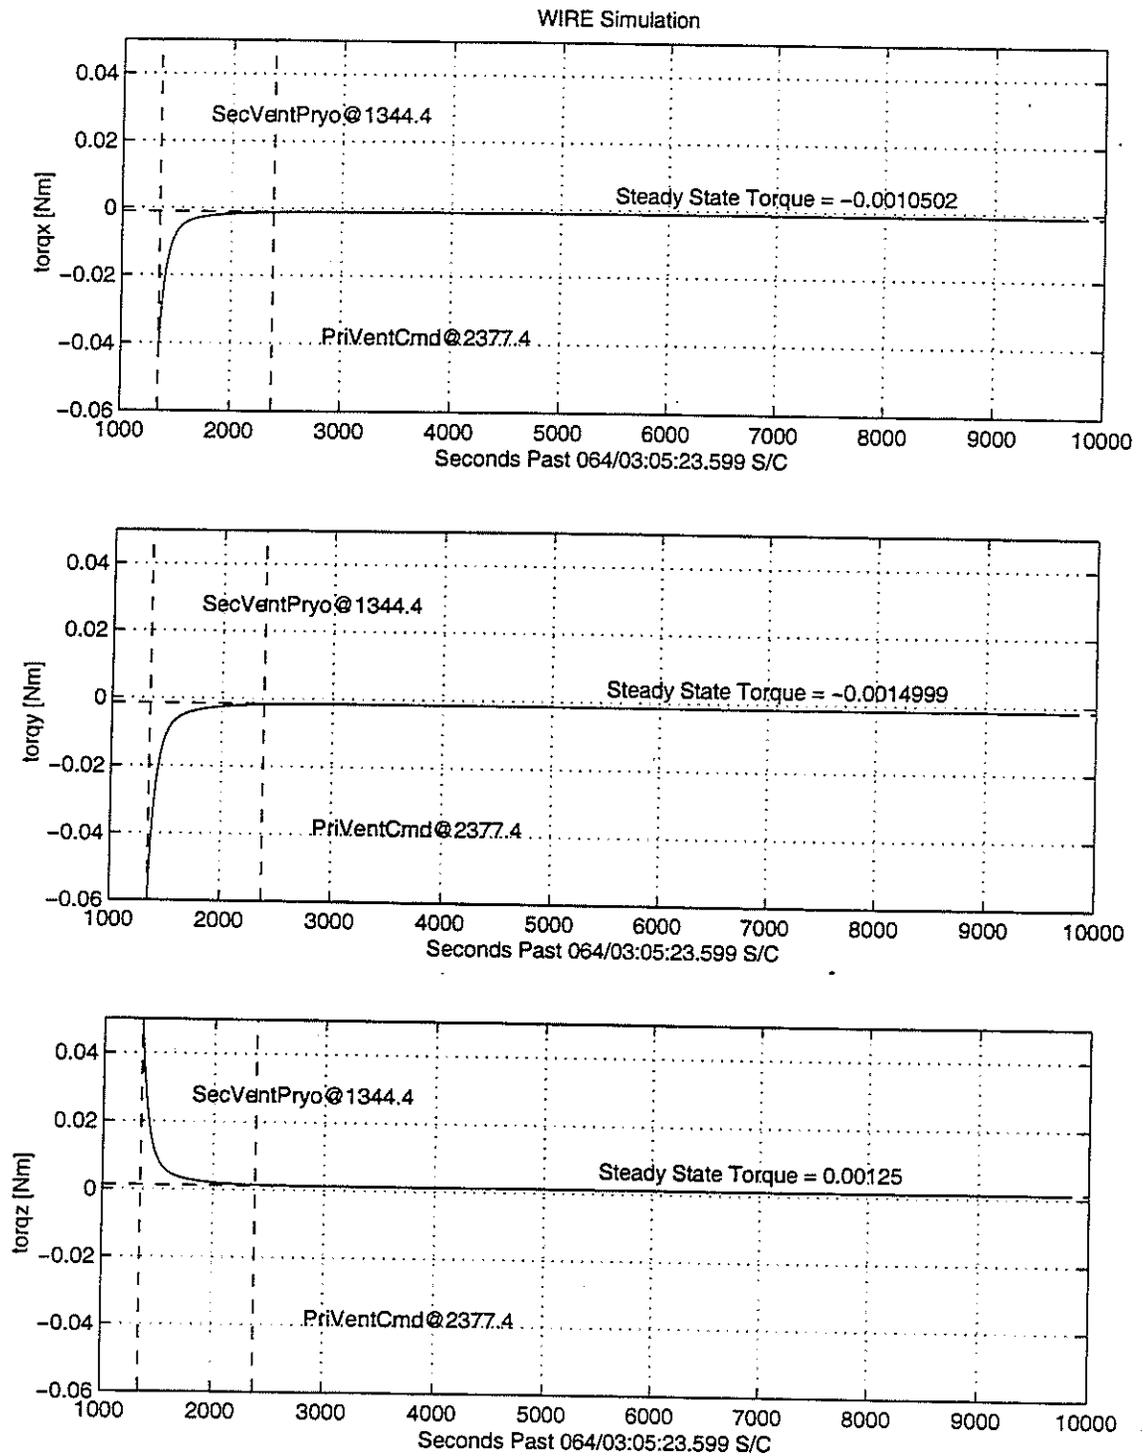
Figure 4.B.10 Simulation Venting Torques

In addition, the initial thrust was found to be more consistent with two decaying exponentials (vent decay and thermal decay) rather than a single decay to a steady-state value. Therefore, two exponential decays were used with the time constants and relative distribution of impulse between the two adjusted to match flight telemetry. The time constants of the exponential decays were 1 minute and 5 minutes.

The final results for the applied torques are shown in Figure 4.B.10. The accompanying simulation rates are shown in Figure 4.B.11.

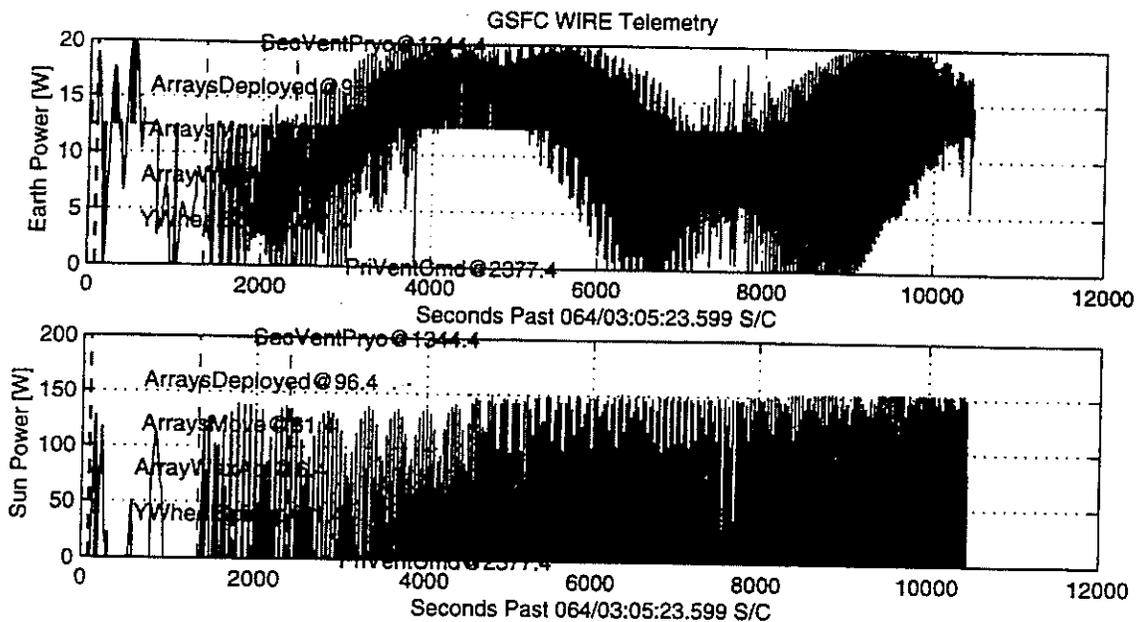
**On-Orbit Solar and Earth Heating.** To assess the total expected heating of the dewar due to Earth and solar radiation, the spacecraft attitude data were combined with models for the incident Earth and solar radiation level as a function of angle of incidence. Figure 4 displays computations of the instantaneous Earth and solar heating of the open dewar based on the measured spacecraft attitude data from the time of initial ACS powering just after separation from

Figure 4. Computed Earth and solar heating of the open dewar based on the measured WIRE spacecraft attitude data for the first 12,000 seconds of the mission.

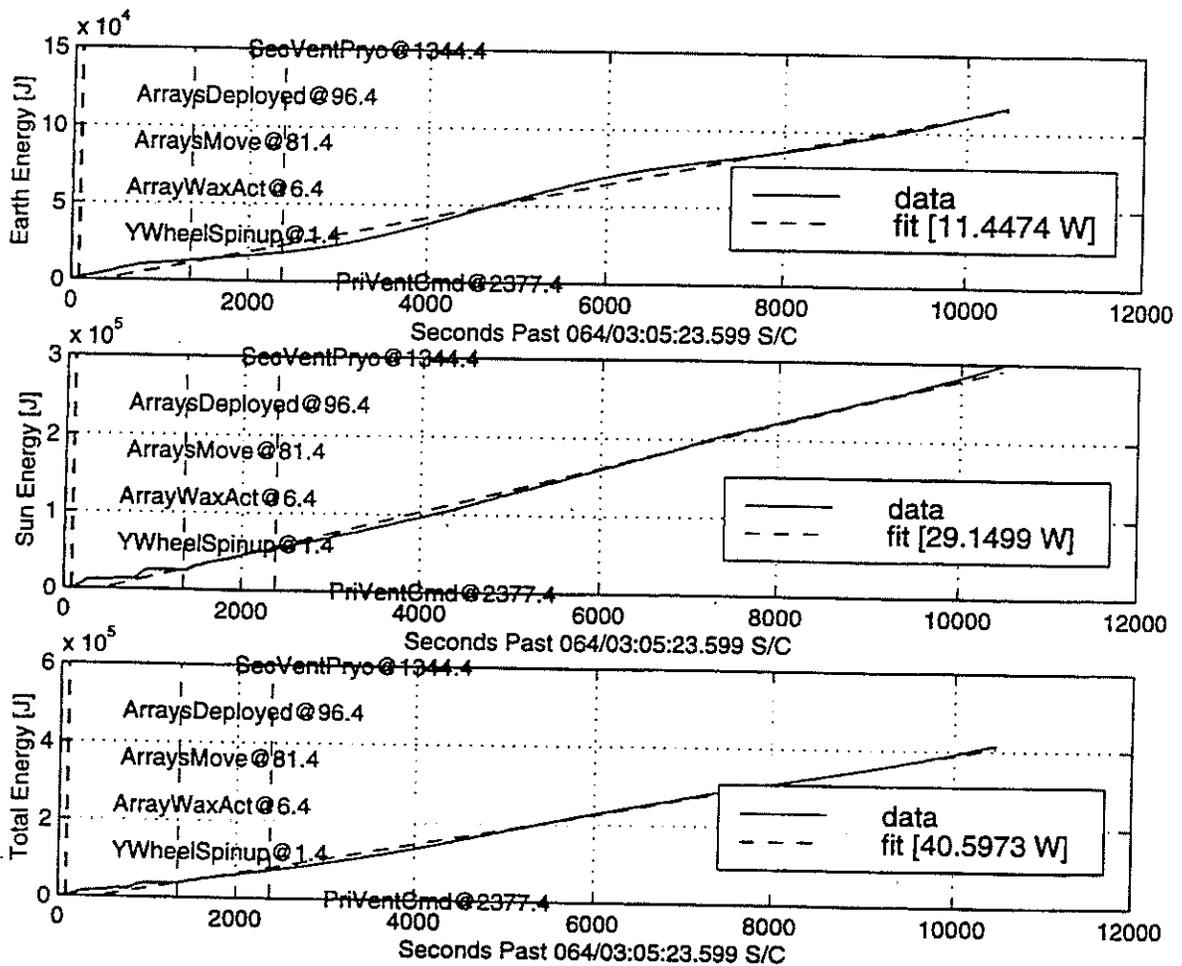
the launch vehicle. Figure 5 displays the resulting integrated heat loading which is seen to total to about 40 watts. As will be shown later, this heat load is consistent with the observation that the cryogen was totally exhausted at around 15 hours after cover deployment.

Figure 5. Integrated Earth and solar heating of the open dewar based on the measured WIRE spacecraft attitude data for the first 12,000 seconds of the mission.

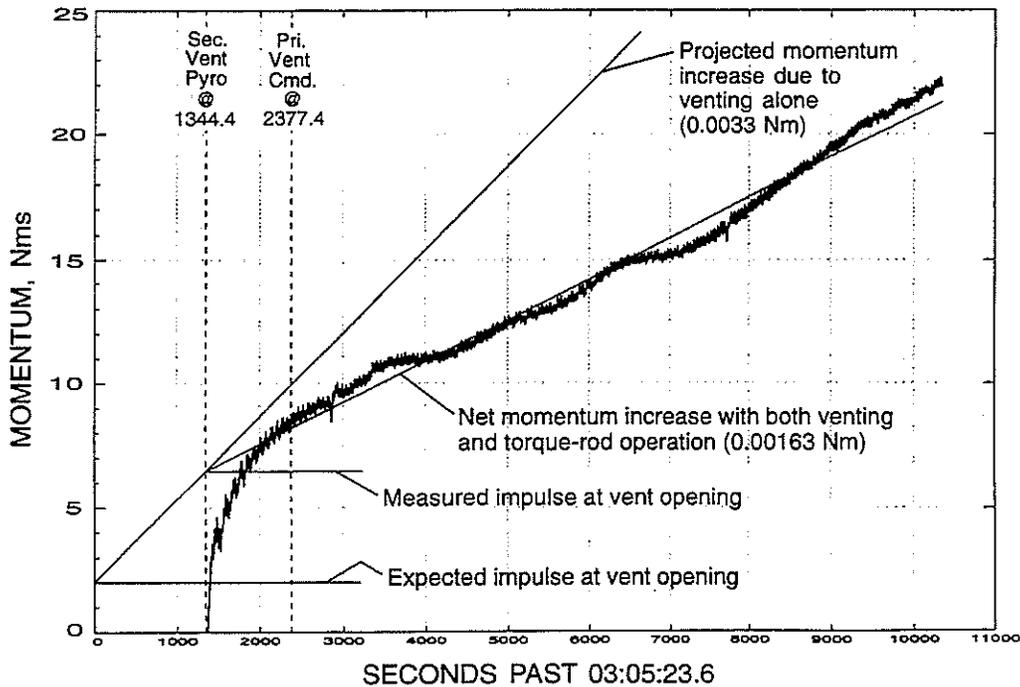
Figure 8. Recorded increase in spacecraft momentum following secondary vent opening.

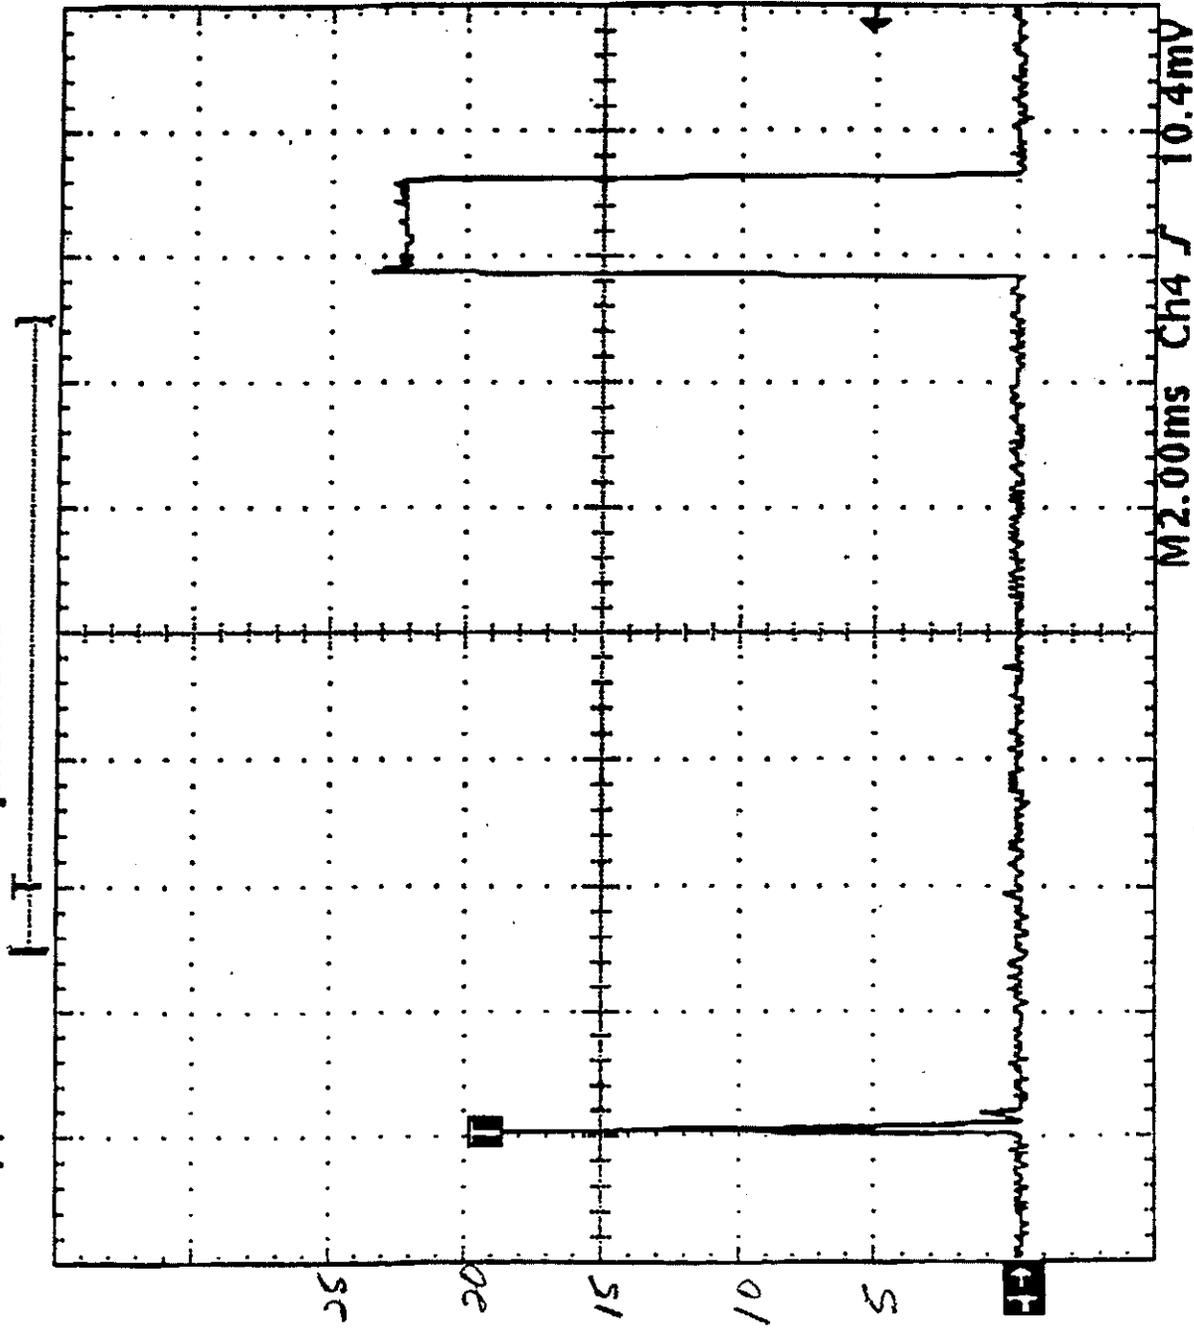
5A/DIV  
A SIDE POWER  
INPUT - ETH  
PYRO BOX

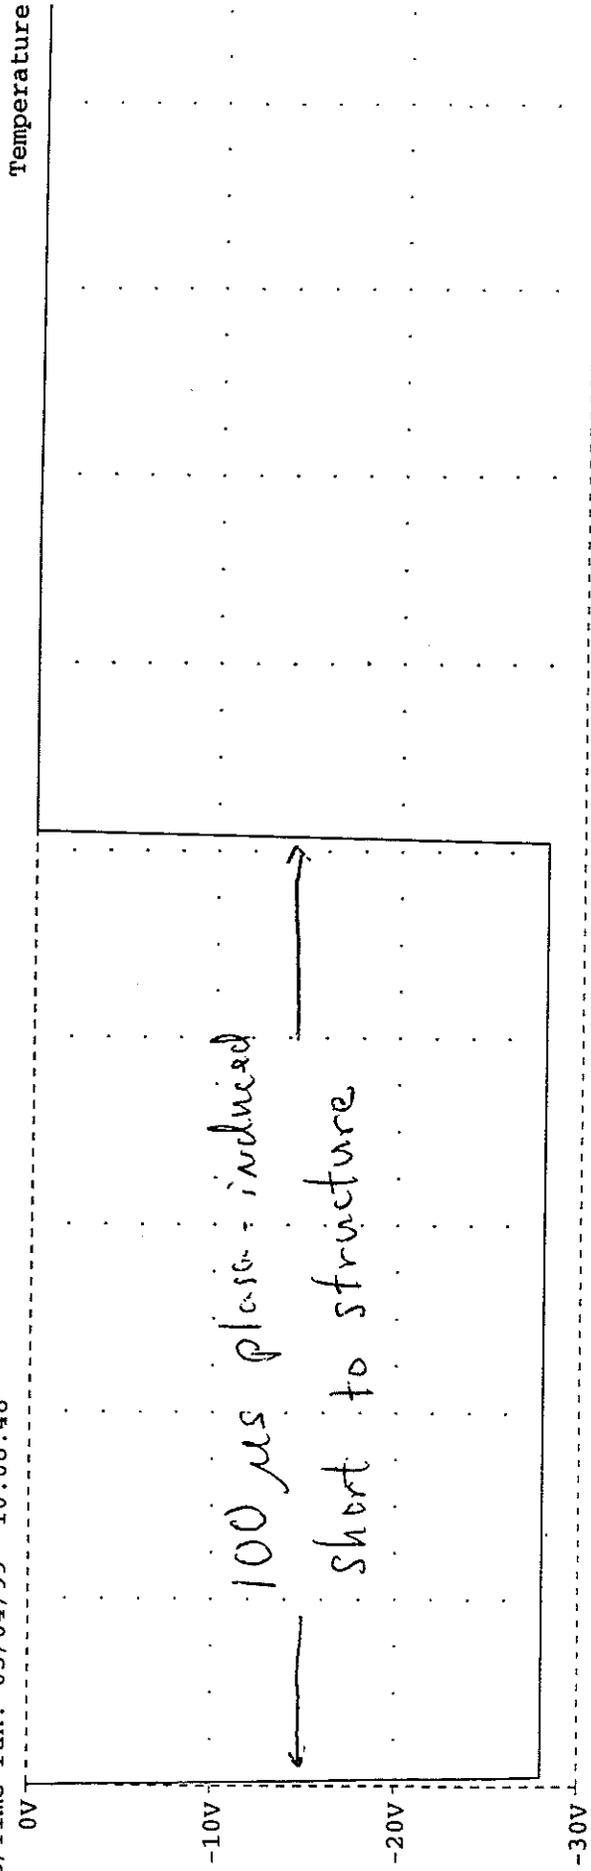
Analysis ATTACHMENT 2: Model for cross-talk induced ringing in Logic Return  
 Leading to sympathetic firing

Resulting ringing in Logic Return

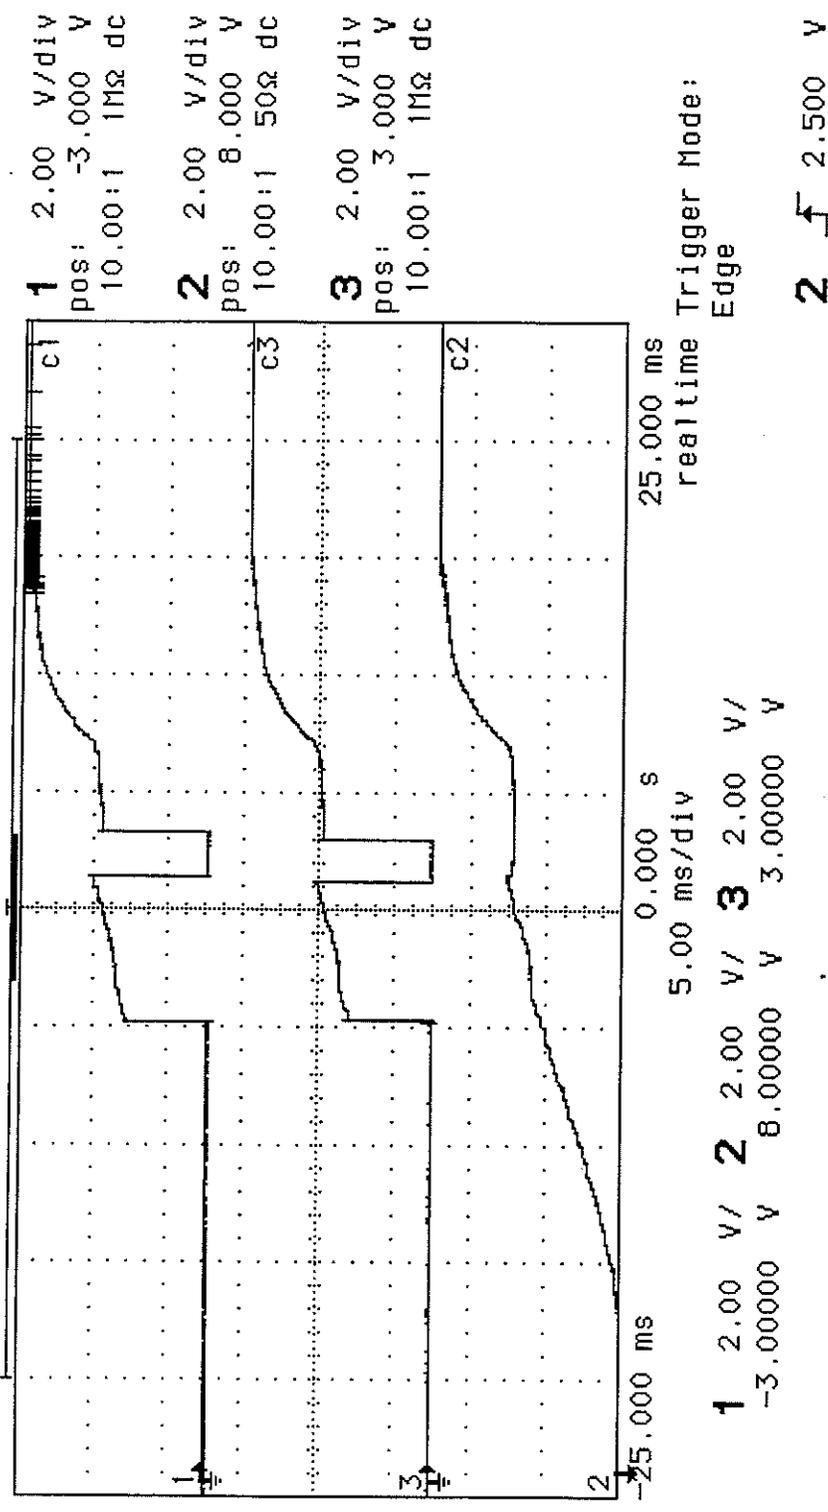
Figure 3. Power-on transient of a space-qualified A1020 (2.0  $\mu$ m). The power supply rise time was approximately 20 msec. Horizontal scale is 5 msec per division and vertical scale is 24 hours off; it would not repeat after rapid power on-off cycles.
