Mars Observer Loss of Signal: Special Review Board Final Report

November 1993

NASA

JPL Publication 93-28

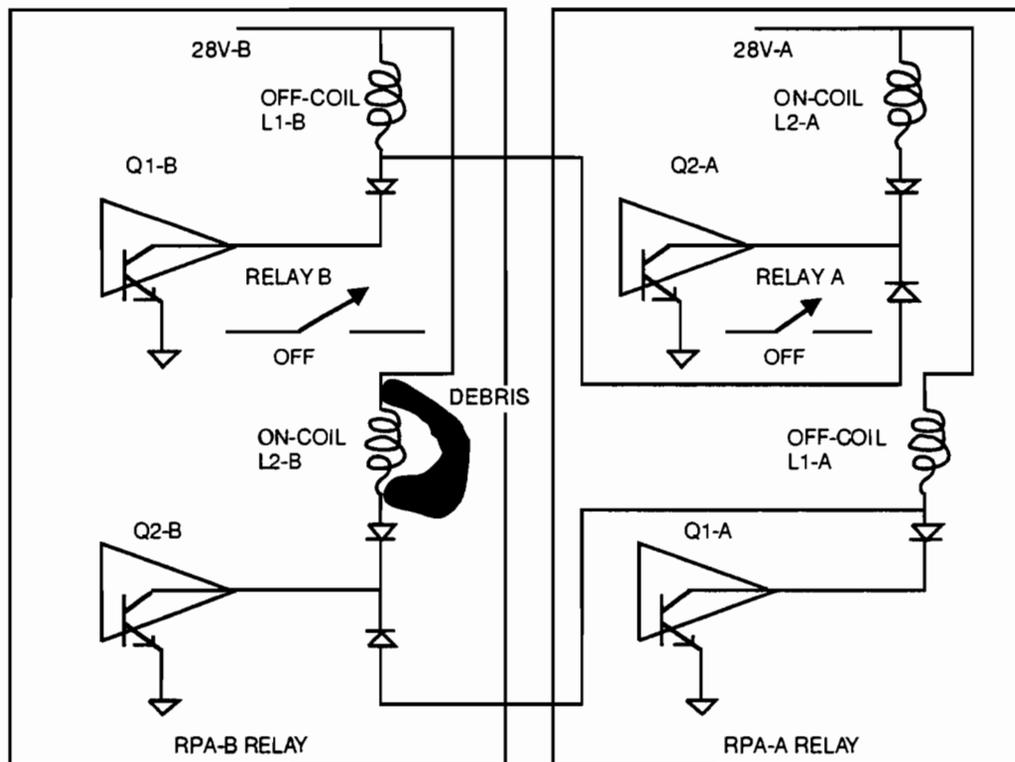
Figure 7-8. Pyro shock leads to internal debris, which leads to short across coil L2-B.

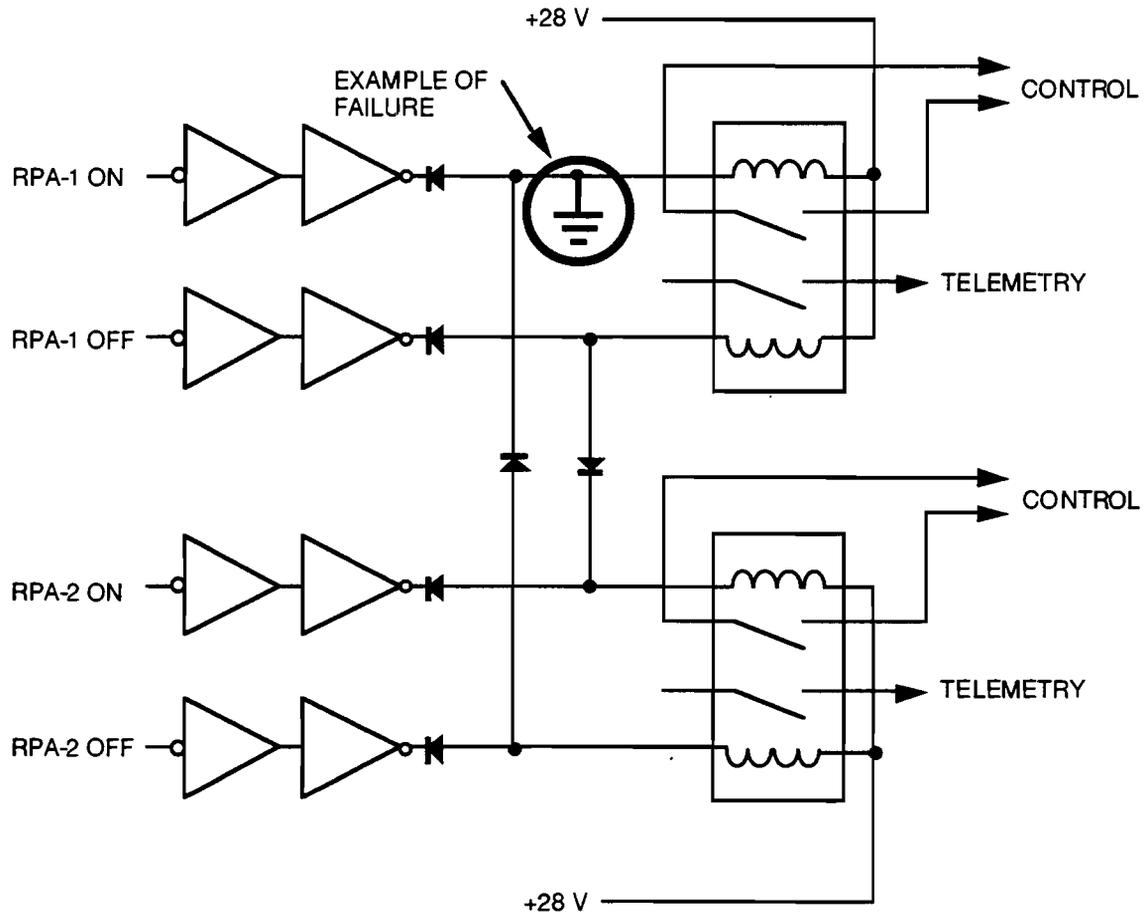
Figure 7-10. An example of a single-failure point in SCU that inhibits RPA Beam On.

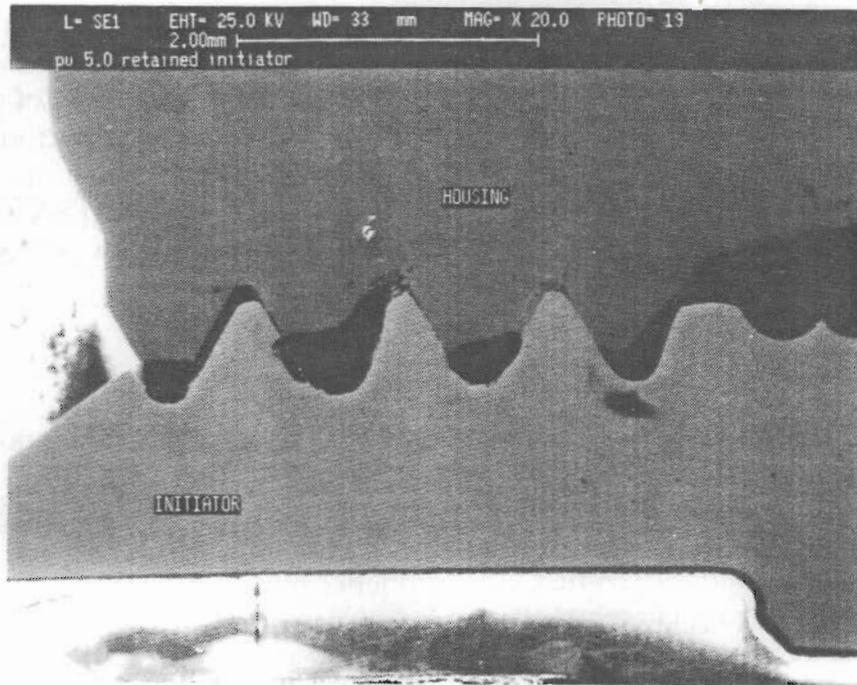
Figure P-1. Detail of the thread of the passive initiator, showing erosion damage to the Ti-alloy thread and to the Inconel 718 thread.

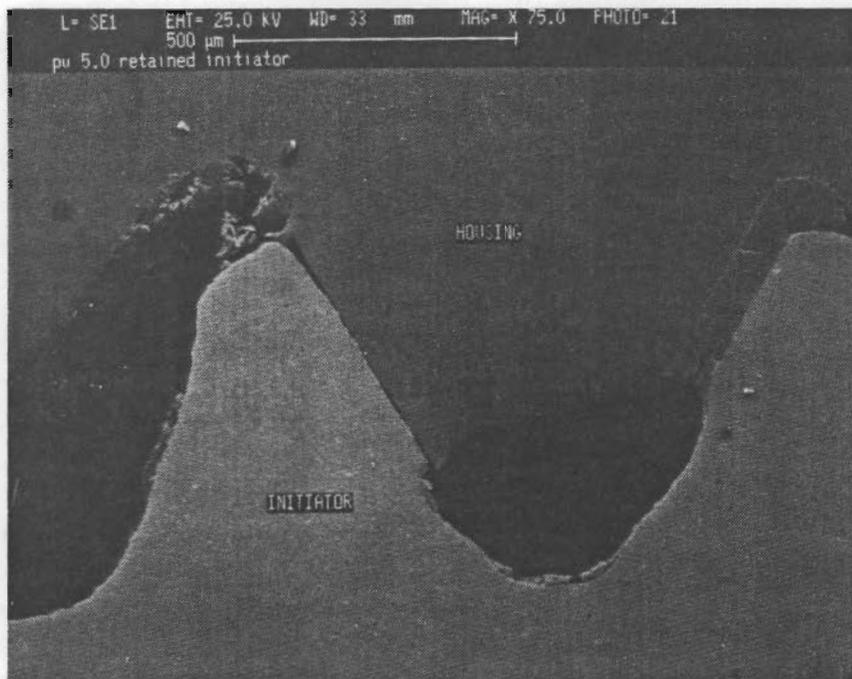
Figure P-2. Detail of eroded initiator and housing threads. In every case, the Ti-alloy thread is eroded at the top of a tooth and the Inconel at the opposite side at the root of the thread. Firing residue can be seen between the threads.
