Report
on
High Energy Solar Spectroscopic Imager (HESSI) Test Mishap

By the
HESSI Test
Mishap Investigation Board

Released May 18, 2000

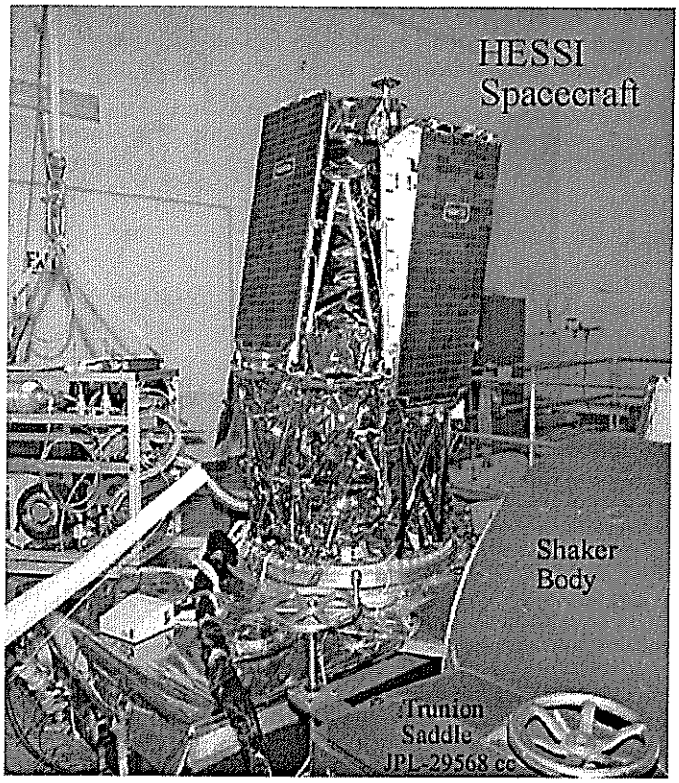
Figure 4-1

The High Energy Spectroscopic Imager (HESSI) spacecraft primary mission objective is to explore the basic physics of particle acceleration and explosive energy release in solar flares. The HESSI spacecraft was scheduled for a July, 2000, launch on a Pegasus vehicle as part of the Small Explorer Program (SMEX). On March 21, 2000, the HESSI spacecraft was being subjected to a series of vibration tests at JPL as a part of its flight certification program. The structural qualification test, denoted as the sine-burst test, subjected the spacecraft to a major overtest that resulted in significant structural damage to the spacecraft. The incident has been designated as a Class A mishap since the damage exceeded $1 million.

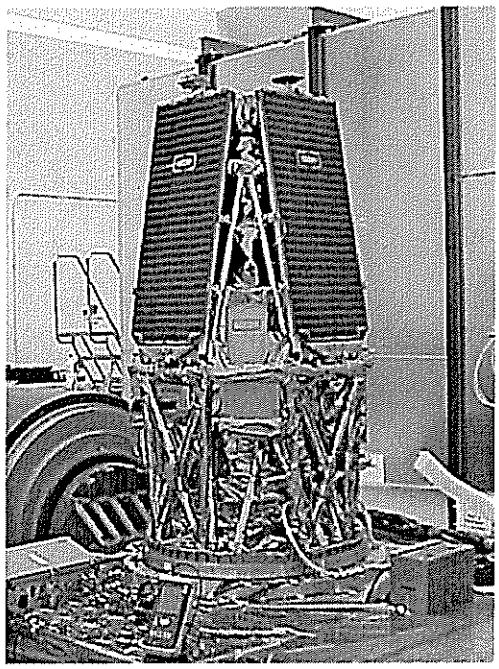
Figure 6-1

The HESSI spacecraft was mounted to an adapter ring that was then mounted to the magnesium alloy slip table via an aluminum fixture plate, as shown in Figure 6-1, in preparation for testing in the spacecraft's X direction. Twenty-four force gages were placed between the spacecraft adapter ring and the fixture plate at each of the attachment bolt locations to measure the force input to the spacecraft.

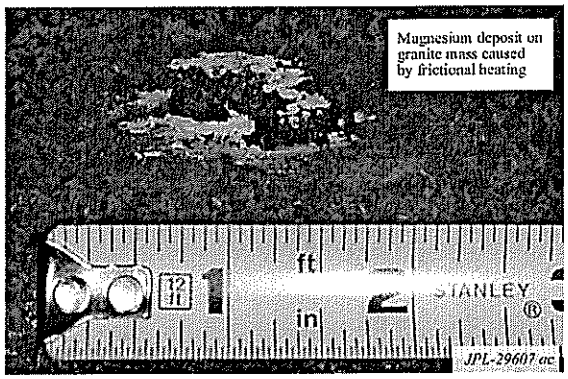
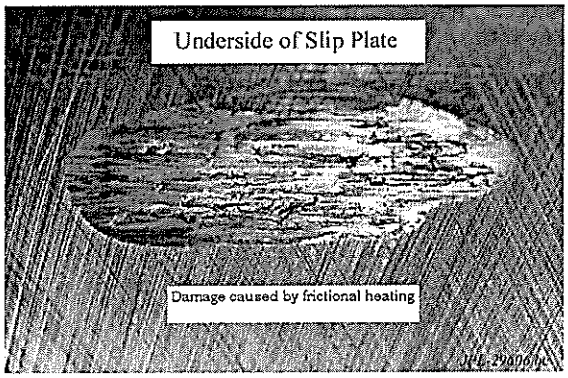
Subsequent disassembly of the shaker system by the JPL laboratory personnel revealed that the trunion support needle bearing on the north side of the shaker has a broken outer race and some of the rollers are loose and missing from the bearing housing. The 1", grade 8 bolts mentioned above are actually broken with the through holes for the fasteners being misaligned with the threaded holes by approximately ½ diameter of the fastener. The underside of the slip table is also damaged. The area of contact between

the slip table and the granite mass generated sufficient heat due to friction to cause the magnesium alloy material from the plate to deposit onto the granite mass, refer to Figure 7-1 below. The plate has an area of material loss that is consistent with the metallic deposit found on the granite mass, refer to Figure 7-2 below. The damage to the bottom of the slip table is not consistent with a shock event that has duration of only a few cycles. It is consistent with several minutes of operation during which heat would have continued to build in that local contact area. The slip table and granite would have to operate in a "rubbing" condition for sufficient time to build enough heat in that area to cause the deposit of the magnesium alloy onto the granite mass. It is evident that the material loss of the damaged area of the slip table is not simply the result of abrasion. Ample evidence has been detailed that shows the stiction condition was present throughout the day's testing.

Recommendation: Refurbish or replace the Ling Model A-249 shaker.
