JPL Publication 2005-2

Genesis Failure Investigation Report

JPL Failure Review Board, Avionics Sub-team

July 2004

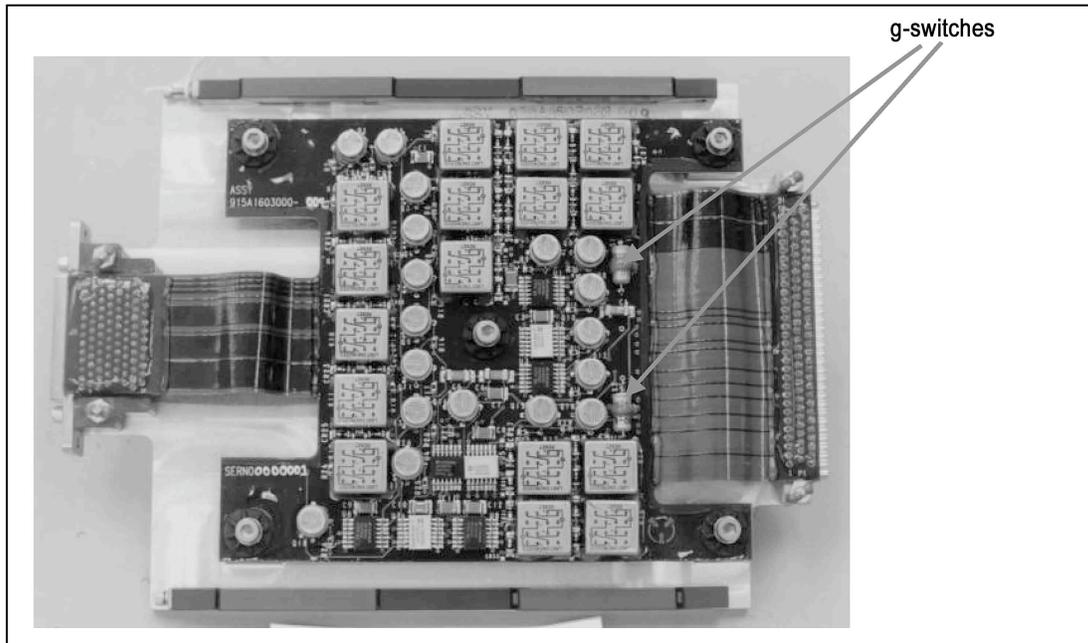
Figure 2-9. G-switch location in relay module

Shortly after the mishap, LMA engineers identified the proximate cause of the failure in less than a week. The forensic evidence indicated that the first pyro event had not occurred (i.e., the drogue chute had not deployed). The list of possible common mode failures that could affect both avionics units was small. LMA engineers quickly identified the improper orientation of the G-switch as a simple common fault in both redundant avionics units that could explain the entire failure. Examination of the as-built relay module indicated that this was indeed what had happened.

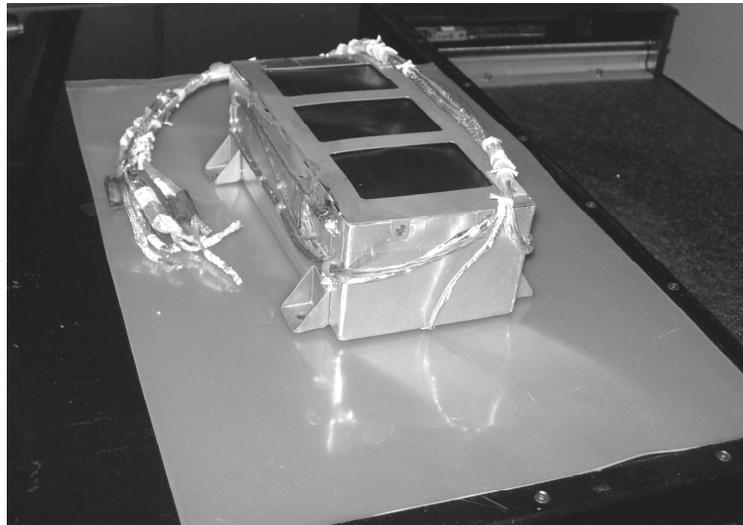
Figure B-2. SRC battery, pre-flight

A thorough inspection of the battery was performed at JPL, including dimensions, weight, and some electrical measurements at the battery level. Peripheral devices such as the four temperature sensors and the three heater strips were also measured. All measurements were also done on the ATLO battery for comparison. The outer appearance of the battery looked very clean and indicated minimal damage from the hard landing. Figure B-2 shows the battery during initial inspection at JPL.

With the exception of a bowed top cover and some discoloration/staining on the top cover and black Kapton (Figures B-3, B-4), the battery surprisingly escaped severe damage from the hard landing. Physical dimensions of the battery were measured and were found to be comparable to pre-flight measurements, with the exception of height. This discrepancy is due to the bowing of the top cover.

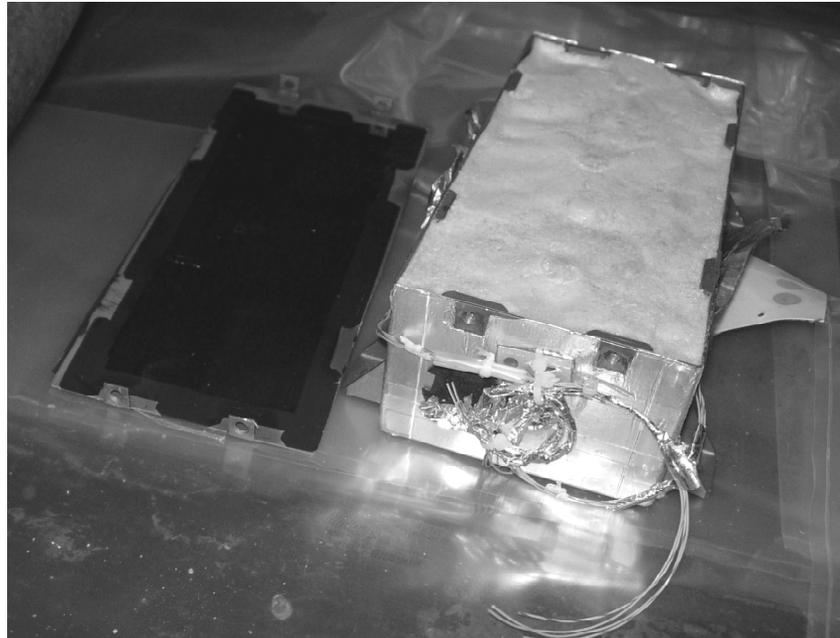
Figure B-6. ATLO battery showing pristine Eccofoam insulation

The ATLO battery (i.e., one that had not been exposed to a flight environment) was opened first for comparison purposes. Figure B-6 shows the top of the ATLO battery underneath the cover and Kapton layers. The Eccofoam insulation looks pristine and has a pinkish color. By contrast, when the SRC battery top cover was removed, there was significant discoloration of the Eccofoam insulation, indicating exposure to excessively high temperatures (Figure B-7). The worst discoloration, almost black, was localized over the nickel cell interconnect tabs. This condition is consistent with high-rate discharge over a significant duration.

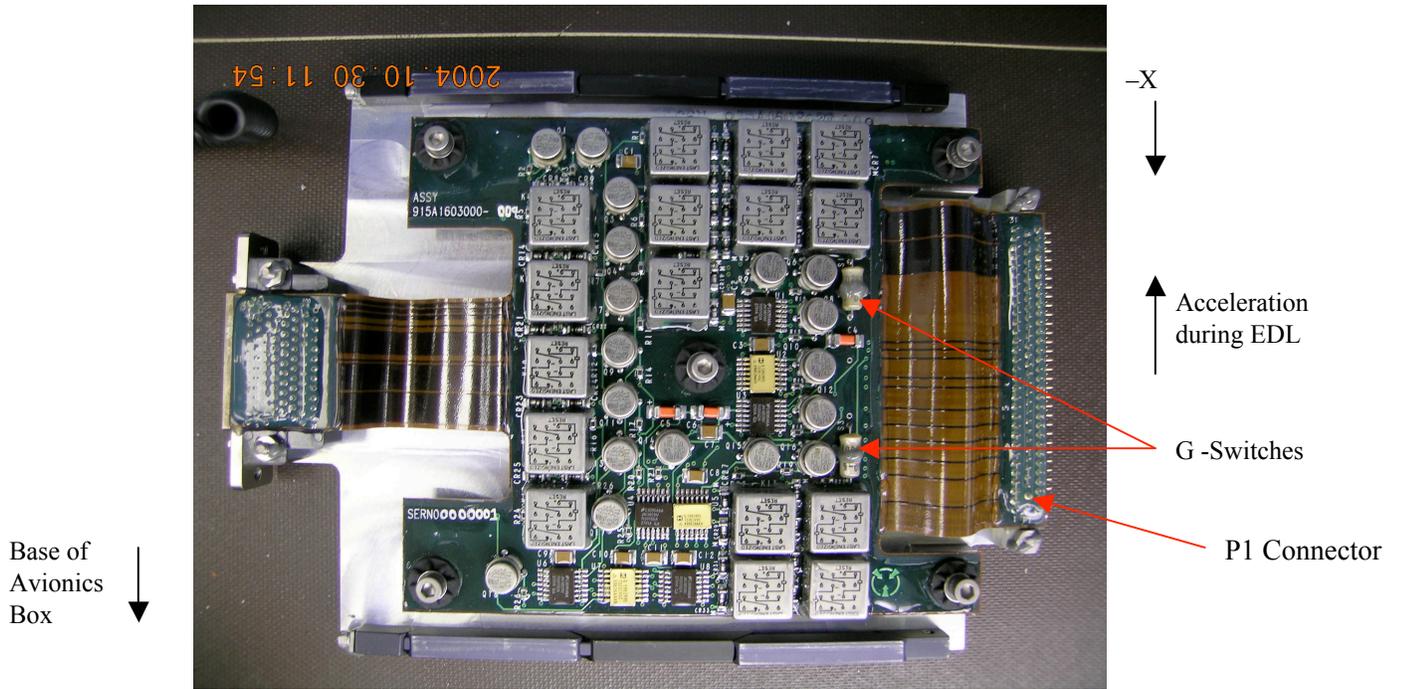
Figure G-1. Avionics Box A Relay Card SN 001

A card-level continuity test was performed. Continuity was measured from power-to-ground and power-to-power for each primary and secondary power net. There were no shorts.

Continuity was also measured at the card level from each separate pyro output-to-ground and from each separate pyro output-to-pyro output. There were no shorts.
