NATIONAL TRANSPORTATION SAFETY BOARD

MATERIALS LABORATORY FACTUAL REPORT

Report No. 04-133

Place : Dugway, Utah
Date : September 8, 2004
Vehicle : Genesis Spacecraft
NTSB No. : ENG04SA028
Investigator : Clint Crookshanks, AS-40

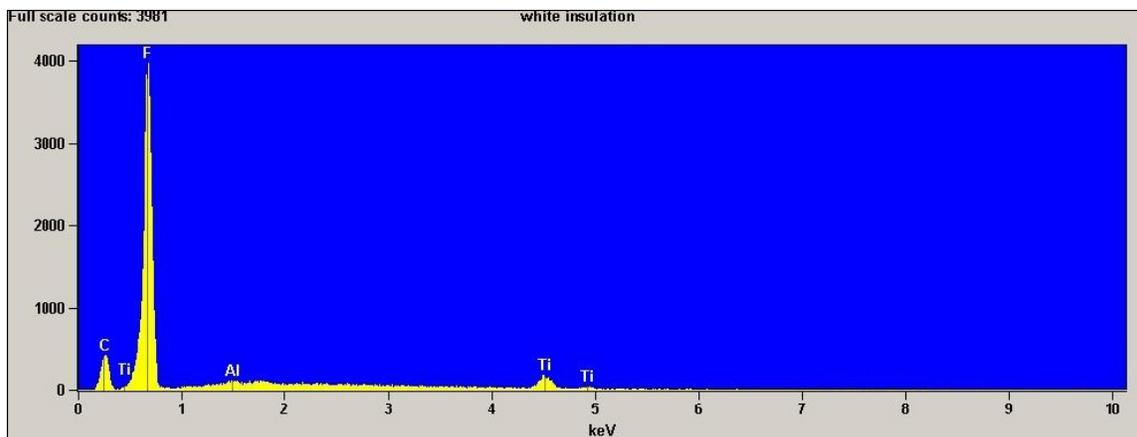
Figure 21. EDS spectrum for the white strand insulator adjacent to the power cable.

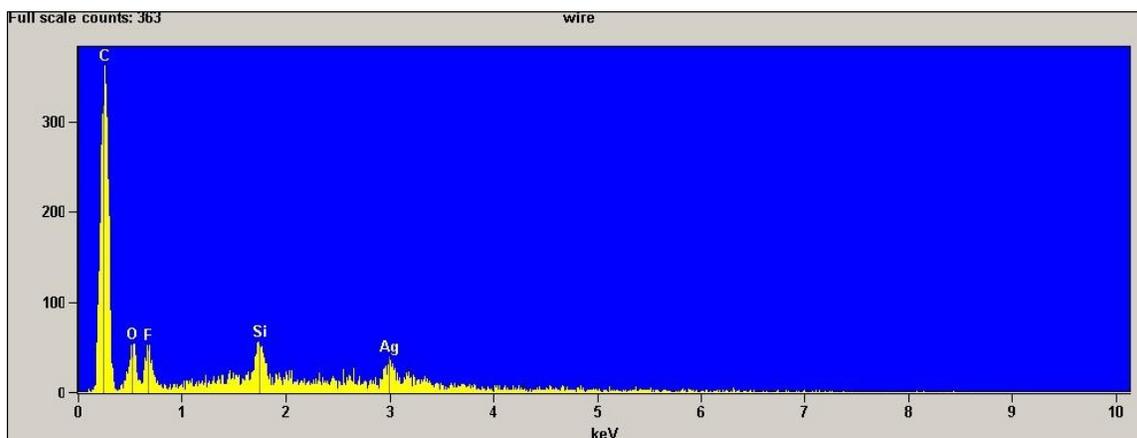
Figure 22. EDS spectrum for black deposits on the exposed white strand at Area 3.

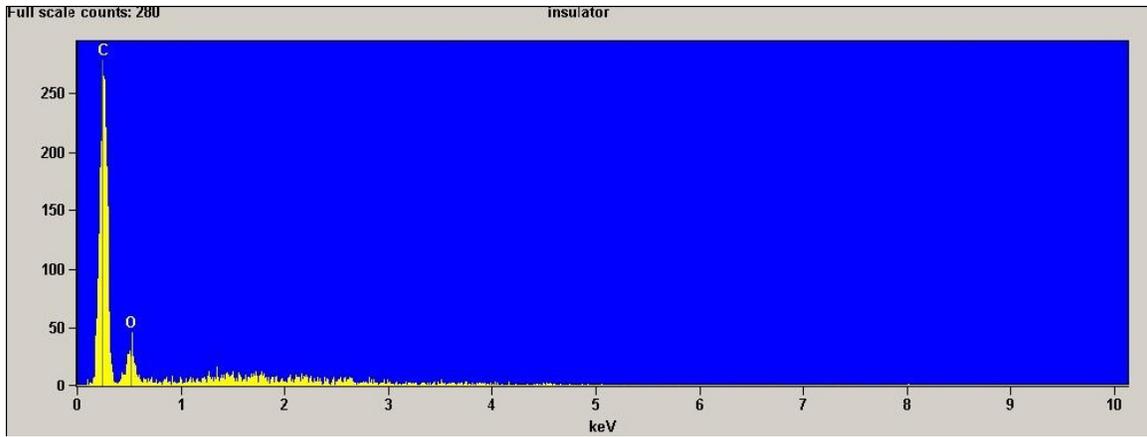
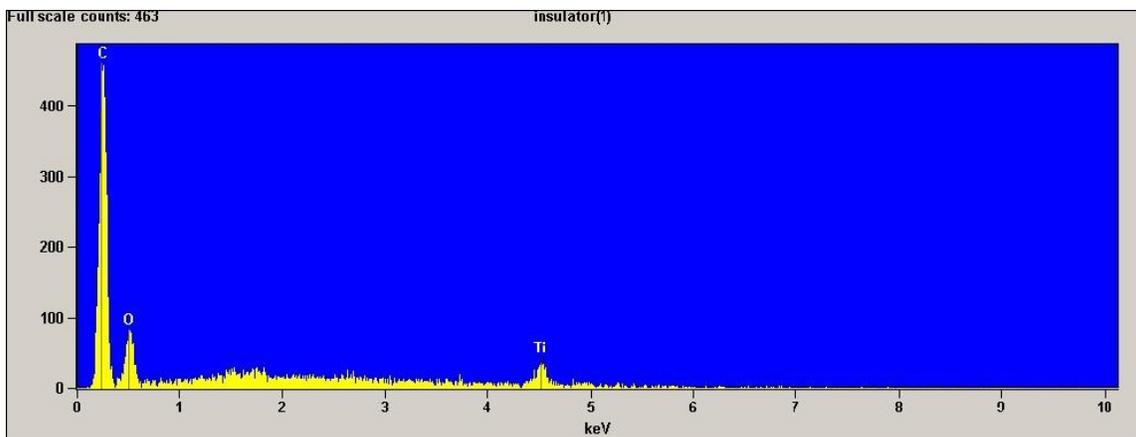
The EDS spectra for the green and yellow power cable strand insulators are shown in figure 36. Both insulator colors had a high peak of carbon and a smaller peak of oxygen. One color also had a peak of titanium.

Figure 36. EDS spectra for the yellow and green power cable strand insulators.

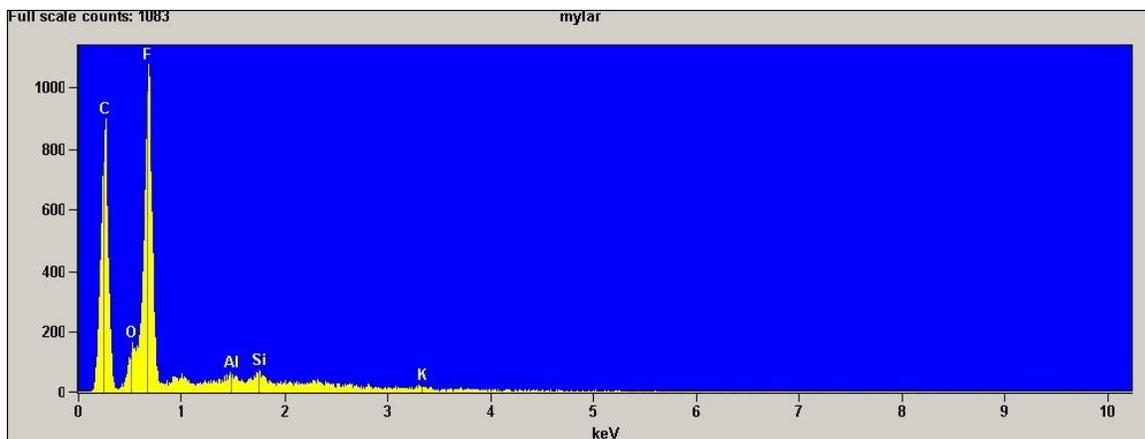
An EDS spectrum for undamaged shrink tubing is shown in figure 37. High peaks of carbon and fluorine were observed with smaller peaks of oxygen, aluminum, silicon, and potassium. A black portion of the charred shrink tubing located at Area 3 also was examined using EDS, and the resulting spectrum is shown in figure 38. Peaks of carbon and oxygen were observed in similar ratios to that of the undamaged shrink tubing, but the fluorine peak was substantially smaller.

Figure 37. EDS spectrum for undamaged shrink tubing.

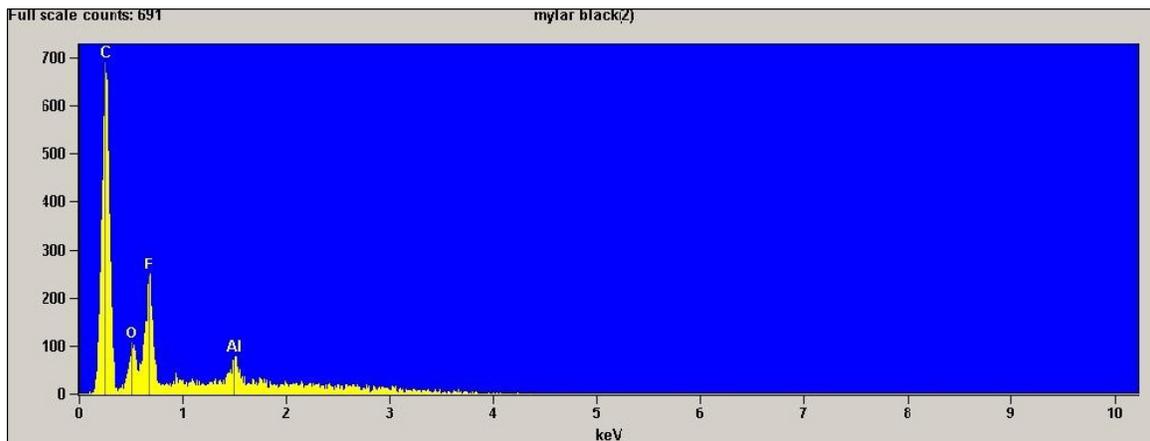
Figure 38. EDS spectrum for a blackened area of shrink tubing.

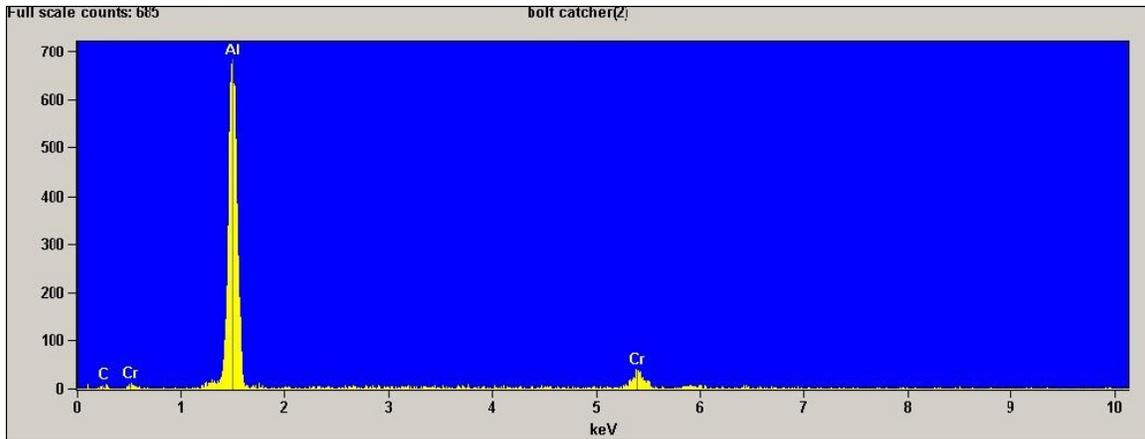
An EDS spectrum of the bolt catcher is shown in figure 41. The bolt catcher had a high peak of aluminum and much smaller peaks of chromium and carbon.

Figure 41. EDS spectrum of the bolt catcher.

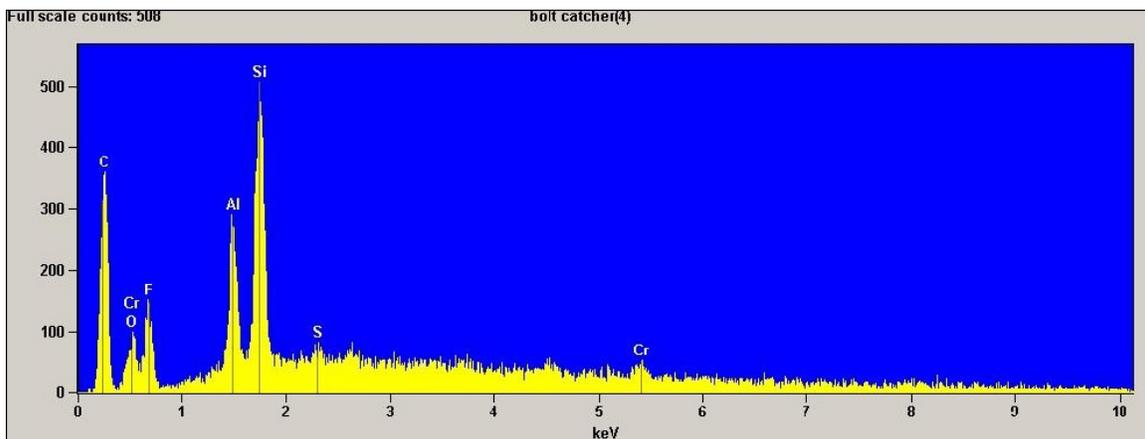
An EDS spectrum of the black deposits on the bolt catcher is shown in figure 42. This spectrum had high peaks of silicon, carbon, and aluminum with smaller peaks of fluorine and oxygen and much smaller peaks of sulfur and chromium.

Figure 42. EDS spectrum of black deposits on the bolt catcher.

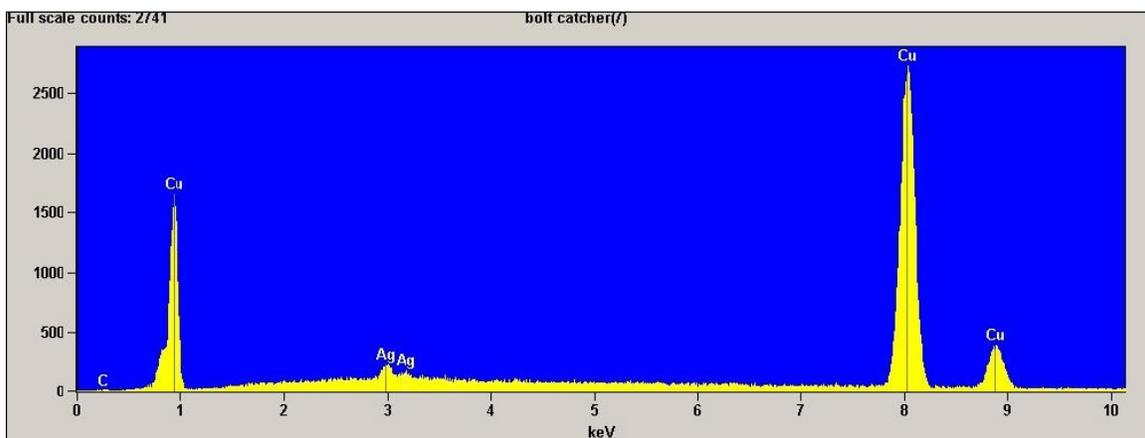
An EDS spectrum of the deposits appearing round and white in figure 40 is shown in figure 43. The spectrum had high peaks of copper with much smaller peaks of silver and carbon.

Figure 43. EDS spectrum of deposits appearing round and white using SEM with backscattered electrons.
