**MAY 24, 1999**

# **WIRE ANOMALY INVESTIGATION REPORT**

**This report documents the results of the JPL Team investigation into the loss of the WIRE Science Mission**

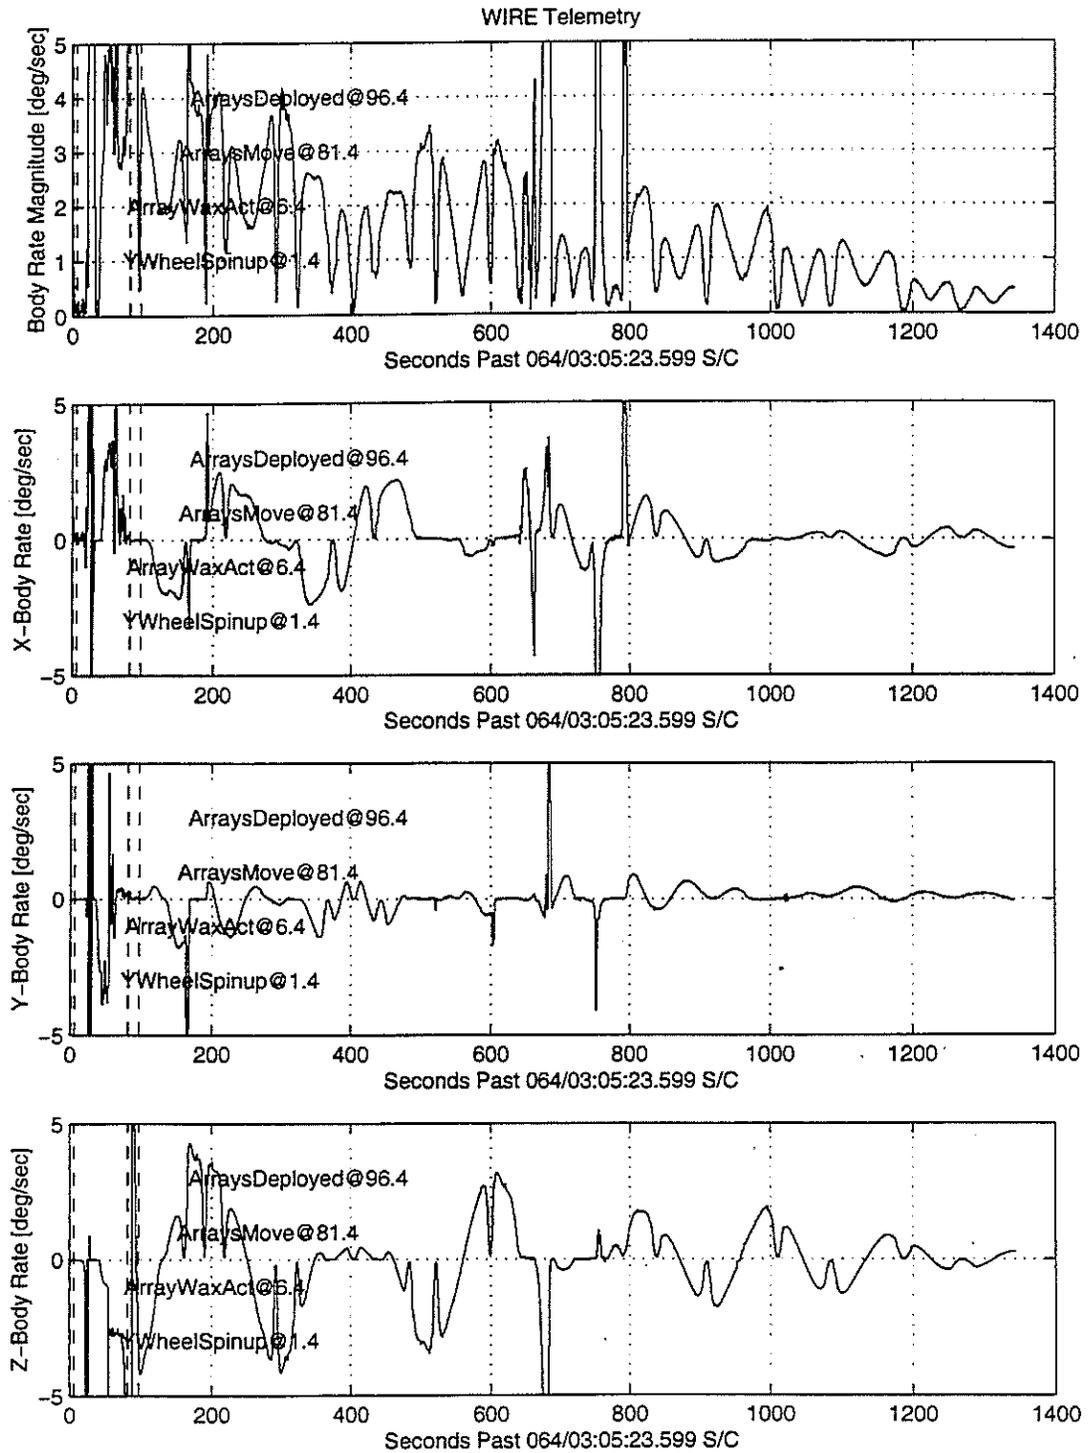
Figure 4.B.2 Sun Sensor Derived S/C Angular Rates

The sun sensor data was processed in a variety of ways in an attempt to extract S/C rate. Due to the coarseness of the data, telemetry dropouts, and various other operational aspects of the sun sensors, the resulting rates are very noisy and contain many artifacts that are not believed to truly indicate rates. Figure 4.B.2 shows a representative set of derived S/C angular rates expressed in S/C body coordinates. The time span covered here is also from S/C separation until just prior to pyro box turn on.

The top plot in the figure shows the magnitude of the total rate vector. One can see that the initial tip-off rates and y-axis wheel spin-up caused about a 3 to 4 deg/sec tumble. However, the rates were slowly being damped out over this time period.

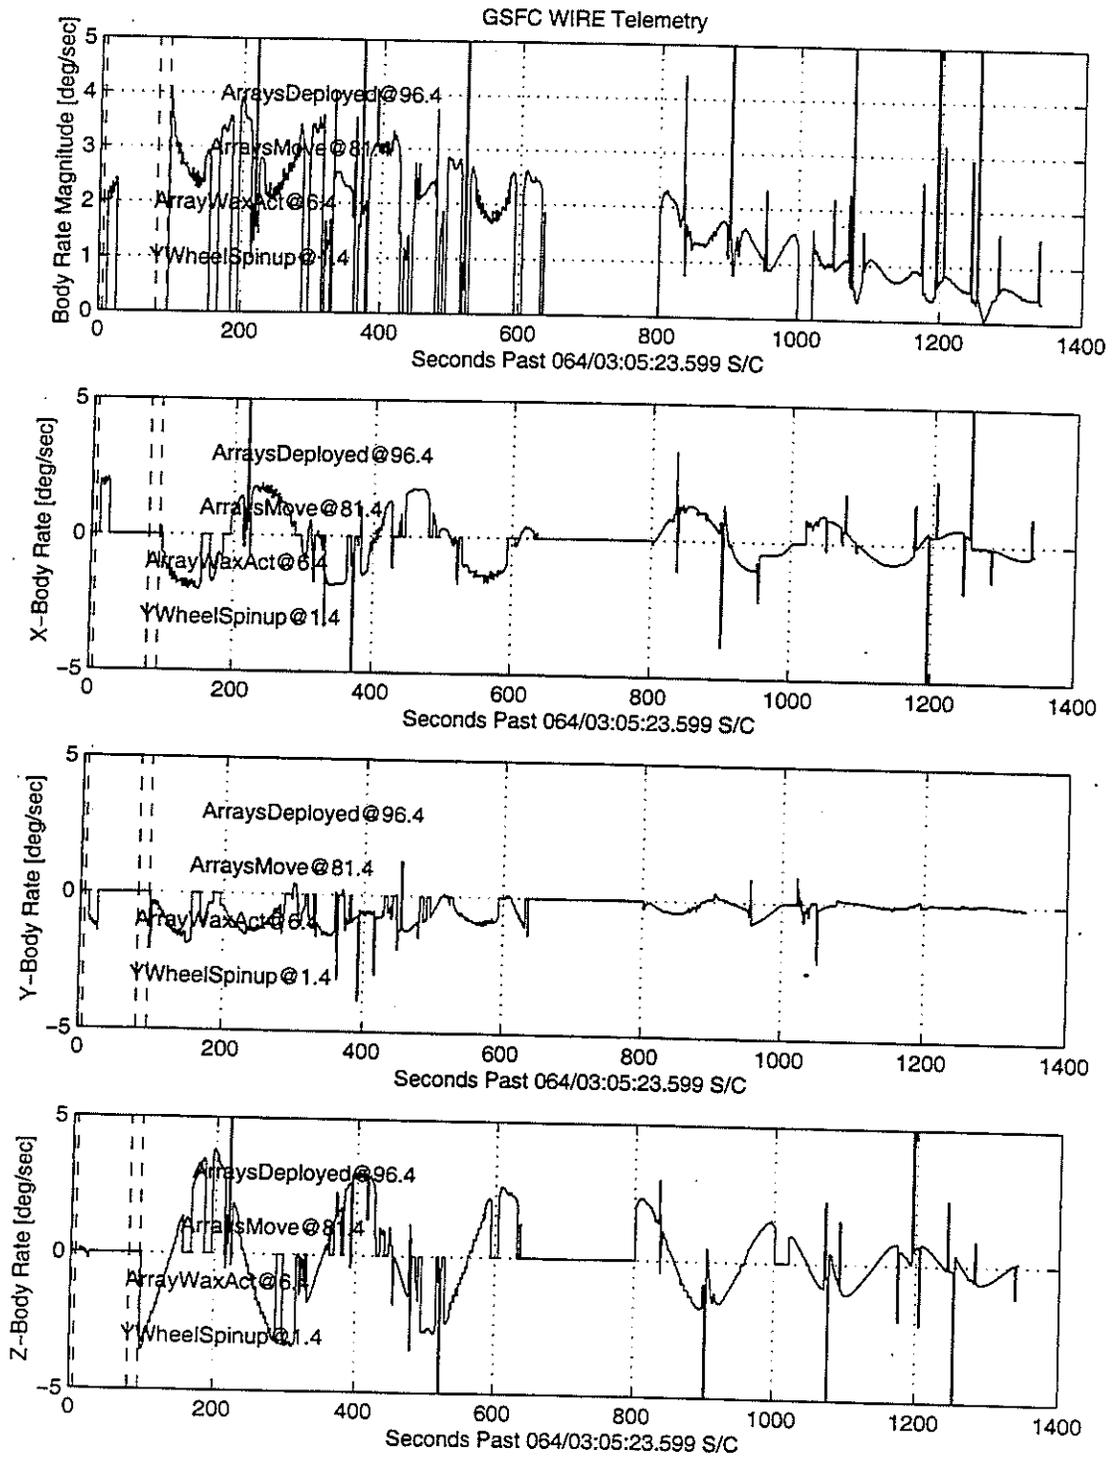
Figure 4.B.3 GSFC Derived S/C Rates

The coarse sun sensor, fine sun sensor, magnetometer, and magnetorquer outputs were processed at Goddard Space Flight Center by Tom Correll to remove "questionable" telemetry values. Figures 4.B.3 & 4 show the GSFC processed data for derived S/C angular rate and the values of the magnetic torque that the torque rods were applying to damp out the rates.

Note that the rates are very similar to those derived using the raw data from the coarse sun sensors. Also note from the signs of the magnetic torques that the magnetic torquers were applying torques opposing sensed rates. In other words, the control system was working as expected in reducing S/C rates.

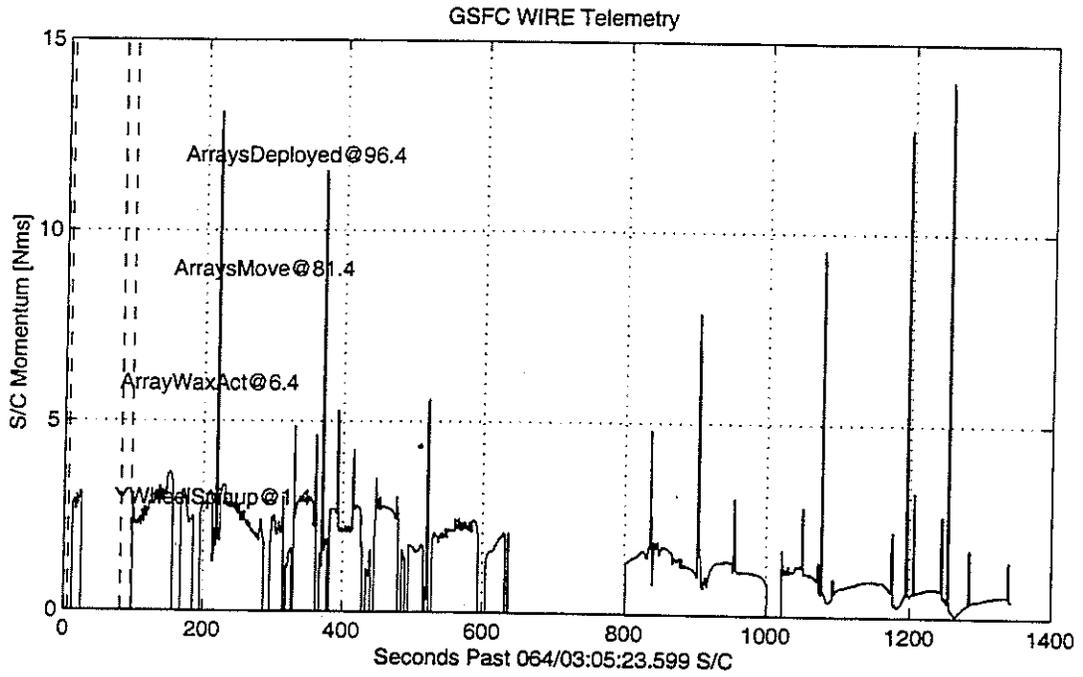
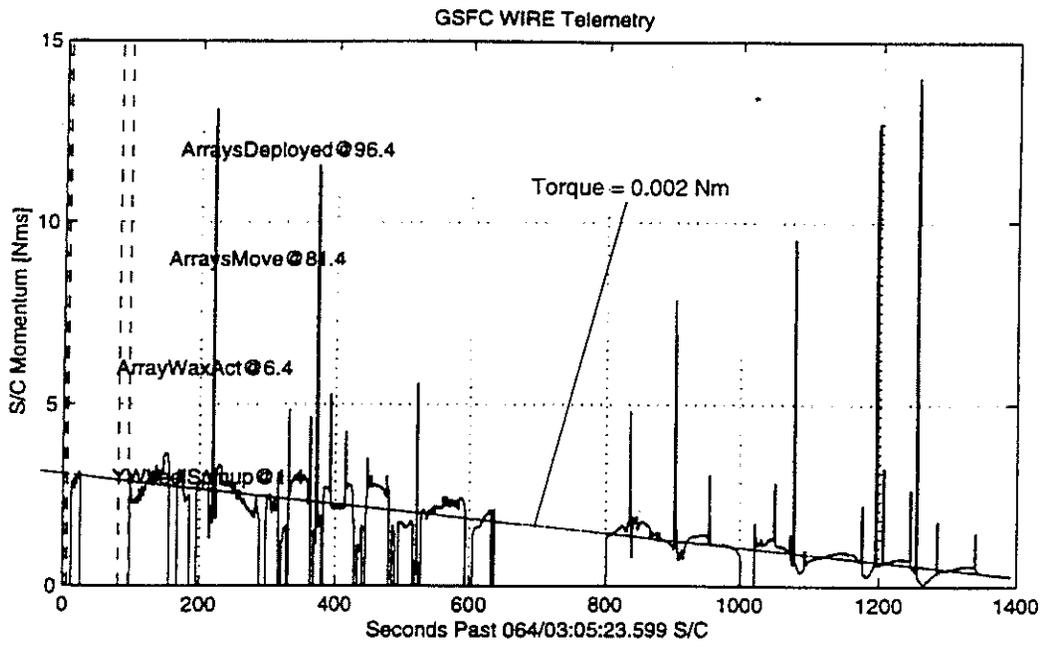
The upper plot in the figure is the raw magnitude of  $H$  and the lower plot represents a filtered version using a 20<sup>th</sup> order moving average filter.

Note that  $H$  is reducing as expected. Also note that a straight line fit to the filtered data indicates that the slope of  $H$ ,  $dH/dt$ , which roughly corresponds to average applied torque, is approximately -0.001 Nm. This agrees roughly with the torque values seen in the previous figure and is about the capability of the magnetorquers.

Measured decay in spacecraft momentum due to torque rod operation after L/V separation.

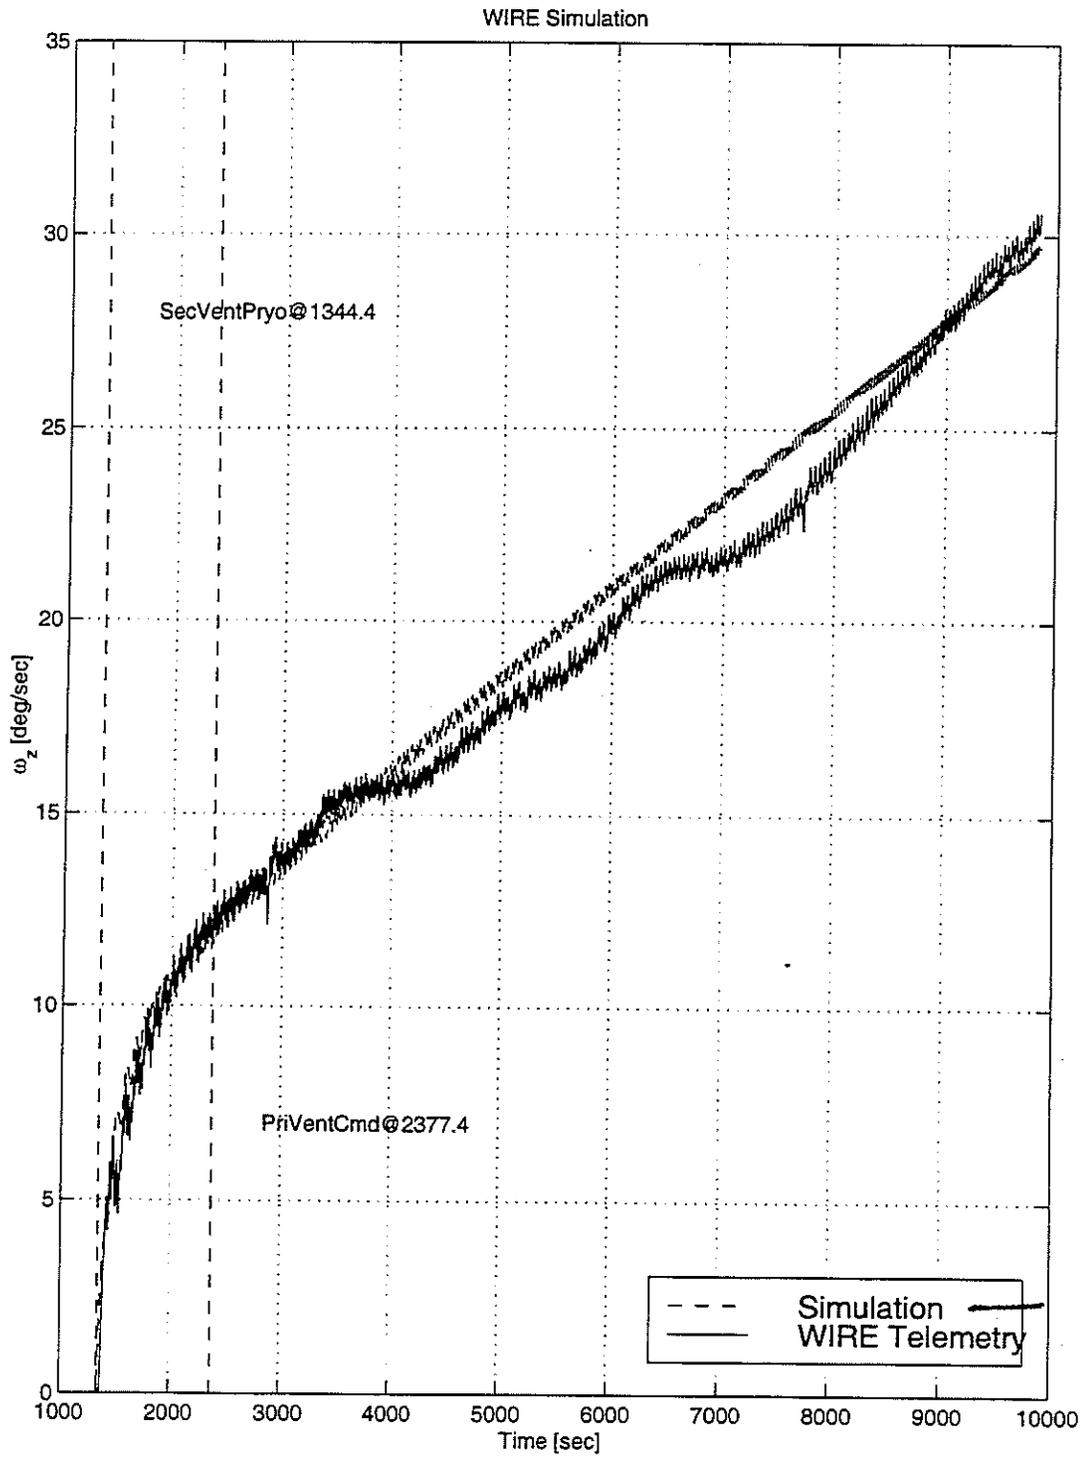
Although noise and artifacts and other frequencies exist in the transverse axis data, a phase-locked loop can very selectively lock onto an oscillation in a set of data, particularly if the frequency is very dominant in the data. The results of running the X-axis sun body vector data through the phase-locked loop simulation are shown in Figure 4.B.12.

Superimposed on the PLL-processed telemetry are the Z-axis rates from the WIRE S/C tuned simulation. Note the excellent agreement.

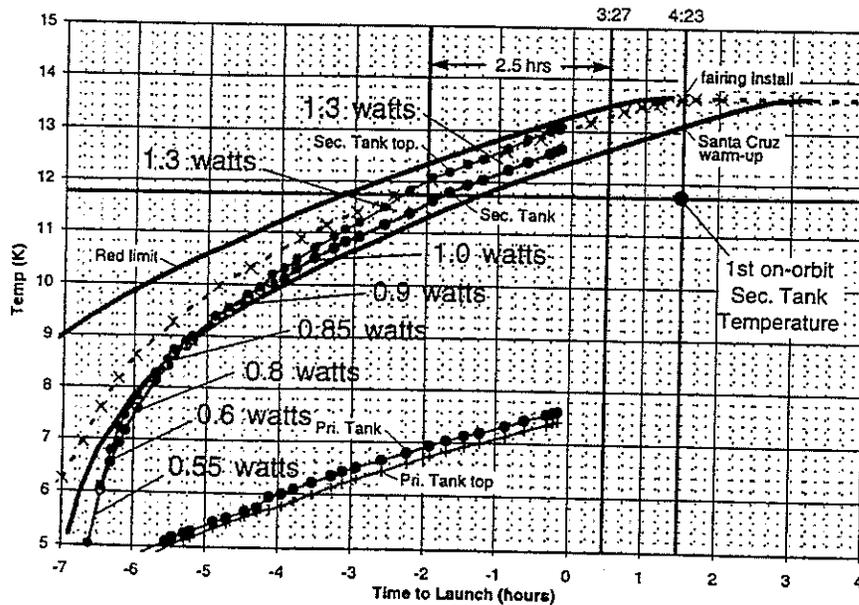
Figure 2. Cryostat tank temperatures and computed heat loads for L-1011 portion of the mission.

**Launch Heating of the Dewar.** Figure 2 displays the recorded temperature of the cryogen tanks during the L-1011 portion of the mission and after the WIE box was turned on approximately one hour after orbit insertion. To assess the possibility of some sort of unexpected heating occurring during launch, the parasitic heat-load into the tanks was computed based on the mass and thermal properties of the hydrogen and the recorded warm-up rate. The computed heat rates are noted on the plot for each 1 K temperature interval. The heating rates are completely nominal.

The heating calculations are also useful to examine the expected cryogen venting upon opening of the vents on-orbit. Upon venting, a sufficient quantity of hydrogen must escape to remove the heat absorbed when the tank temperature was above its final on-orbit temperature of 11.75 K. From Fig. 2, the integrated heating above 11.75 K is seen to be approximately 1.3 watts for 2.5 hours, i.e. 3.25 watt-hrs or  $\sim 12$  kJ.

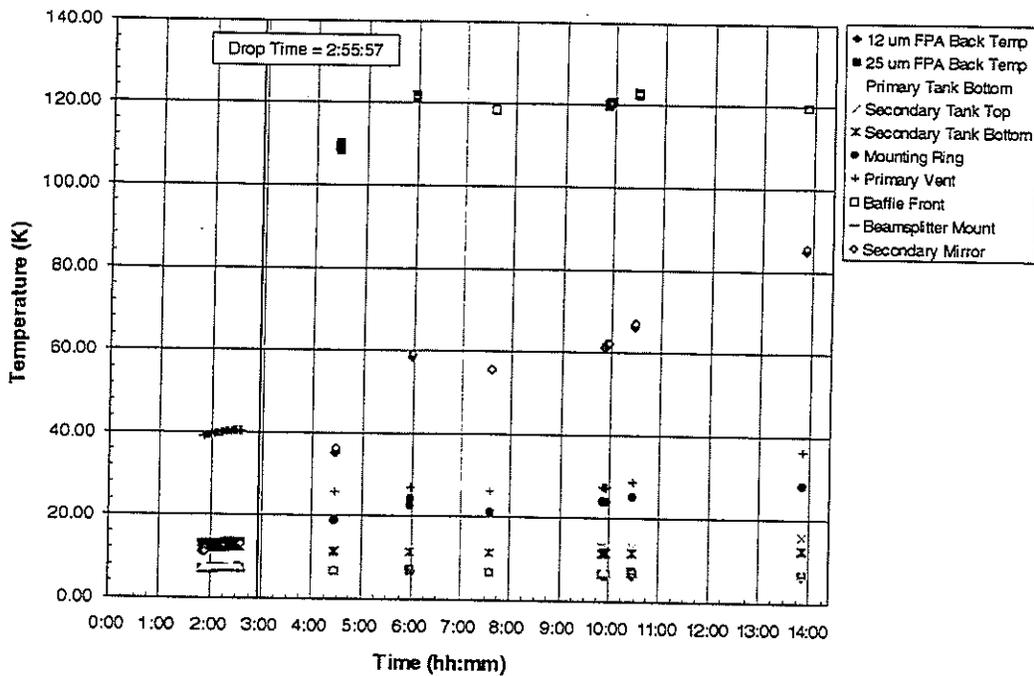
Figure 3. Cryostat temperatures for the on-orbit portion of the mission.

**On-Orbit Dewar Temperatures.** Figure 3 displays the measured temperature of the cryogen tanks during those on-orbit portions of the mission when the WIE box was turned on. It is apparent from these data that the telescope optical baffle has been heated to nearly 120 K from its expected temperature near 10 K; the secondary mirror has similarly been greatly heated. Heating of the baffle is totally consistent with the cover being off and solar and Earth radiation being incident upon the baffle surfaces. The baffle temperature would not be expected to be elevated above the tank temperature for the case of an external heating source. This strongly discredits the possibility of a guard vacuum leak or other failure leading to the excessive heating.

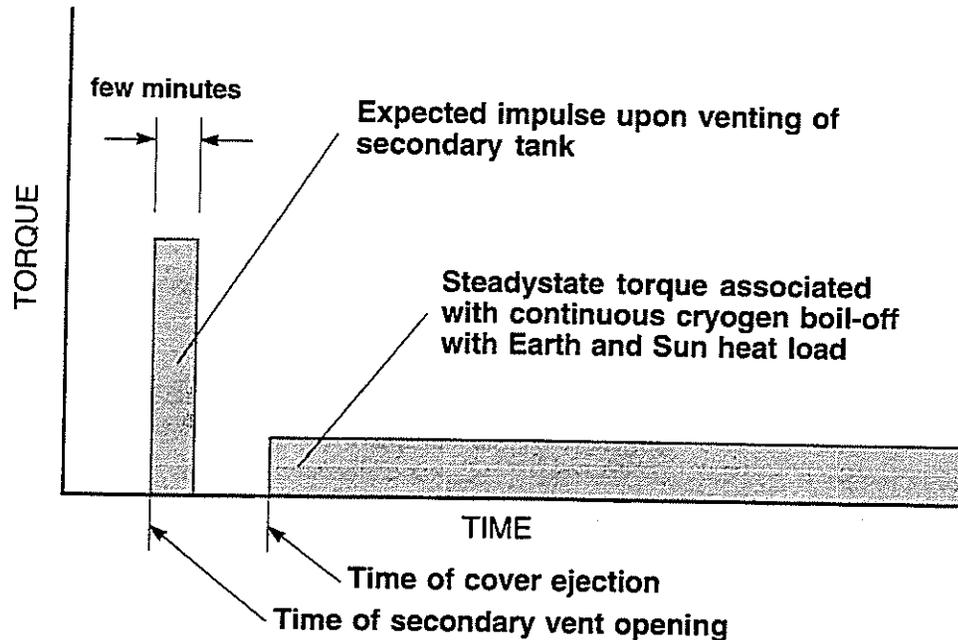
Figure 6. Expected spacecraft torque attributes associated with vent firing and cover deployment.

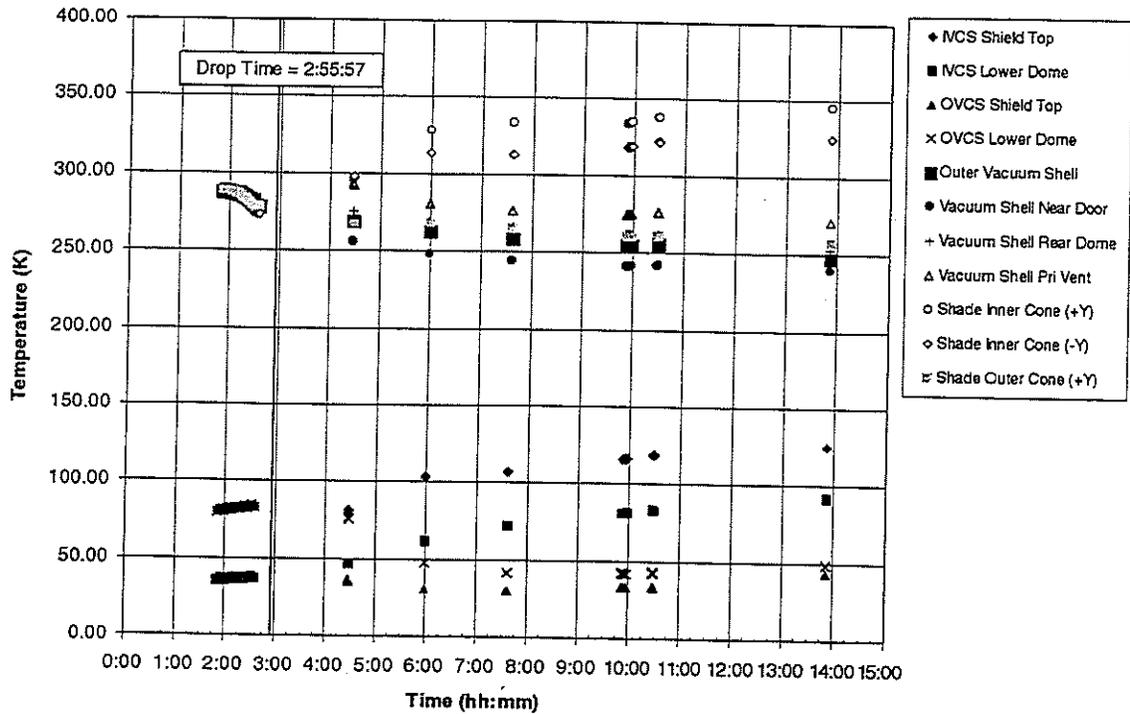
Figure 7. Vapor cooled shield and outer cryostat temperatures for the on-orbit portion of the mission.

exit temperature is quite uncertain, but has been assumed to be 200 K during the initial rapid blowdown, and 50 K after the vent plumbing has cooled to its long-term equilibrium value. These values are guesstimates reflecting the initial (80 K) and final (30 K) temperature of the outer vapor cooled shield as measured in orbit (see Fig. 7). The sonic velocity varies as the square root of the absolute temperature, somewhat tempering the uncertainty in these exit temperatures.

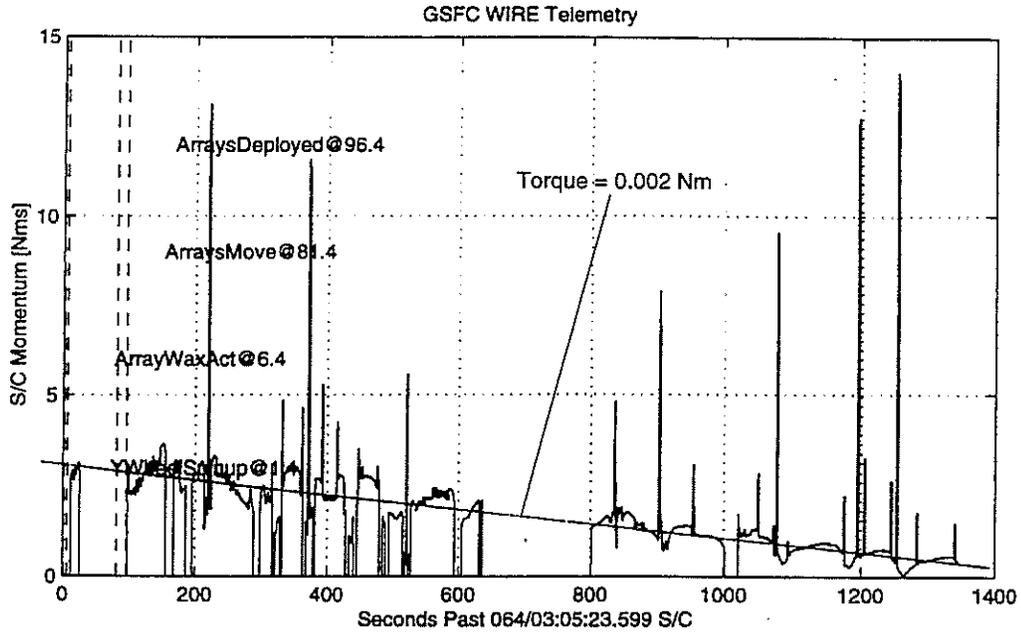
Figure 9. Measured decay in spacecraft momentum due to torque rod operation after L/V separation.

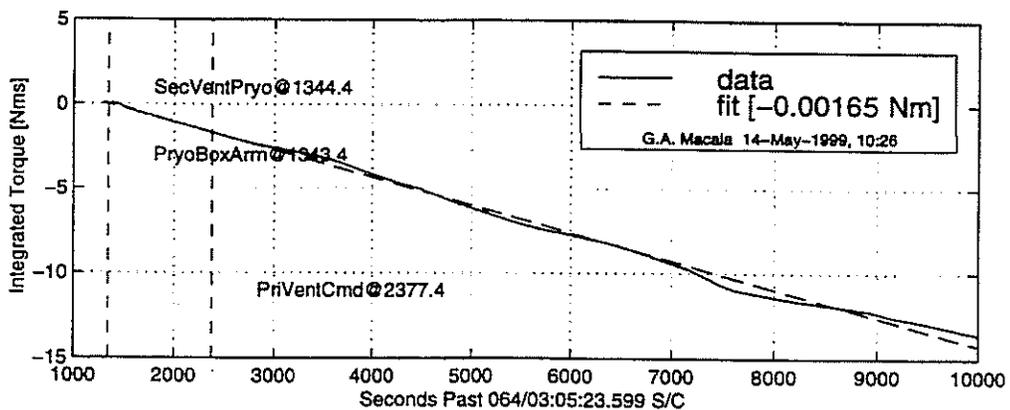
of the effective torque that reduces the S/C momentum, as the momentum is dominated by spin about the Z-axis. The result of this third approach is displayed in Fig. 10, and is in close agreement with the average (0.0017 Nm) of the first two approaches.

Figure 10. Time integration of ACS torque-rod torque applied about the S/C Z-axis.

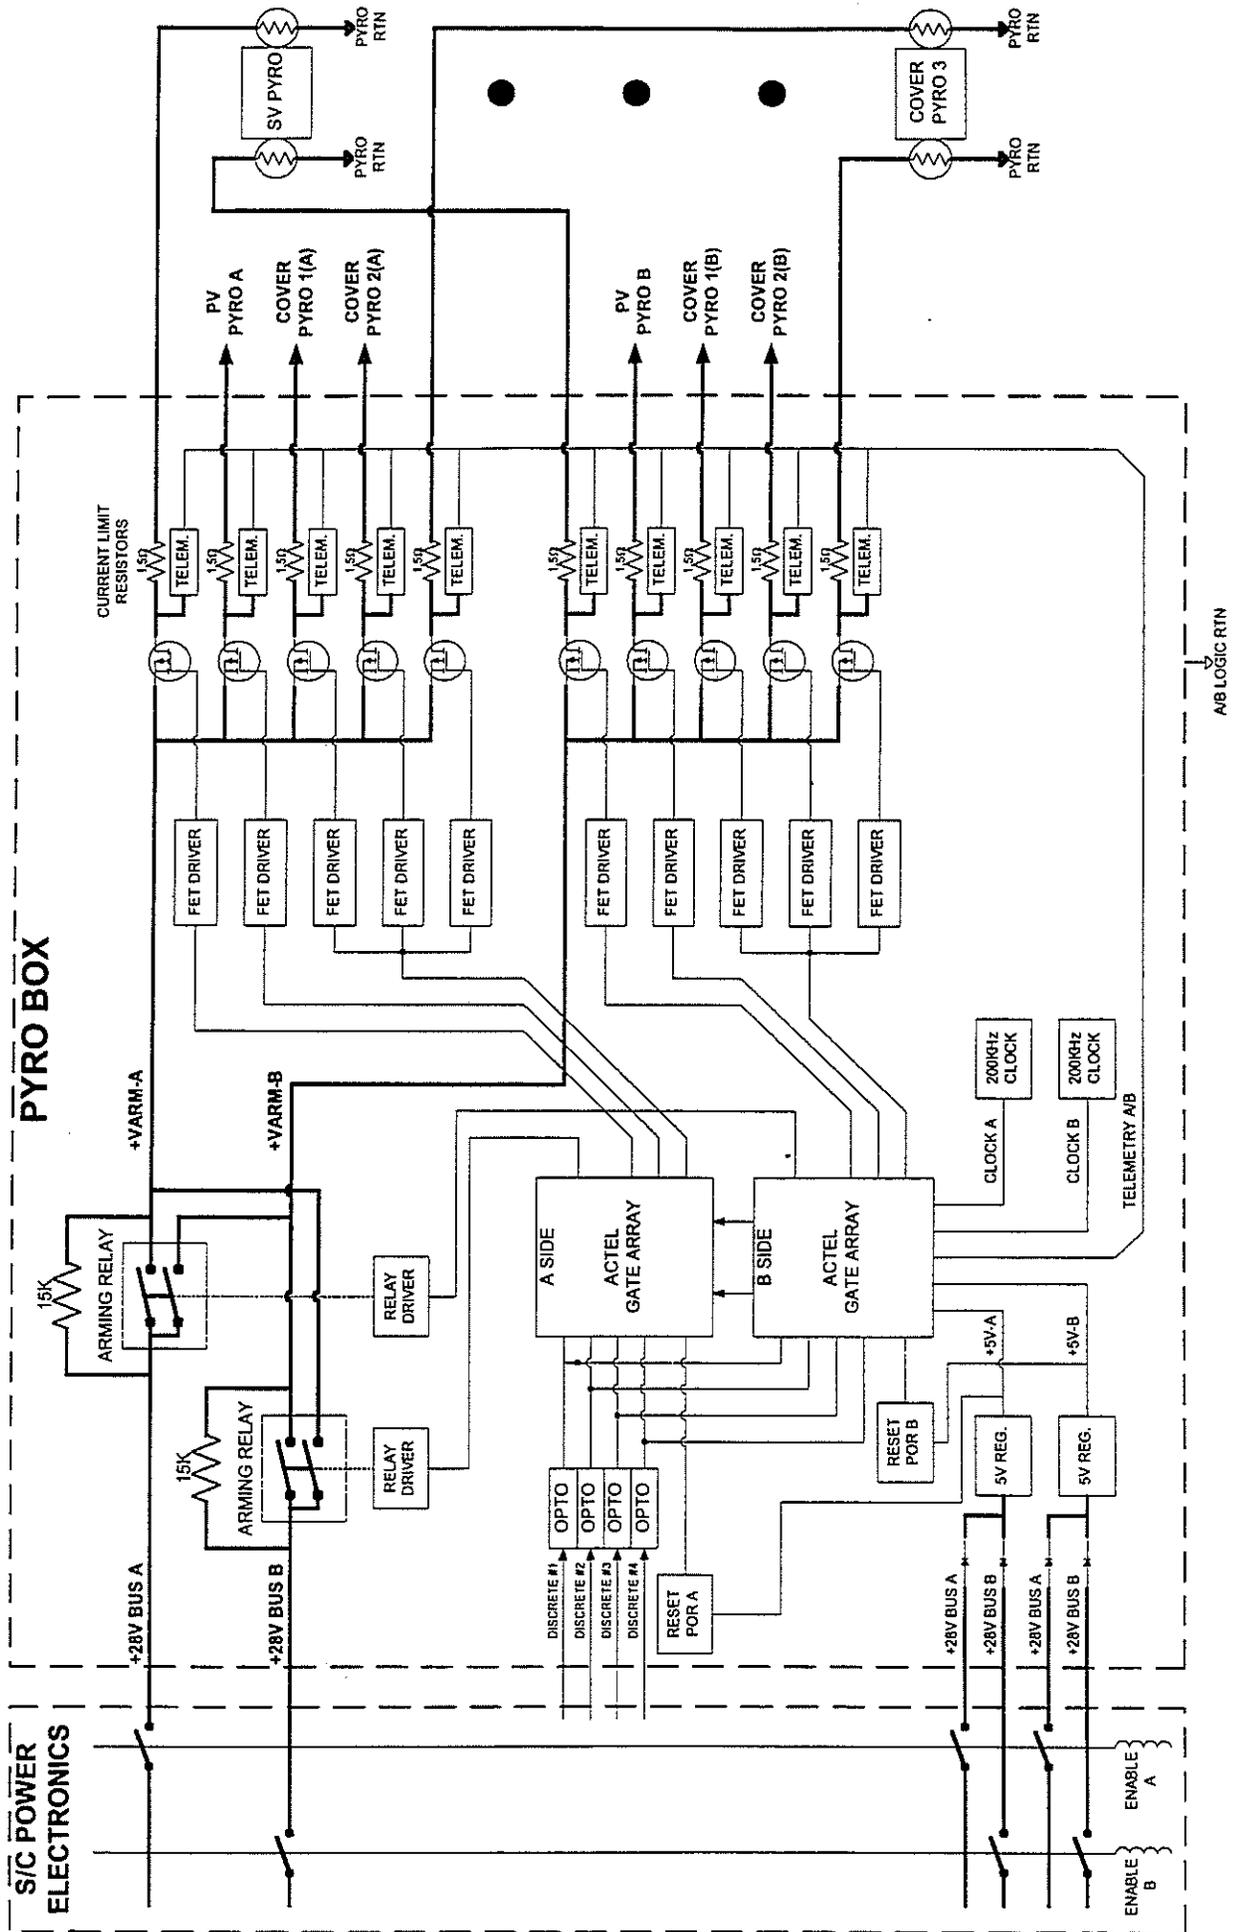
# 5A. SPE to PYRO BOX RETURNS

During a pyro firing, it is possible that pyro firing transients generated by an intended firing may have caused other pyros to fire, sympathetically. Pyro firing transient data taken from other projects shows that when squibs fire, a transient (~100 - 500  $\mu$ sec) ionization-induced electrical path is formed between the squib body and spacecraft chassis. This path momentarily creates a short circuit across the +28 volt spacecraft battery (the battery circuit return is tied to spacecraft chassis). This "shorted" condition can result in significant transients in the logic return causing the FPGA to issue spurious fire signals (See Figure 5A).

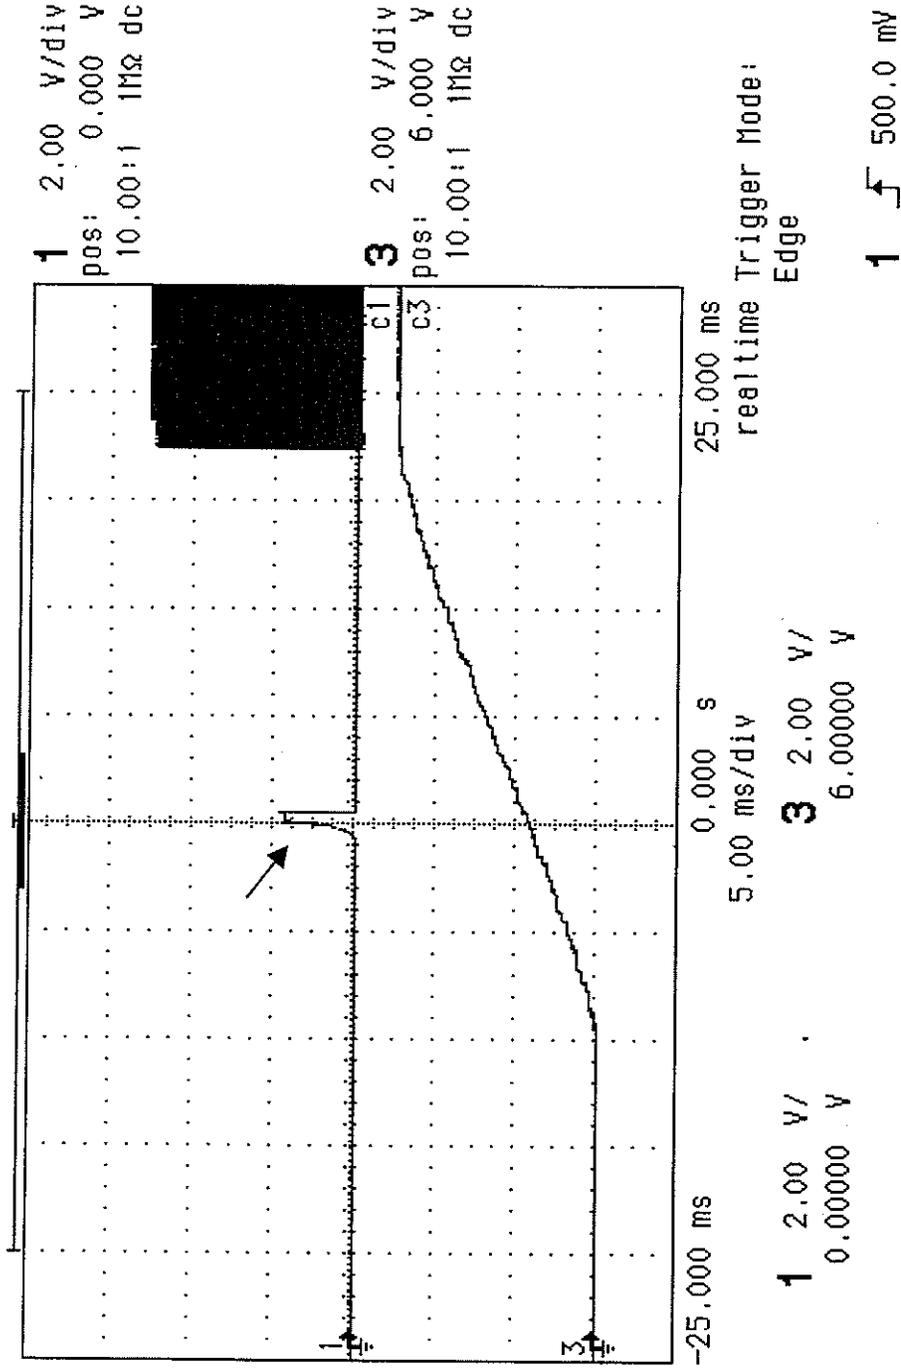
Figure 1. Start time of a space qualified 200 kHz oscillator. The rise time of the power supply is 20 msec and the horizontal scale is 5 msec per division. Start time from the application of power is approximately 27 msec.

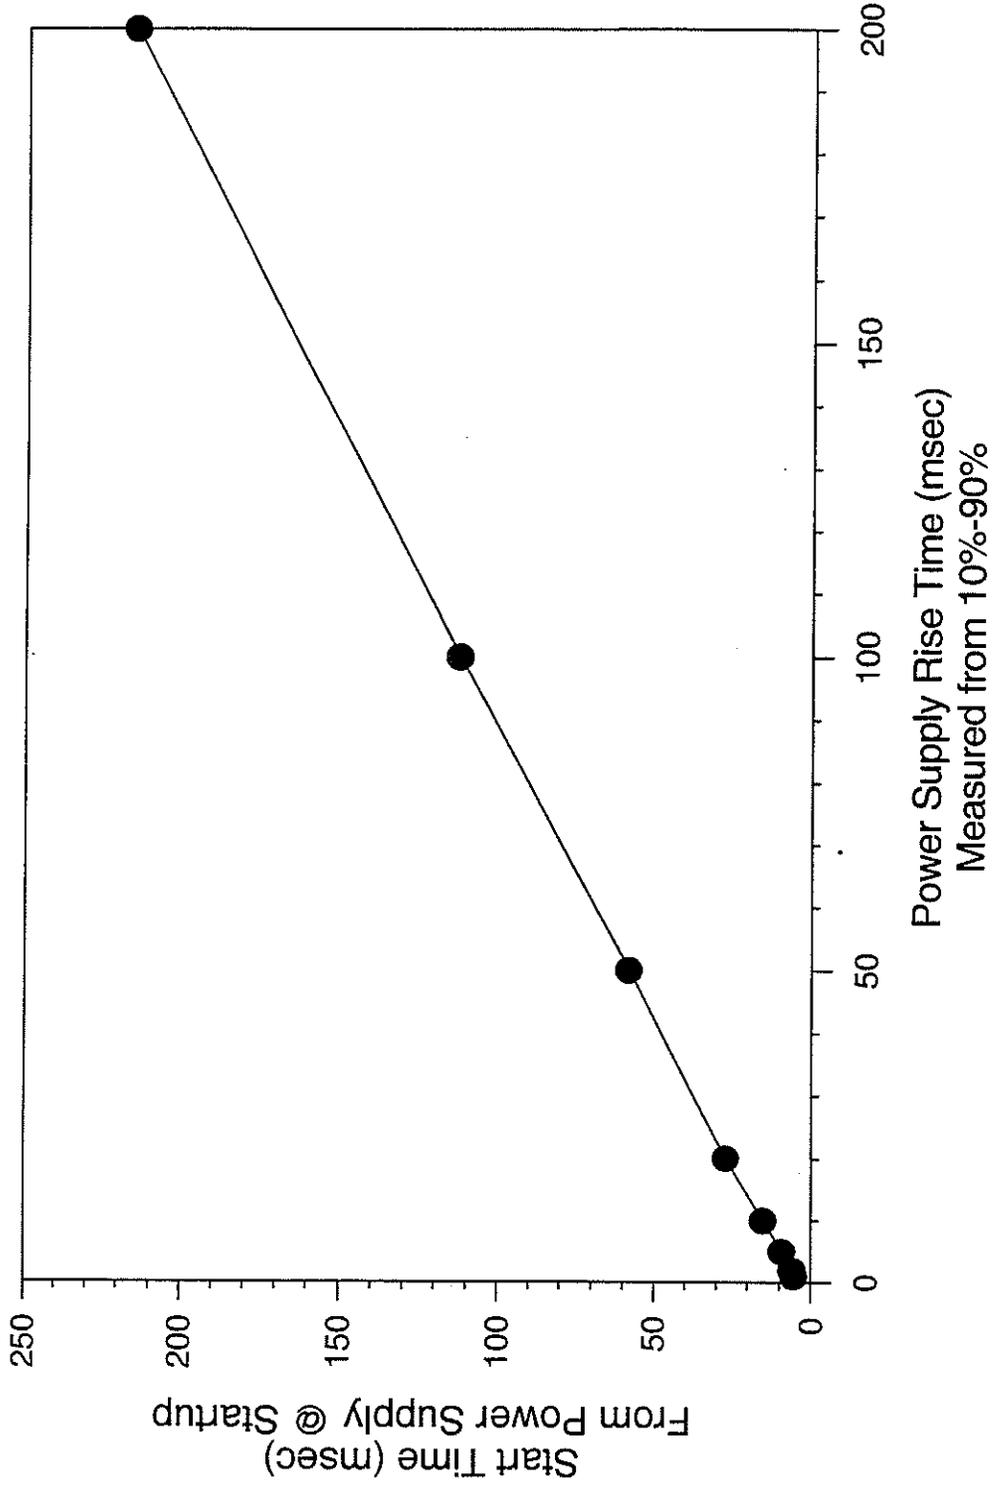
Figure 2. Summary of start time of a space-qualified 200 kHz oscillator as a function of power supply rise time at 10°C.
