Mars Observer Loss of Signal: Special Review Board Final Report

November 1993

NASA

JPL Publication 93-28

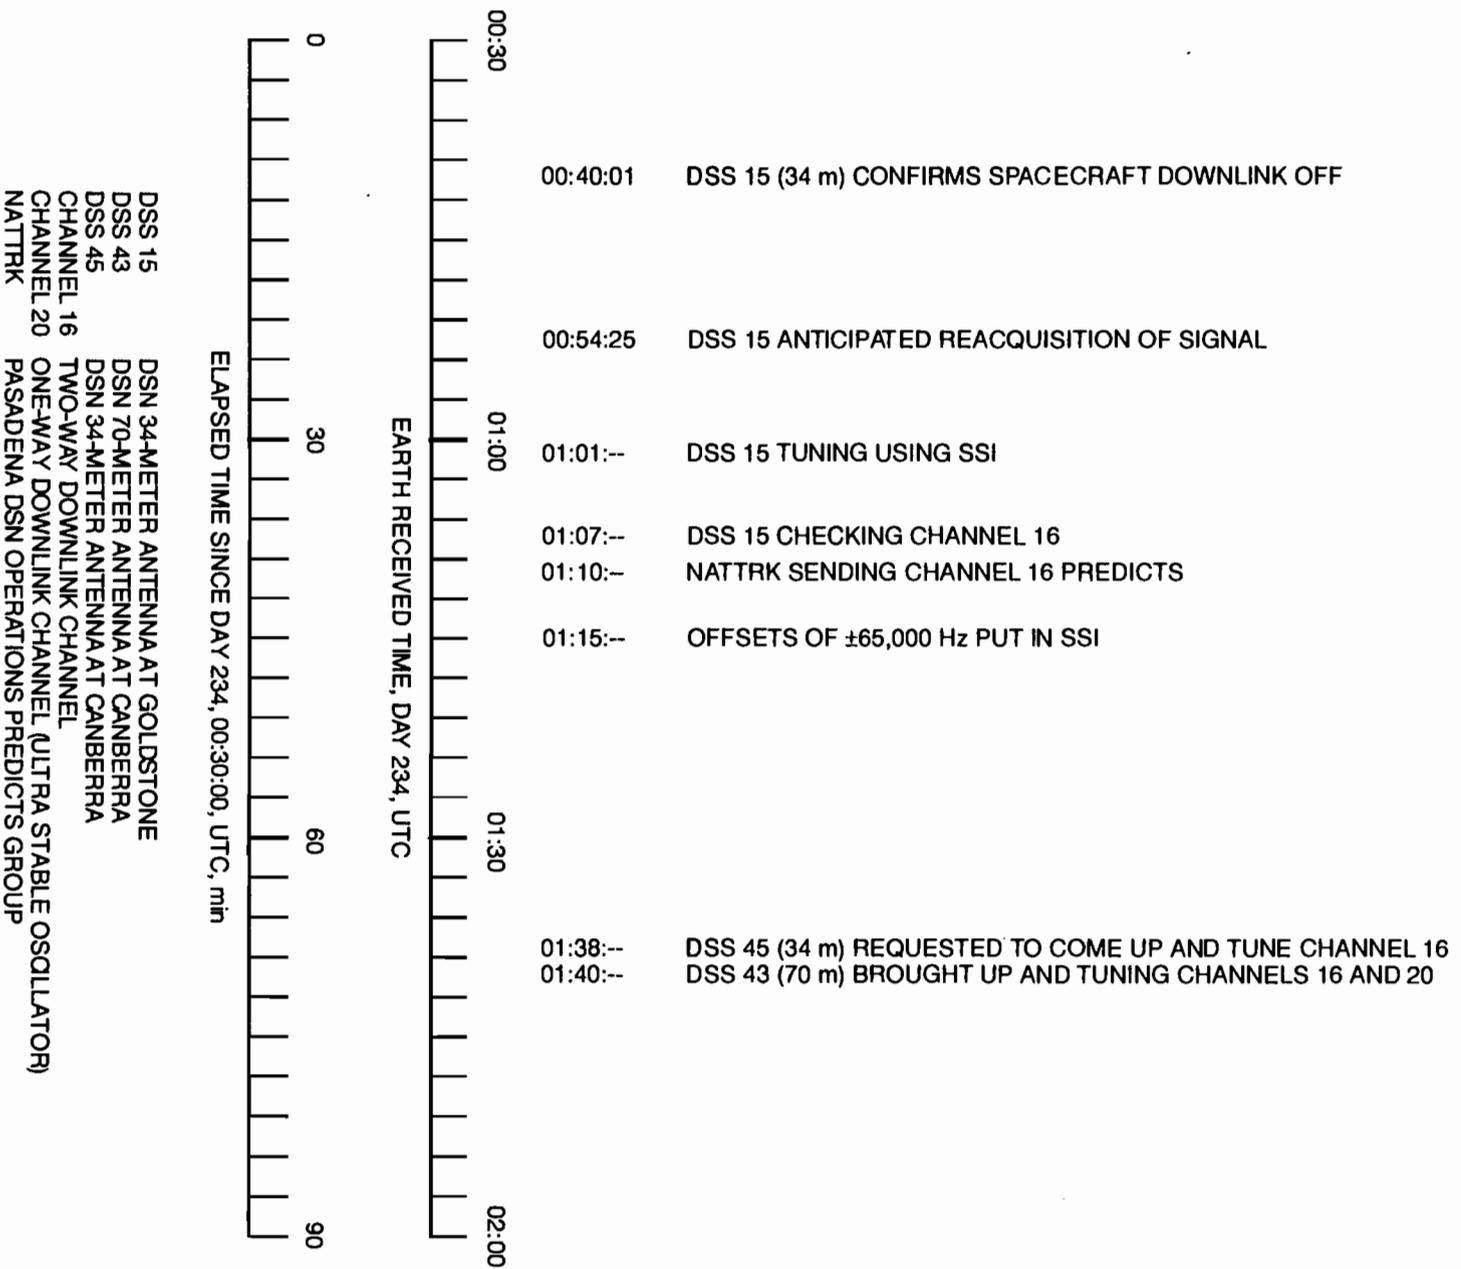
Figure 4-1. DSN events just after onset of anomaly.

To answer these questions requires communications link analyses with varying assumptions about spacecraft attitude and rates, coupled with ground-based actions to detect transient weak signals. A summary of such analyses is presented below. Refer to the timeline of Figure 4-1 for the correct juxtaposition of ground events.

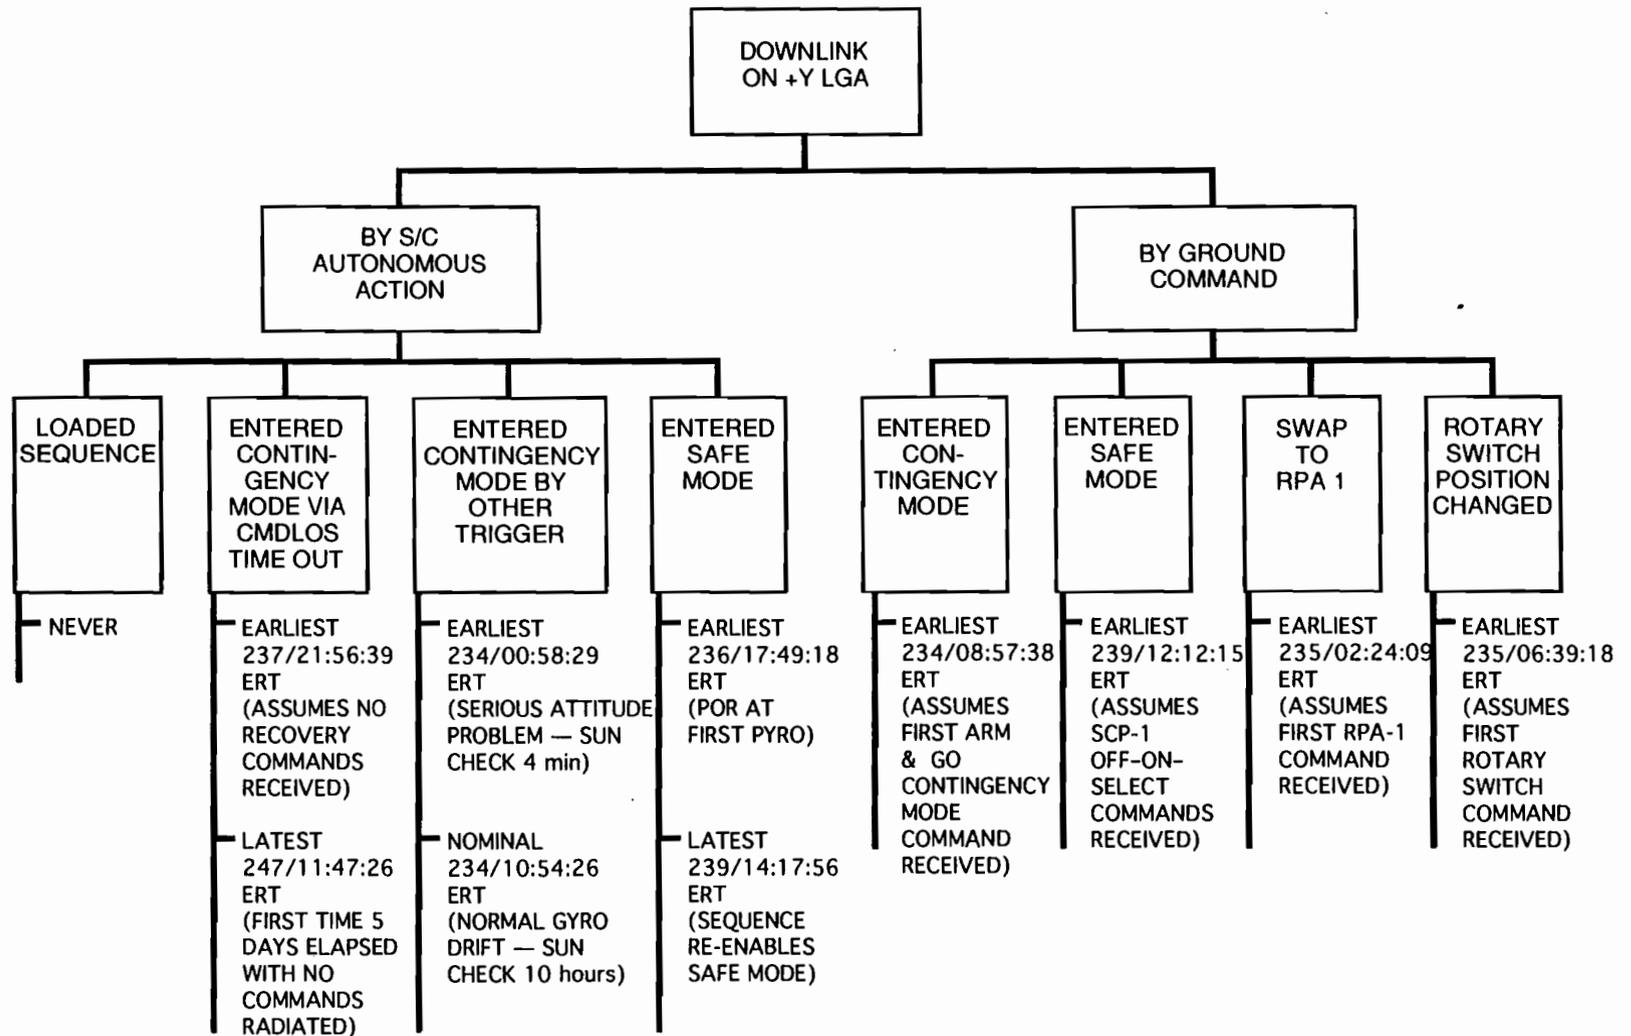
**Figure 4-2. Time delays to transfer to LGA.
(expected HGA AOS = 234/00:54:25 ERT).**

RPA 2 AND HGA WERE SELECTED AT TIME OF PRESSURIZATION SEQUENCE. IT IS POSSIBLE THAT THE ABOVE EVENTS NEVER HAPPENED.

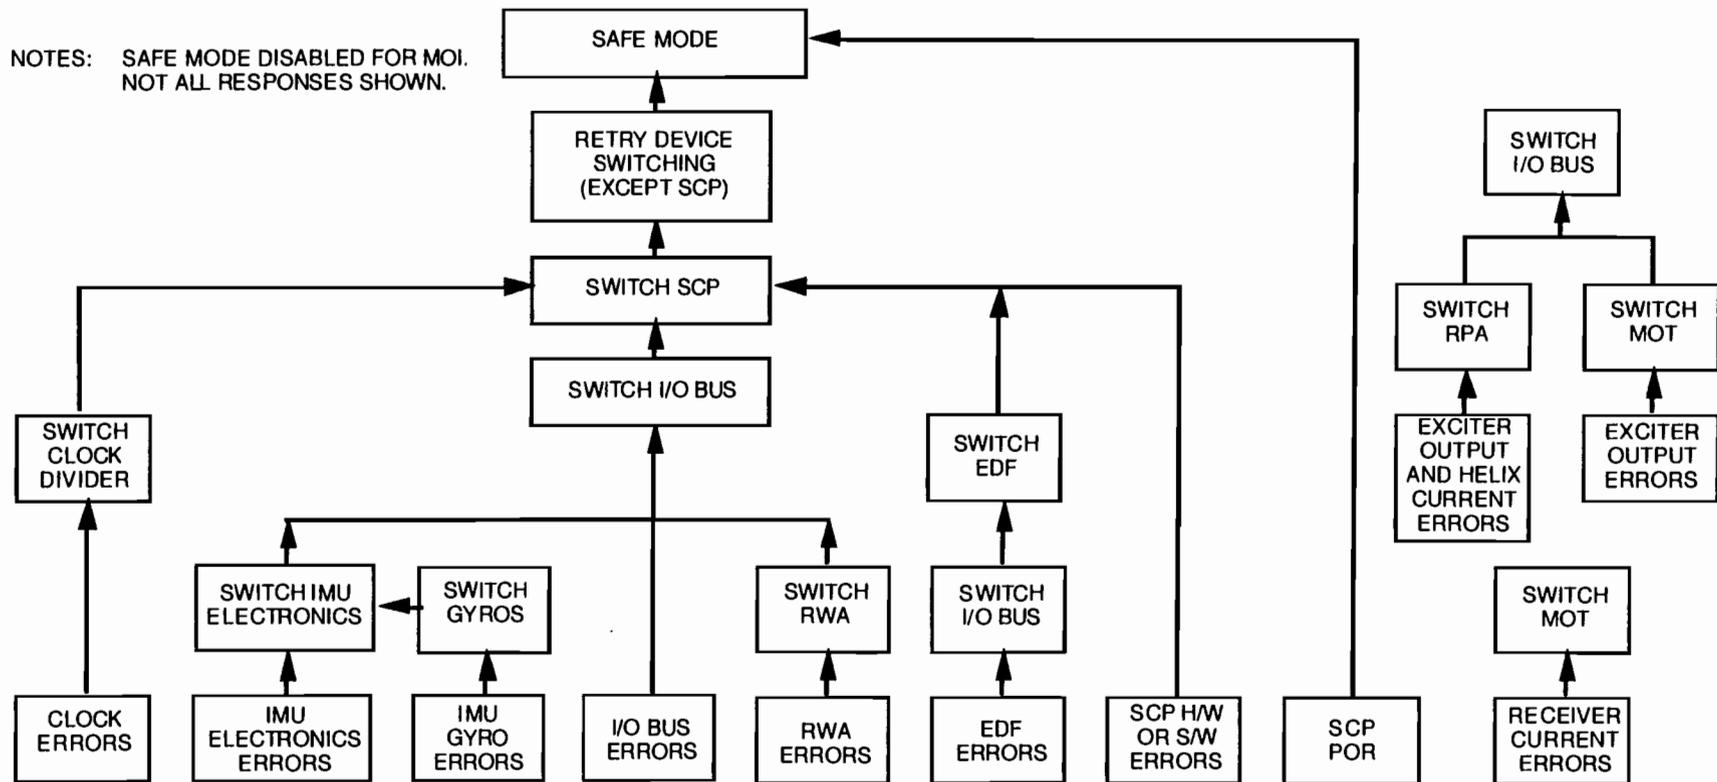
Figure 5-8. General REDMAN response block diagram.

The SCP REDMAN response to a failure of the primary-side RXO frequency output was discovered to be incomplete only after the loss-of-signal anomaly. This appears to

be due to a lack of understanding either that this failure could occur or of the effects of this failure and the resulting software design and test deficiencies.

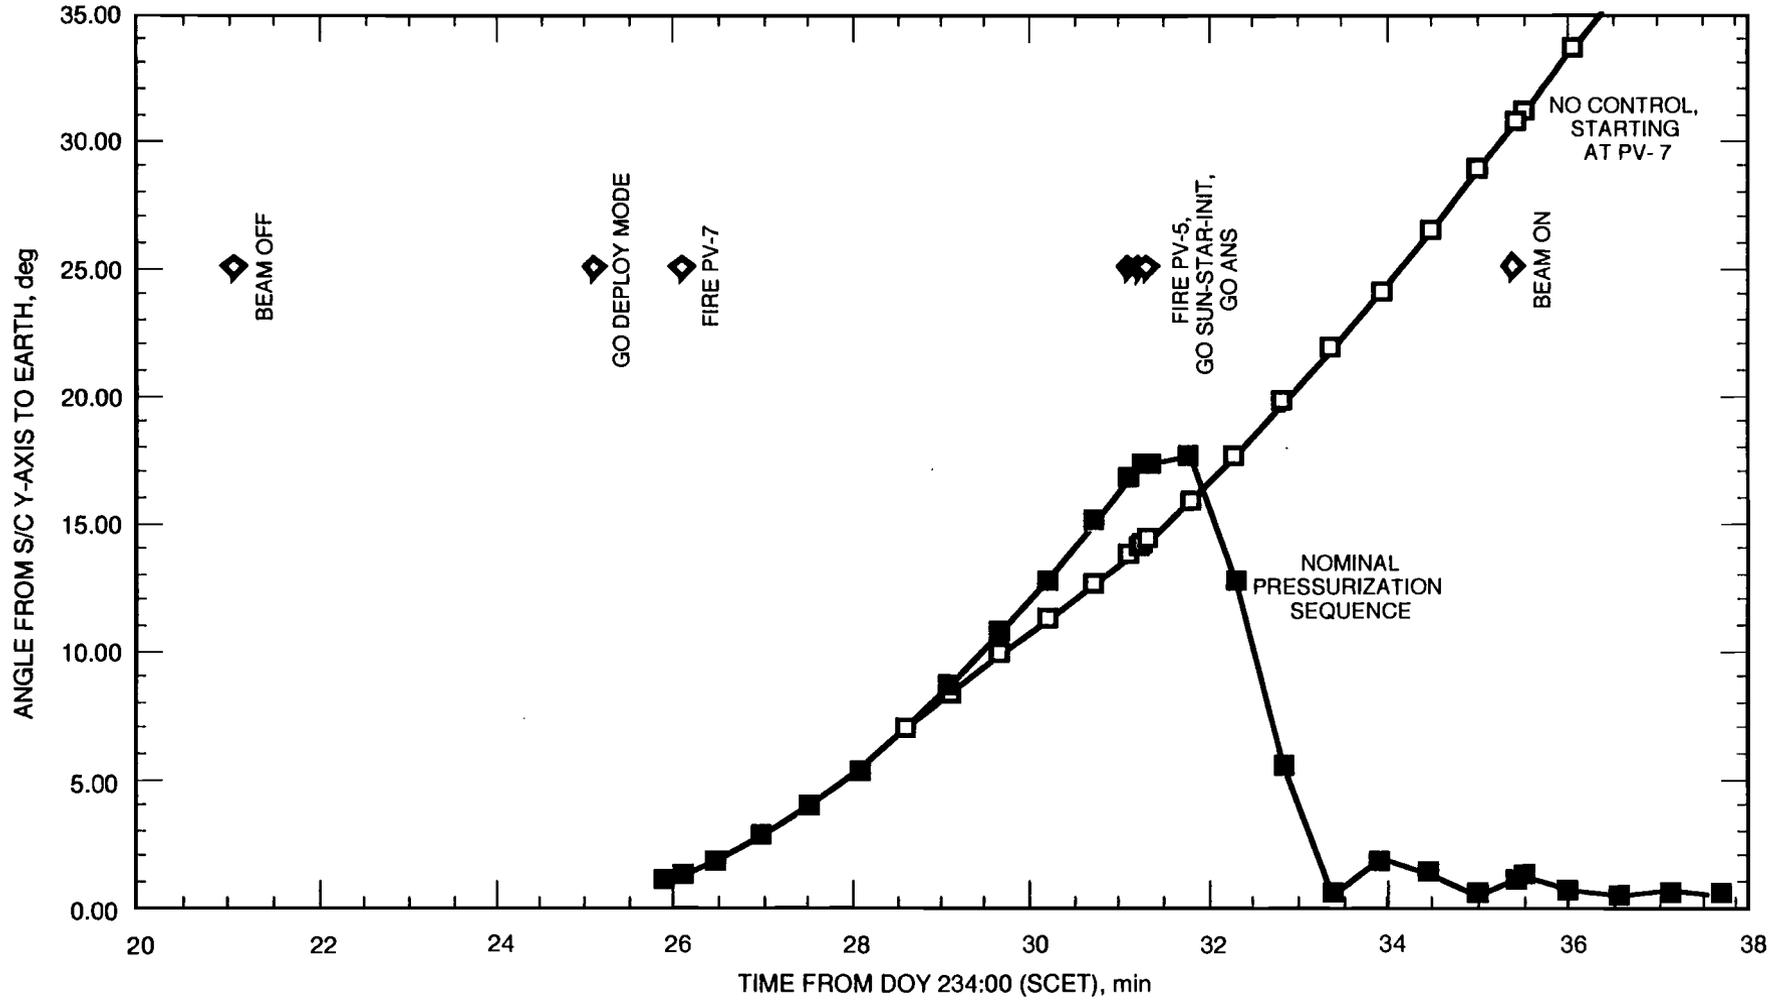
Figure 5-10. HGA offset from Earth line during pressurization.

The spacecraft response to the cessation of control and the rapid skew wheel spin-up is shown in Figure 5-10, HGA offset from Earth line during pressurization. Note that this figure shows two scenarios: the nominal, planned sequence, and the situation if all attitude control is halted. The nominal response has the HGA deviating by about 18° from the Earth line during Deploy Control Mode, then rapidly returning to an error of less than 2° before the Beam On command.

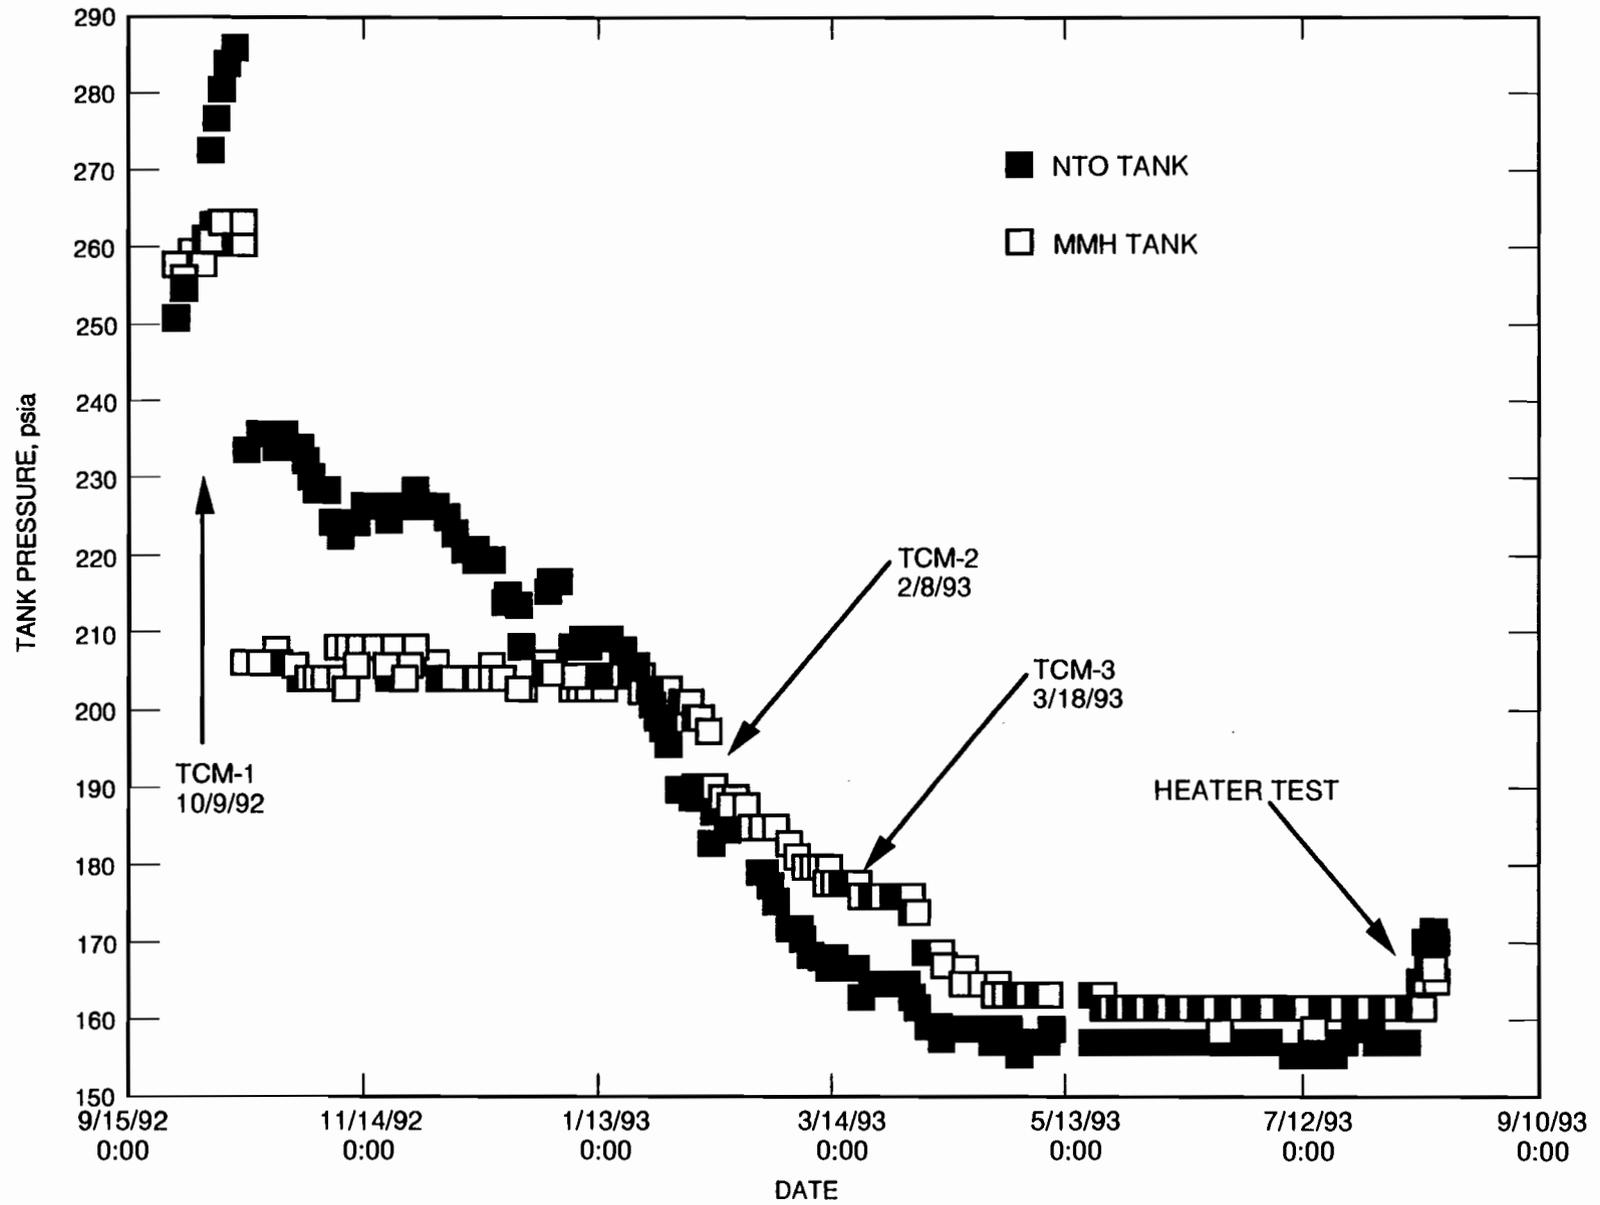
Figure 5-15. Bipropellant tank in-flight pressure telemetry data.

Several weeks prior to the Titan III launch of Mars Observer, the bipropellant tanks were pressurized to a level of 285 to 315 psi (Figure 5-14). The tank pressures gradually decreased to a launch level of 250 to 260 psi, and then increased to 265 to 285 psi right after launch (see the in-flight telemetry data in Figure 5-15). During the 11 months of interplanetary transit, the pressures of the bipropellant tanks decreased to a level of 160 to 170 psi due to lower tank temperatures and greater ullage from three TCMs. The target pressure of the tanks for MOI pressurization was 260 psi, as controlled by the regulators. The fact that neither a rupture nor leak was detected during and after the launch events leads to the conclusion that structural integrity—including fracture mechanics design—of the bipropellant tanks was adequate for the Mars Observer mission. It is extremely unlikely that an error related to the design, analysis, fabrication, or quality control of the bipropellant tanks has caused the loss-of-signal anomaly. However, this does not preclude the possibility that one of the tanks was weakened, either by impacts of meteoroids or fragments of another failed Mars Observer component, and ruptured catastrophically during the MOI pressurization.

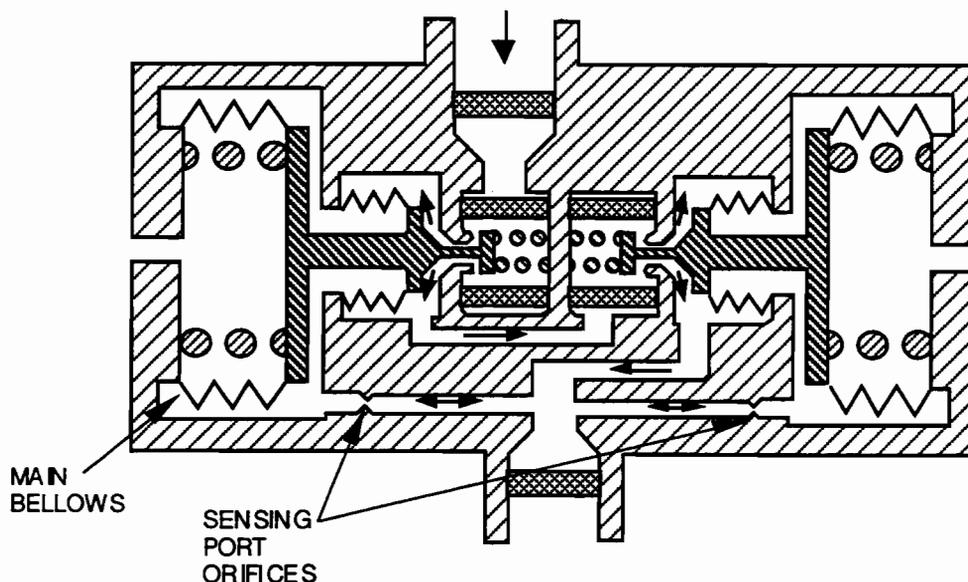
Figure 7-1. Regulator schematic.

The regulator design is shown schematically in Figure 7-1. Blockages of the sensing port orifices would prevent the regulator stages from sensing increases in downstream pressure, thus preventing closure. Contaminants in the convolutions of the main bellows would lead to failure by mechanically jamming the regulator seats in the open position, where they had been for most of the flight.

A failure of this type might have been possible on Mars Observer in the presence of contamination levels that would not have a significant impact on a normal Earth-orbiting communication satellite. This is because the pressure-regulated operation of the communication satellite lasts only a few days to a few weeks; there would not be the opportunity for extensive interaction of contaminants with NTO vapors.

If the regulator failed in a nearly wide-open condition, the NTO tank would have burst approximately 30 s after the opening of PV-7. If the regulator failed in a partially open state, the propellant tank burst could have required several minutes. This would have led to critical physical damage to the spacecraft.

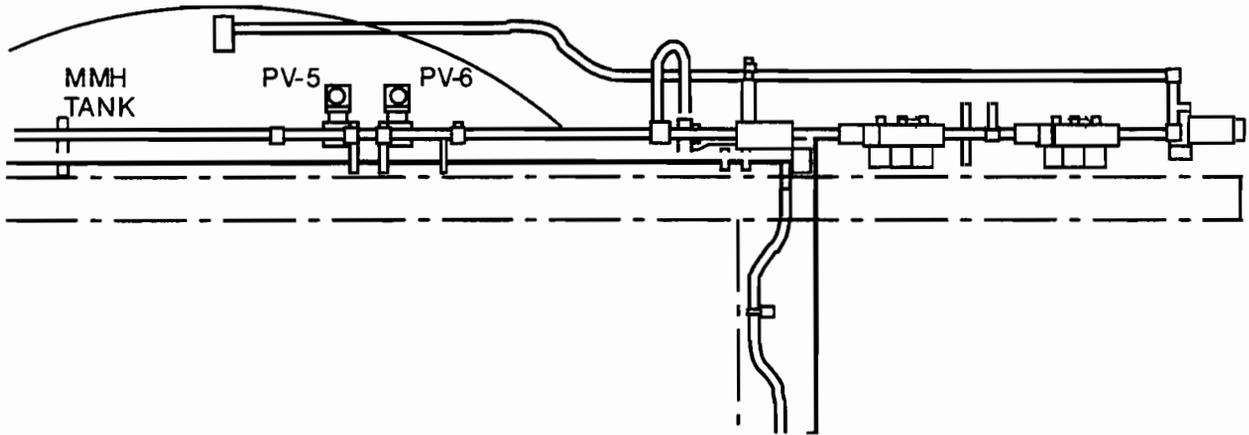
Figure 7-2. Relation of pyro valves to MMH tank (NSI axes are perpendicular to plane of drawing).

The most obvious “target” for an ejected squib would be the MMH tank. As seen in Figure 7-2, one squib in PV-5 was pointed in the direction of the MMH tank. Other potential targets are the pressurant lines.

If the MMH tank were ruptured, the resulting critical physical damage would be consistent with the observables.

An analysis has been performed to evaluate the damage that could be inflicted by an ejected NSI impacting the MMH tank.³ Results of the analysis showed that if the ejected NSI is moving at a velocity of 200 m/s, it is very possible that it will penetrate the tank wall upon impact and lead to a catastrophic rupture of the pressurized tank.

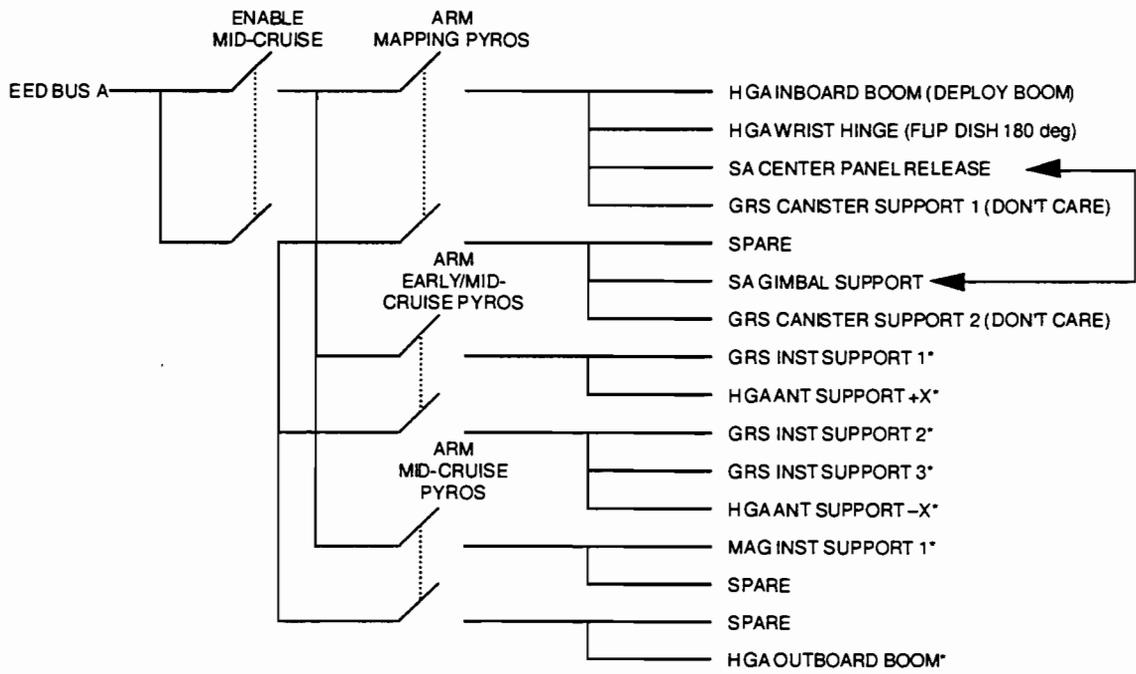
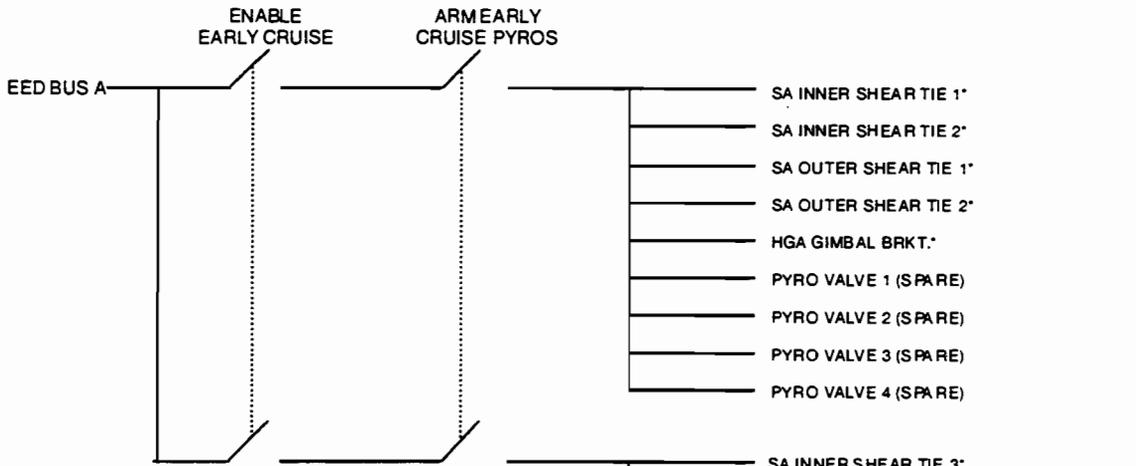
Figure 7-3. Pyro bus Enable and Arm System (primary side shown).

The pyro bus Enable and Arm System is shown in Figure 7-3. This figure shows which pyros were fired previously in the mission, the pyros planned to be fired, and other pyros that may have been fired instead. Testing included an end-to-end pyro harness, pyro shock, and a number of deployment tests. The end-to-end pyro harness test verified that all the proper pyros fire using a pyro simulator connected to all electroexplosive device (EED) inputs simultaneously (Figure 7-4). Each individual pyro output was verified to be enabled, armed, and fired, and no other EED was inadvertently fired. In addition to verifying the pyro harness, this test verified the EED functions of other spacecraft components, including the SCP, CIU, CIX, SCUs, and PRAs. To prevent damage to the PRA relays, the pyro simulator limits the current through the harness to 2 A. The spacecraft configuration was not changed in any area that might have affected the pyro events after the last time the full end-to-end pyro simulator verification test was performed in May 1992.

Although some questions remain (How many pyro shock test firings were performed? Which pyro valve is 5 and which is 6?), it is almost impossible that the planned pyro firing order was reversed (PV-7 then PV-5). However, if the firing order were reversed, this scenario would then couple to Hypothesis C1B and be consistent with the observables only if Hypothesis C1B results in the loss of the spacecraft.

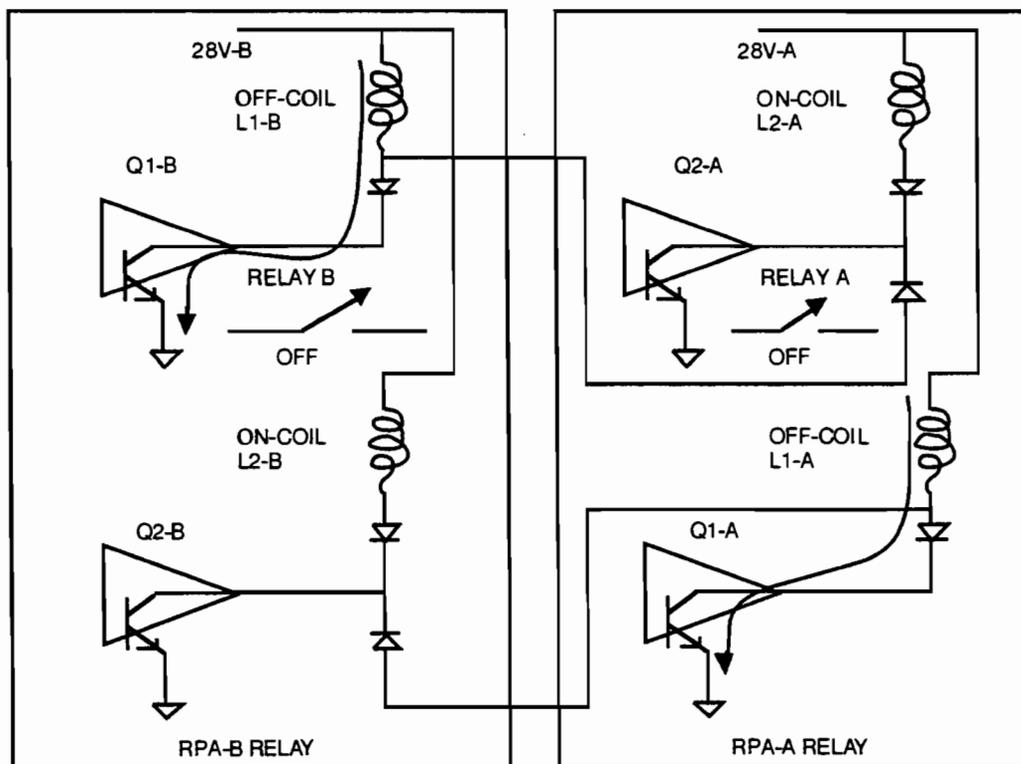
Figure 7-7. Initial condition, both relays are off.

Both RPA-A and -B were powered off during the pressurization sequence. Thus, the initial condition of the two relays of RPA-A and -B is off. This was done by pulsing Q1-A and Q1-B on to energize the L1-A coil of Relay A and the L1-B coil of Relay B (Figure 7-7).

This hypothesis assumes that there was some debris or conductive contamination present in Relay B at the time the pressurization sequence was initiated. The coil has 1- to 2-mm leads 1 to 2 mm apart and, therefore, conductive contamination of at least that

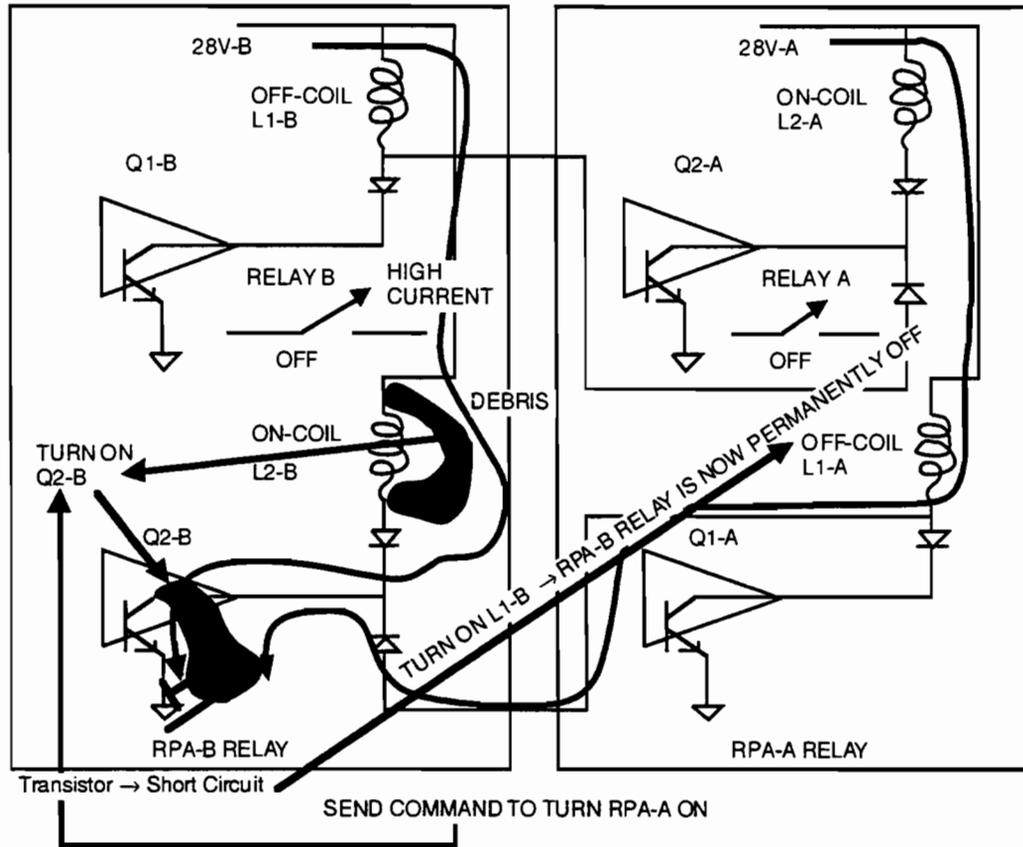
Figure 7-9. Send command to turn RPA-B on.

As part of the pressurization sequence, RPA-B is powered on to get beam-B on. The transistor Q2-B is now turned on. The normal resistance of the L2-B coil is 1.5 k Ω ; therefore, the normal current is 18 mA. Since the debris has now shorted the L2-B coil, there will be no more current limiting to the Q2-B transistor. The current flowing to Q2-B can be 2.8 to 28 A. This current would overstress the Q2-B transistor, with a high probability that Q2-B would now be shorted. This would turn on the L1-A coil. (This is the intentional design of the interlock circuit: whenever RPA-B is turned on, RPA-A has to be turned off—i.e., both RPAs cannot be turned on at the same time.) Since L1-A was previously energized, the RPA-A relay would now be in the permanently off position (Figure 7-9).

time). Based on the possibility that the transistor could become open, it has been recommended that the Project send Beam-B Off, then Beam-A On commands, but with a duty cycle less than 10 percent to preserve the health of Relay A, since both the on- and off-coils of Relay A are now energized.

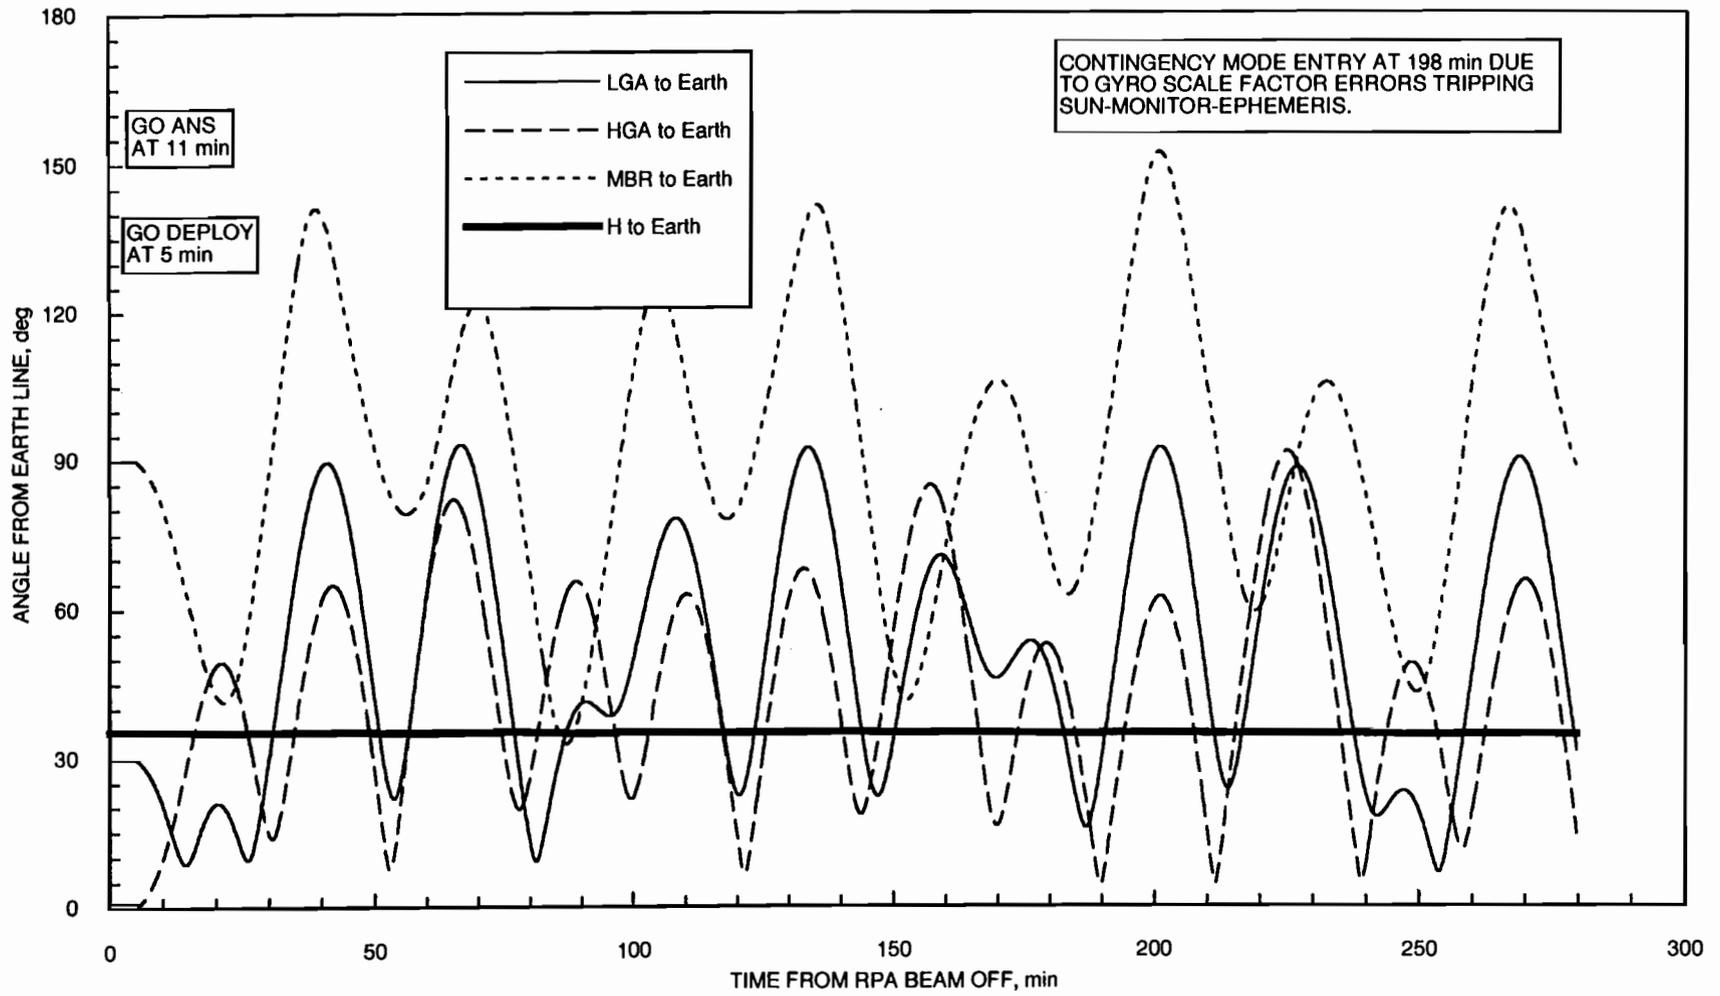
Figure 7-11. LGA boresight deviation from the Earth direction.

If the Y RWA is selected, the situation is a bit more complicated. There will be no momentum unloading, and the attitude time history is such that the batteries would be completely depleted at 15 ± 1 hr after the failure. With this attitude-time history, a Power Alert would be expected to trip at 225 ± 15 min after the failure, but this alert depends on the EDF, which is disabled by the RXO failure. The Power Alert would therefore never take place. Contingency Mode entry occurs at about 200 min after the failure, due to gyro-scale factor errors leading to a Sun-Monitor-Ephemeris violation. At this time, the RPA beam is already on, having been turned back on by the pressurization sequence. The attitude-time history after Contingency Mode entry is favorable for LGA downlink and the carrier would be expected to be detected almost continuously thereafter. Since the LGA-to-Earth angle varies between 0° and 100°, there would be some brief gaps in continuity (Figure 7-11).

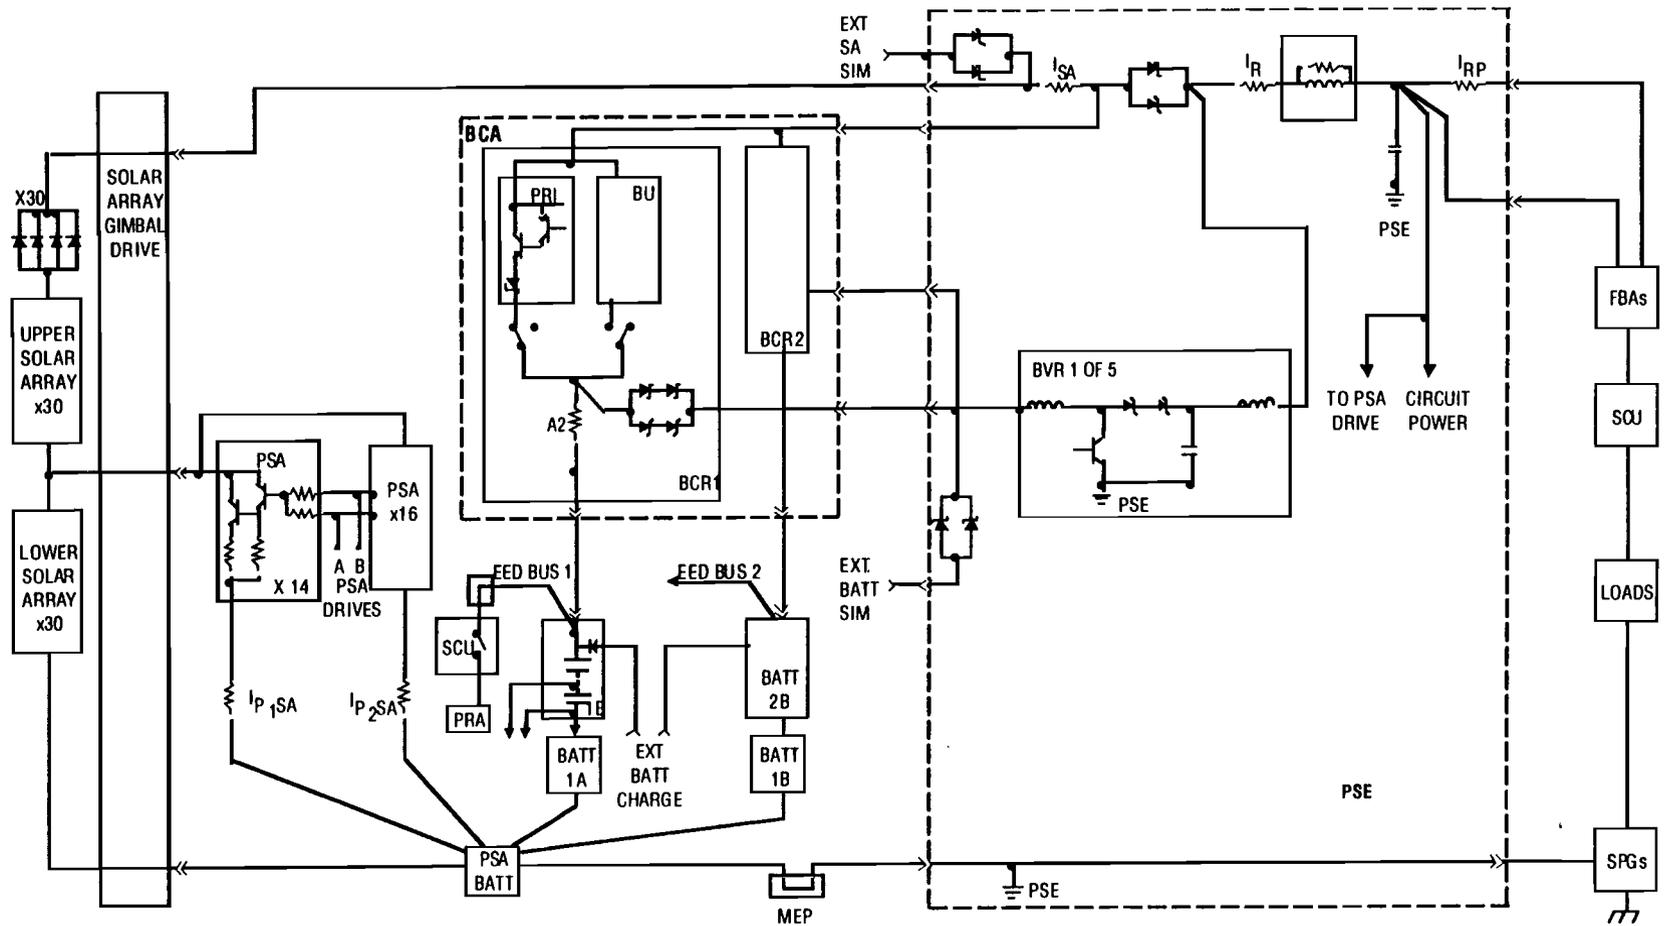
Figure 7-12. Unfused power schematic.

To satisfy the Mars Observer observables, both Solar Array and battery power sources would have to be eliminated. These sources are joined within the PSE; the Solar Array diode coupled, directly to the 28-V bus, and the batteries, diode coupled, through the BVR to the bus (Figure 7-12).

During this investigation, at least seven credible candidates were found that could have caused the Mars Observer anomaly. In this anomaly, the spacecraft would not only be lost, but lost very rapidly. This requires a short to chassis and the subsequent overload of both the Solar Array and battery sources so that the spacecraft primary power regulated bus is held below 24.5 V. The possible fault sites in the PSE can explain all the observables.

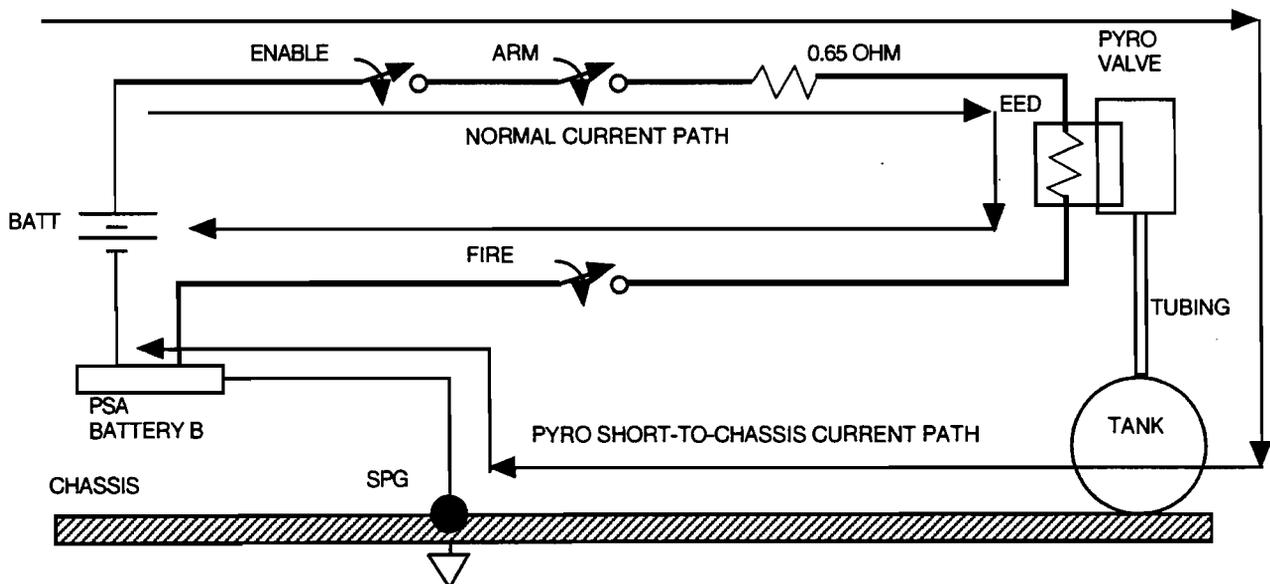
Figure H-1. Chassis current induced by pyro short.

One of differences between Mars Observer and other JPL spacecraft is that the Mars Observer design connects the electrical ground of logic and control subsystems directly to the external chassis. This provides a direct path between currents in the chassis and electronic circuitry. This in turn leads to the possibility that currents from the squib might interact with other circuitry in the event that the squib is inadvertently shorted to the external case. The path from the squib case to the chassis is rather complicated, and involves current flow through structures (such as the fuel tank and associated tubing) as well as through the chassis and wiring. An example is shown in Figure H-1; more detailed discussion will follow in a later section.

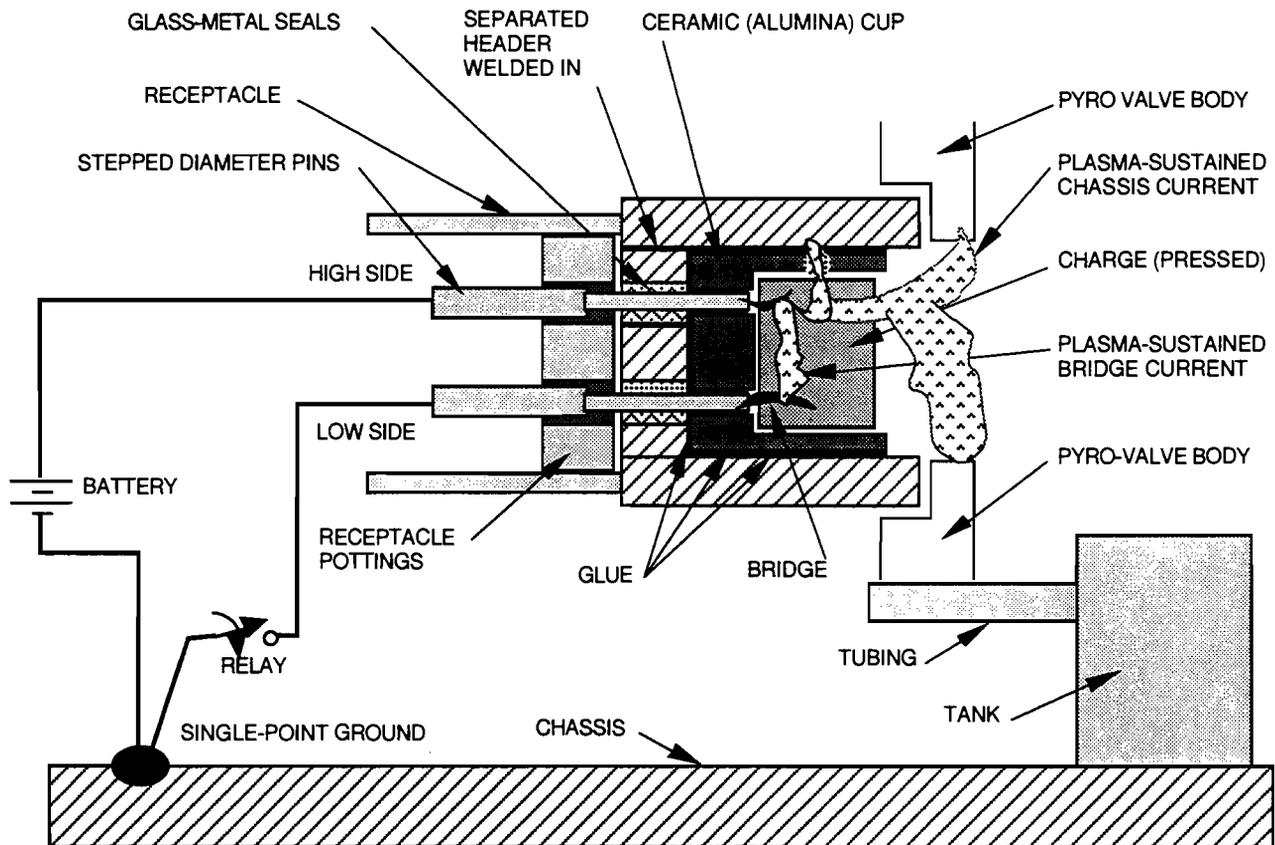
Figure H-2. A model of current flow from short in NSI induced by plasma to chassis.

A number of experimental tests have been done to investigate currents from the squib after it is fired. In some cases (≈ 4 percent, based on very limited statistics) the squib shorts through the insulating cup, and a high-intensity current will then flow in the chassis ground. Figure H-2 shows a cross-sectional diagram of the squib just after it is fired. An intense plasma is created, which opens the bridge wire. The figure shows the plasma shorting through the side of the cup, which occurs in a small number of firings. Evidence for this is provided by examining squibs after firing, which sometimes show fracture through the cup.

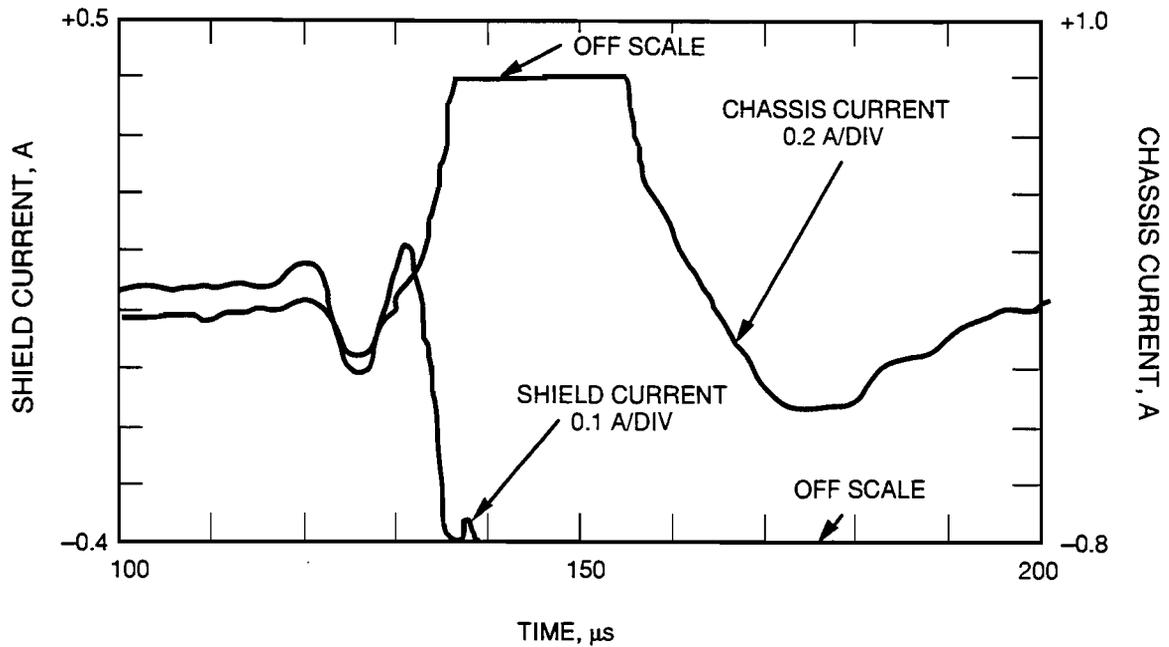
Figure H-3. Chassis and shield currents created by disruption of the squib bridge wire in laboratory simulation of Magellan hardware. Mars Observer used the same type of squib.

Figure H-3 shows experimental measurements of chassis current during one of the cases in which the squib shorted. These measurements were obtained by firing squibs in a mockup of the Magellan system, which used the same type of squib as the Mars Observer NSI. In this example, the maximum current could not be measured, because the oscilloscope sensitivity was too high. However, analysis of the circuit shows that it should be in the range of 5–10 amperes. The pulse width of the chassis current signal is 30 μs ; the pulse width of the shield current appears to be much longer. Pulse rise times are 0.05 to 0.2 μs ; however, note that ringing will result in faster rise times in actual circuits. Assuming that the peak value is 10 A, the total charge induced in the chassis by shorting of the squib circuit is 300 μC .
