Mars Observer Loss of Signal: Special Review Board Final Report

November 1993

NASA

JPL Publication 93-28

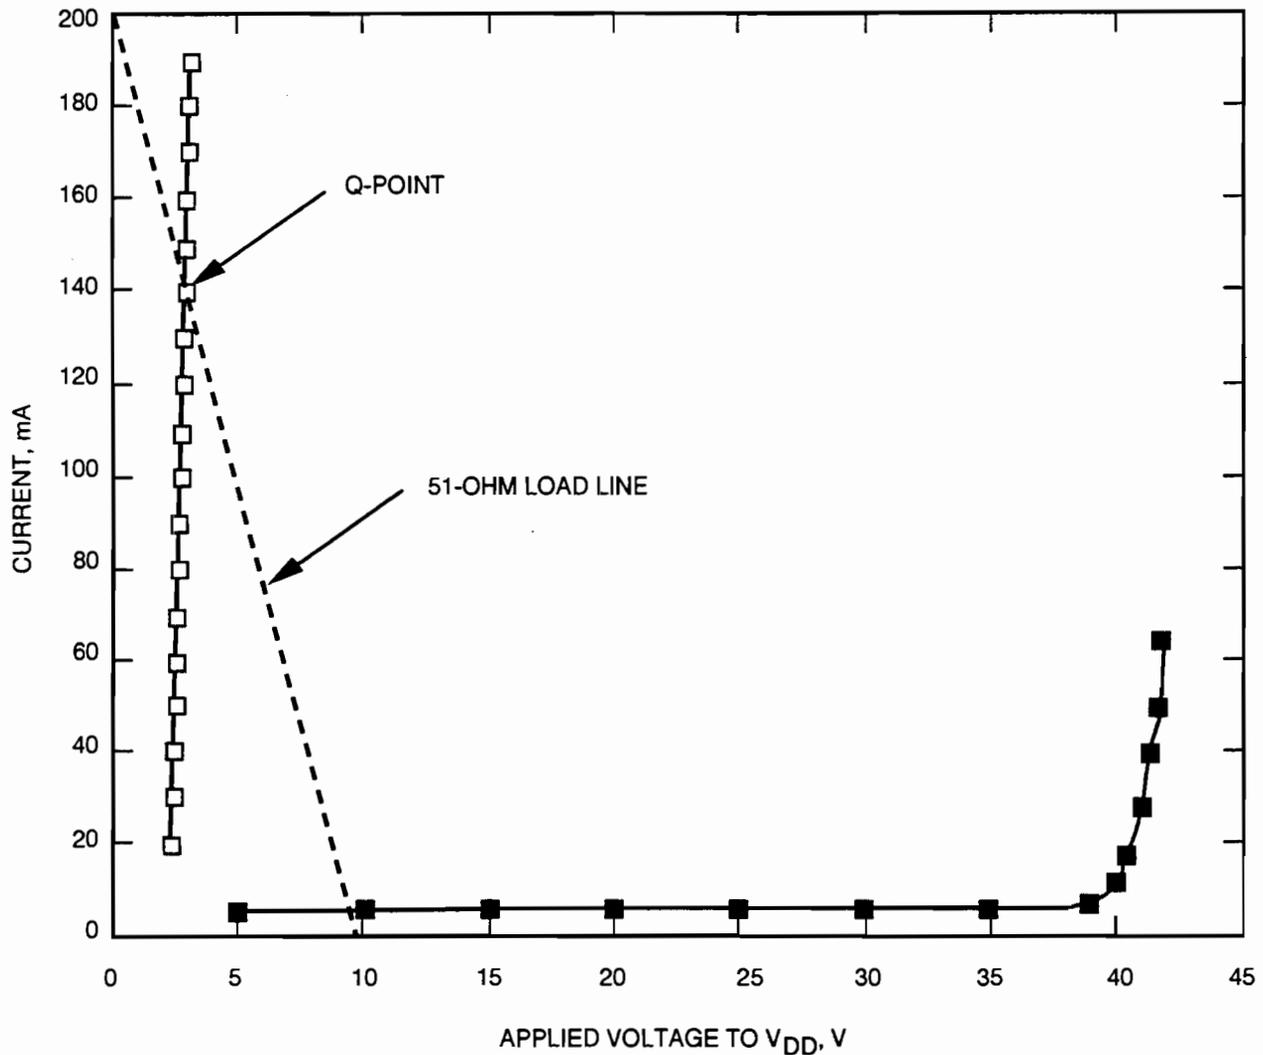
Figure H-4. Latch-up characteristics of a CD4049 inverter triggered by $V_{DD} - V_{SS}$ breakdown mechanism.

current.² This turns out to be an unfortunate choice if devices are driven into latch-up because the nominal 100-mA quiescent current of the CD4000 with this particular load will reduce the output voltage below 5 V. For example, Figure H-4 shows a 51-ohm load line superimposed on the output characteristics of a latched CD4049 circuit. The quiescent point is above the minimum guaranteed value required for a solid "0," and

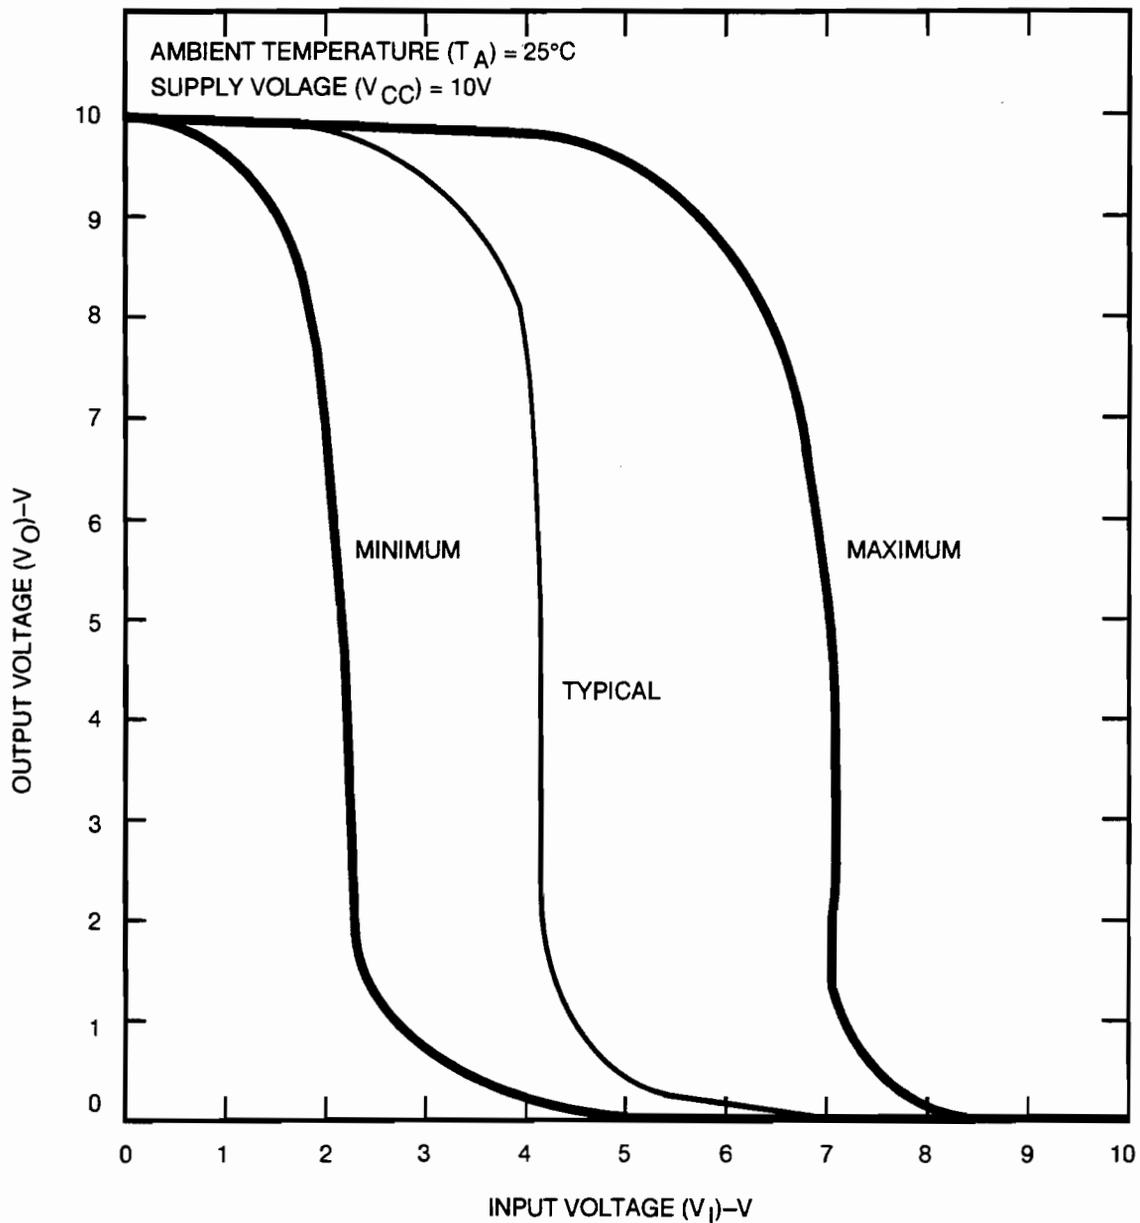
Figure H-5. Transfer characteristics of a CD4049 inverter.

CD4000-series circuits are used in large numbers in the MO CIU, with a 10-V power supply (10-V logic). The transfer characteristics specified by the manufacturer for these devices are shown in Figure H-5. Note that there is a wide variation in inverter switching voltages—from 2 to 7 V—to allow for processing run variations in the threshold voltages of n- and p-channel transistors. Typical devices switch at about 4 V, but the switching point of individual units depends on the threshold voltage of that particular lot. Although it is unlikely that unit-to-unit variations in switching threshold will range over the entire allowed span of 2 to 7 V, there will be differences between different devices. These will likely range from approximately 3 to 5 V. Thus, any logic voltages that fall within this intermediate range will be ambiguous and may be interpreted differently by different circuits.

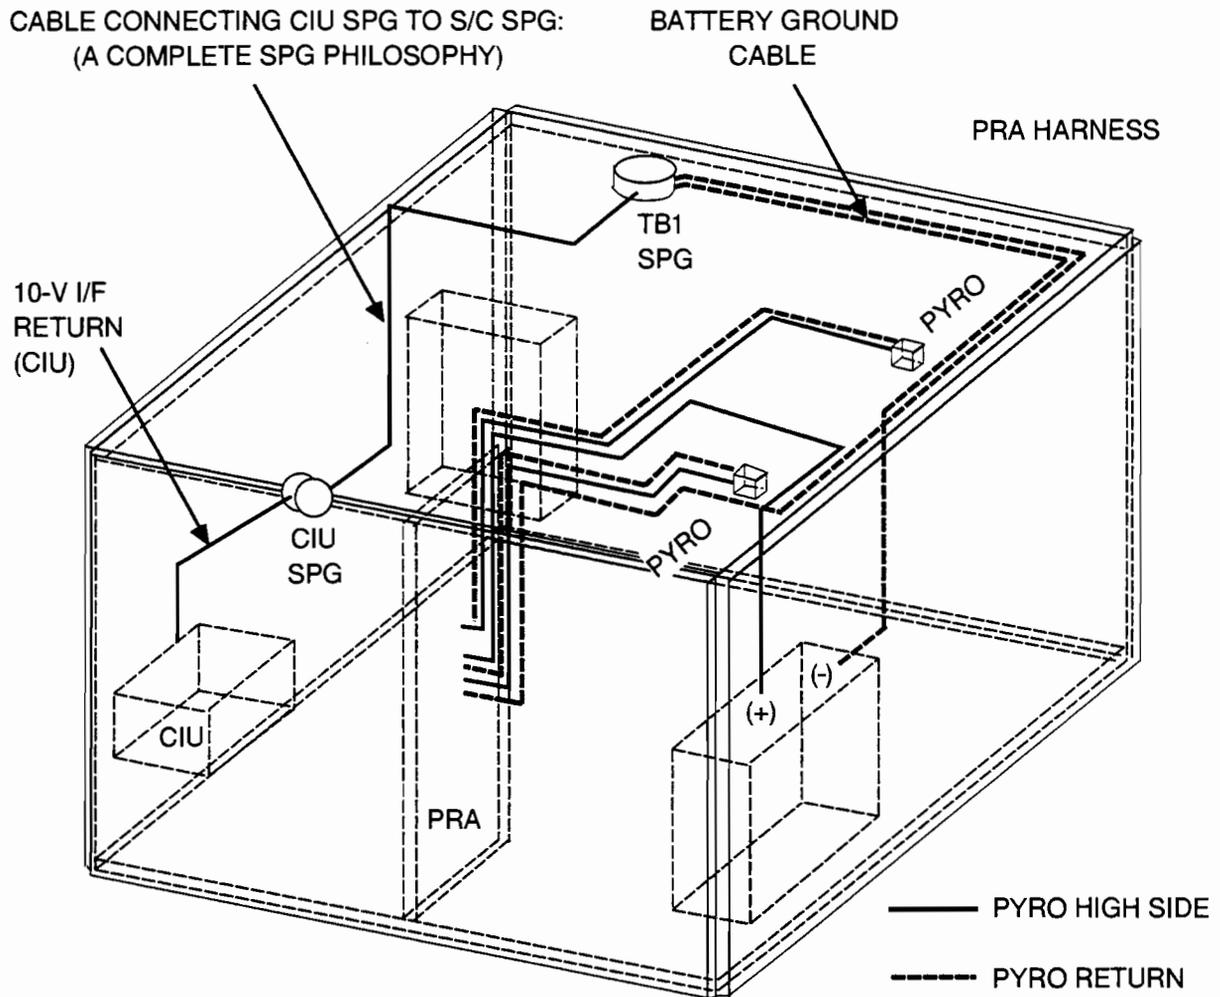
Figure H-6. Geometry of primary current loop from battery through chassis when squib shorts to case. Secondary loop geometries are of similar complexity.

Unfortunately, the geometry of the current loops in the Mars Observer system are very complex. This complexity, along with the strong dependence on distance, makes it extremely difficult to bound the value of the coupled field. The orientation of the loops is also critical, because the field B is a vector quantity. An example of the actual geometry is shown in Figure H-6 for the primary current loop of the squib current. The total area of the loop is estimated to be 4 m^2 , but it makes several twists and turns. There are a number of secondary loops, with similar complexities. The areas of the secondary loops are estimated to be ≈ 1 percent of the area of the primary loop. Initial calculations,³ assuming a secondary loop area of 0.02 m^2 , yielded the results shown in Table H-1. In the table, the primary loop is the "culprit" loop, and the secondary loop is the "victim" loop.

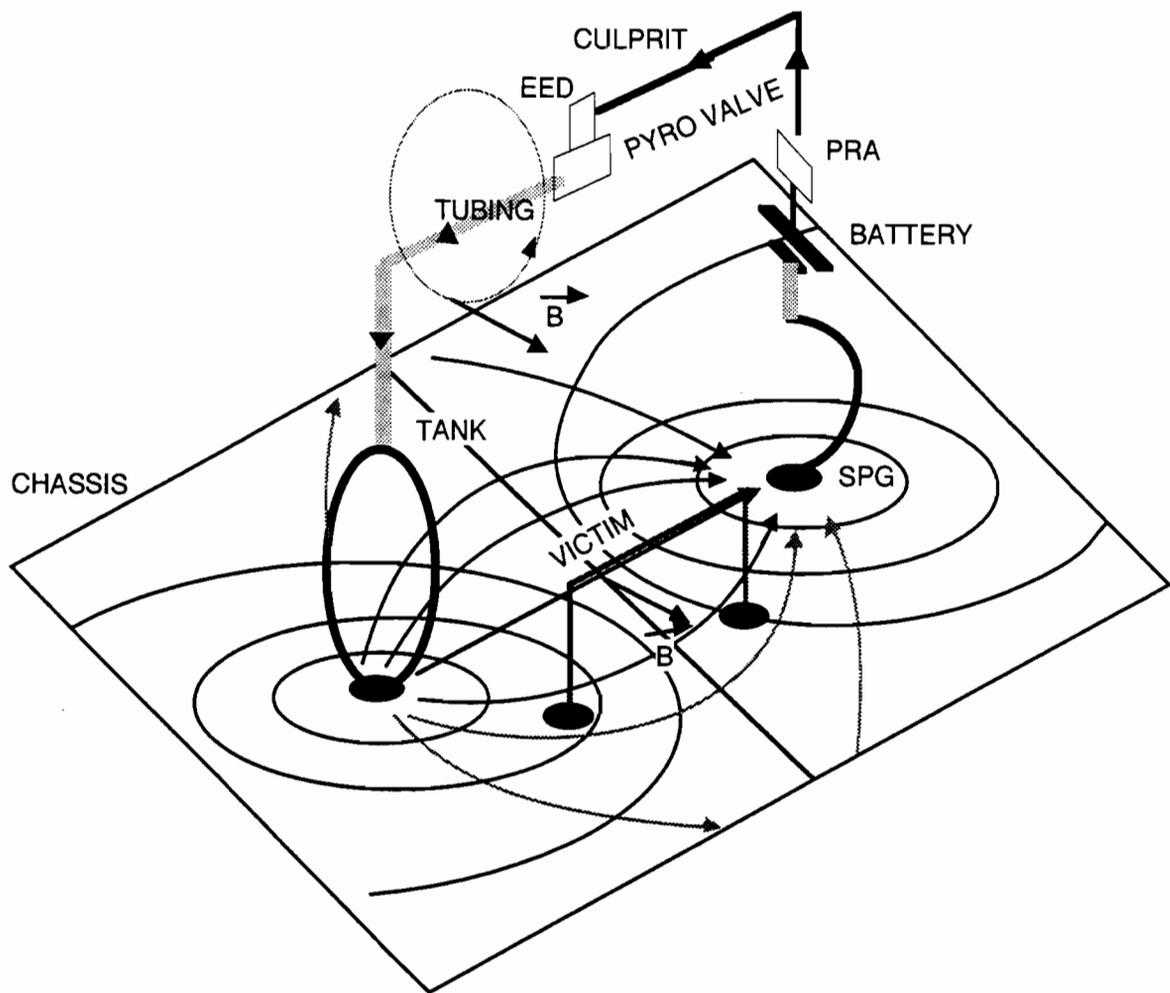
Figure H-8. Loop-to-loop coupling model for Mars Observer pyro-induced chassis current with culprit details.

through the chassis, cables and wiring. A detailed analysis must be three-dimensional. A planar view of the primary and secondary loops is shown in Figure H-8 (in this figure two faces of the Mars Observer enclosure are folded flat for simplicity). Note that current from the primary loop goes from the battery, through the pyro valve, tubing, and tank, and then to the chassis. The approximate location of the secondary loop is also shown in this figure. Figure H-9 shows this same configuration, adding additional details for the secondary loop. These figures demonstrate the extreme complexity of the actual current loops in the Mars Observer system.

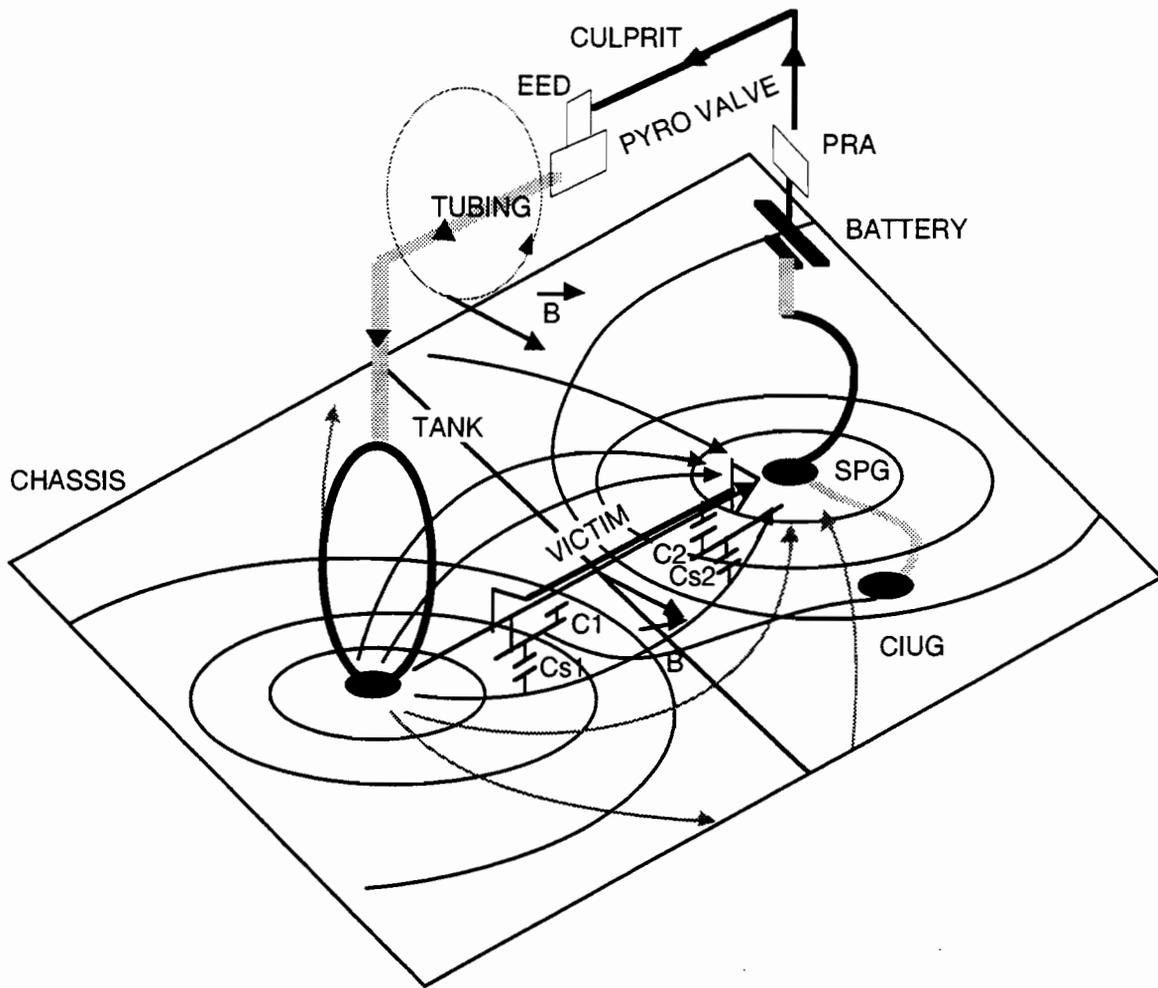
The voltage developed in the primary loop will be coupled to secondary loops through capacitance between the secondary and primary loops ($V = C \, dV/dt$). The effectiveness of this coupling depends on the layout of the secondary loop; if it is close to a ground plane, or protected by cable shielding, little coupling will occur. The effective capacitance can only be roughly estimated. For a capacitance of 1 pF, a primary loop voltage of 360 V with 100 ns transition time will produce a secondary voltage of 3.6 mV.⁴ Ringing and faster transients will increase this voltage, but

Figure H-9. Loop-to-loop coupling model for Mars Observer pyro-induced chassis current with culprit and victim details.

transitions in the subnanosecond range would be required to produce enough secondary voltage to cause latch-up. Thus, compared with the first mechanism, electric-field coupling seems less likely, particularly since the layout of most circuit boards provides significant shielding from ground planes.

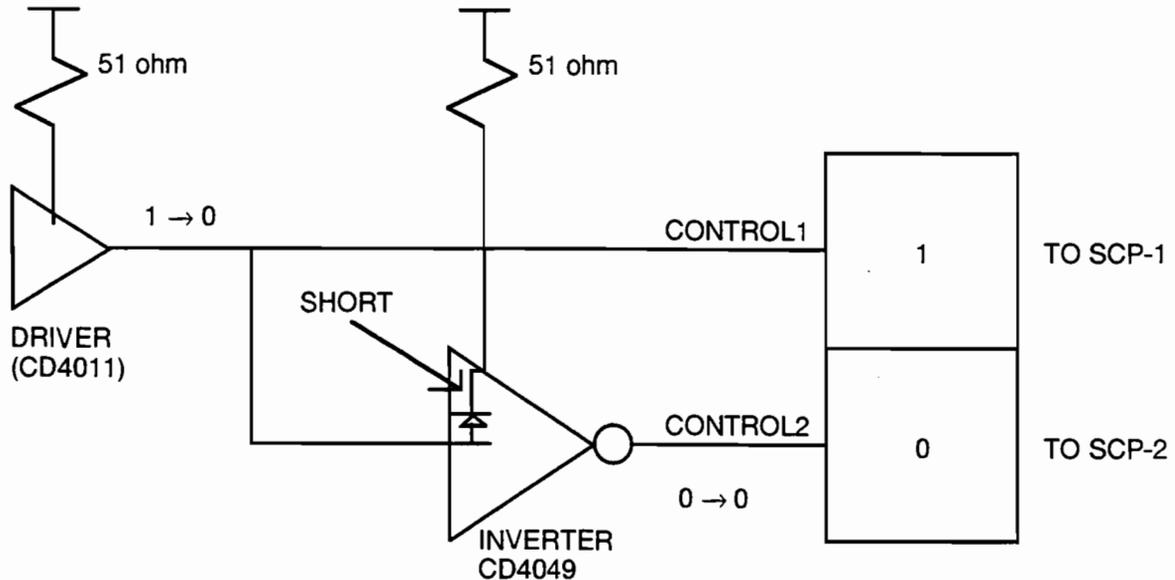
There are two control signals, CONTROL1 and CONTROL2, that are assumed to be complementary because CONTROL2 is generated by a single inverter, with input = CONTROL1. As shown in Figure H-10, if CONTROL1 is high, SCP-1 is selected; if CONTROL2 is high, SCP-2 is selected. If the inverter is placed in a metastable state because of latch-up, then the circuitry can be in either of two forbidden states, i.e., 0/0 or 1/1; the 0/0 condition could also result if the inverter (or other circuits connected to its decoupling resistor) latched.

Condition 2 was in effect at the start of the sequence. Condition 3 simply shifts control from SCP-1 to SCP-2, and will not affect system performance. However, either condition 1 or 4 will effectively halt command generation, with no RPA turn on and no attitude control.

After the anomaly, ground commands were sent to the spacecraft that would turn off power to SCP-1. Turning off power would have resolved condition 1, where both SCPs are attempting to control the spacecraft, but would be ineffective for condition 4, where neither SCP is active.

1. If latch-up occurs, the top protection diode of the inverter is shorted to 5 V.
2. V_{CC} drops to 5 V.
3. The output is now at 5 V (indeterminant—interpreted as “O” by control 2).
4. Pulls output of driver to 5 V (indeterminant—interpreted as “O” by control 1).
5. Therefore, neither SCP-1 nor SCP-2 is active.

Figure H-10. SCP in control.

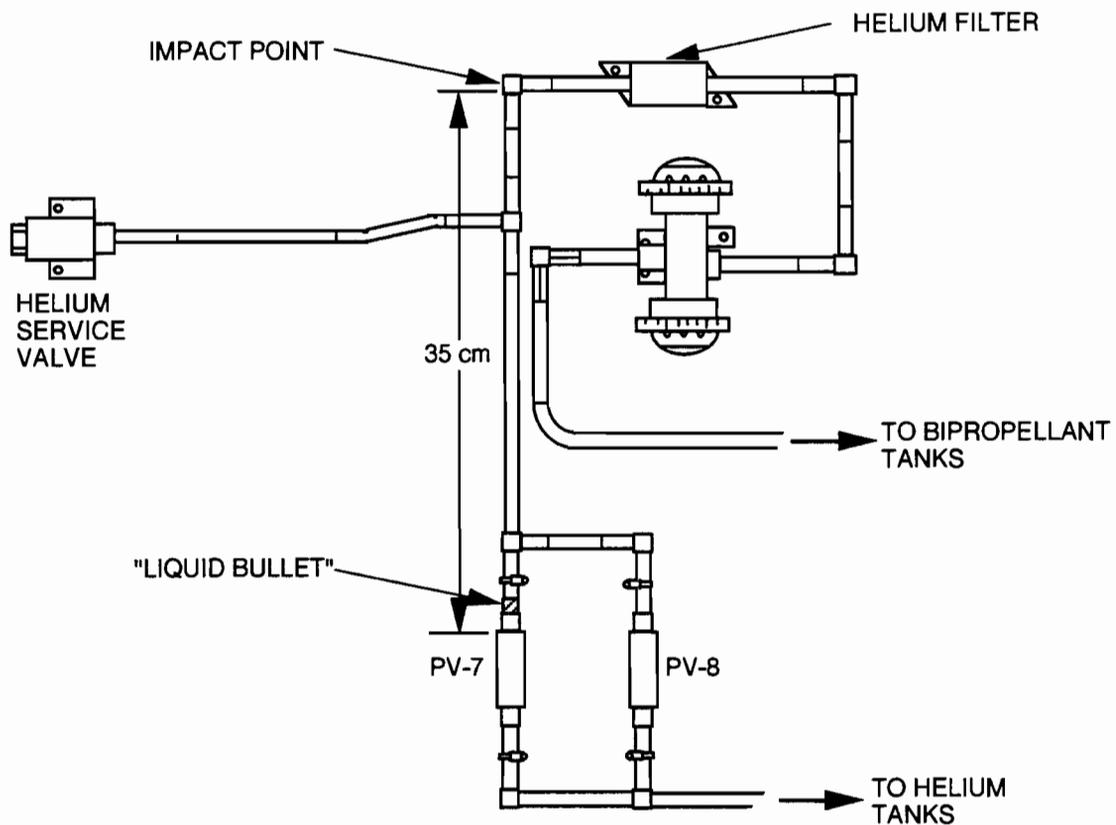
This analysis treated the slug as a rigid body, but accounted for the wall friction factor, the expansion wave that will propagate upstream of PV-7, and the shock wave which will propagate downstream of the slug. Impact pressures at the fitting identified as "Impact Point" in Figure K-3 were estimated by the relations normally used to

Figure K-3. Geometry of the Pressurization System upstream of the regulator.

compute water hammer overpressures. This is conservative in that it assumes the slug is constrained from expanding in a radial direction by elastic tube walls. In fact, some of the flow will expand into the turn, the slug may not be in contact with the tube walls at impact, and the Pressurization System tubing may yield, all of which will tend to reduce the overpressure. Most fluid mechanics experts consulted were essentially certain that the liquid slug would, in fact, be atomized by the pressure differential across it. Other potentially mitigating effects not considered in the analysis are the potential reduction in driving force due to diversion of helium to plumbing leading to PV-8 and the Helium Service Valve shown in Figure K-3 and the finite (order of 0.1 ms) opening time of the pyro valve.

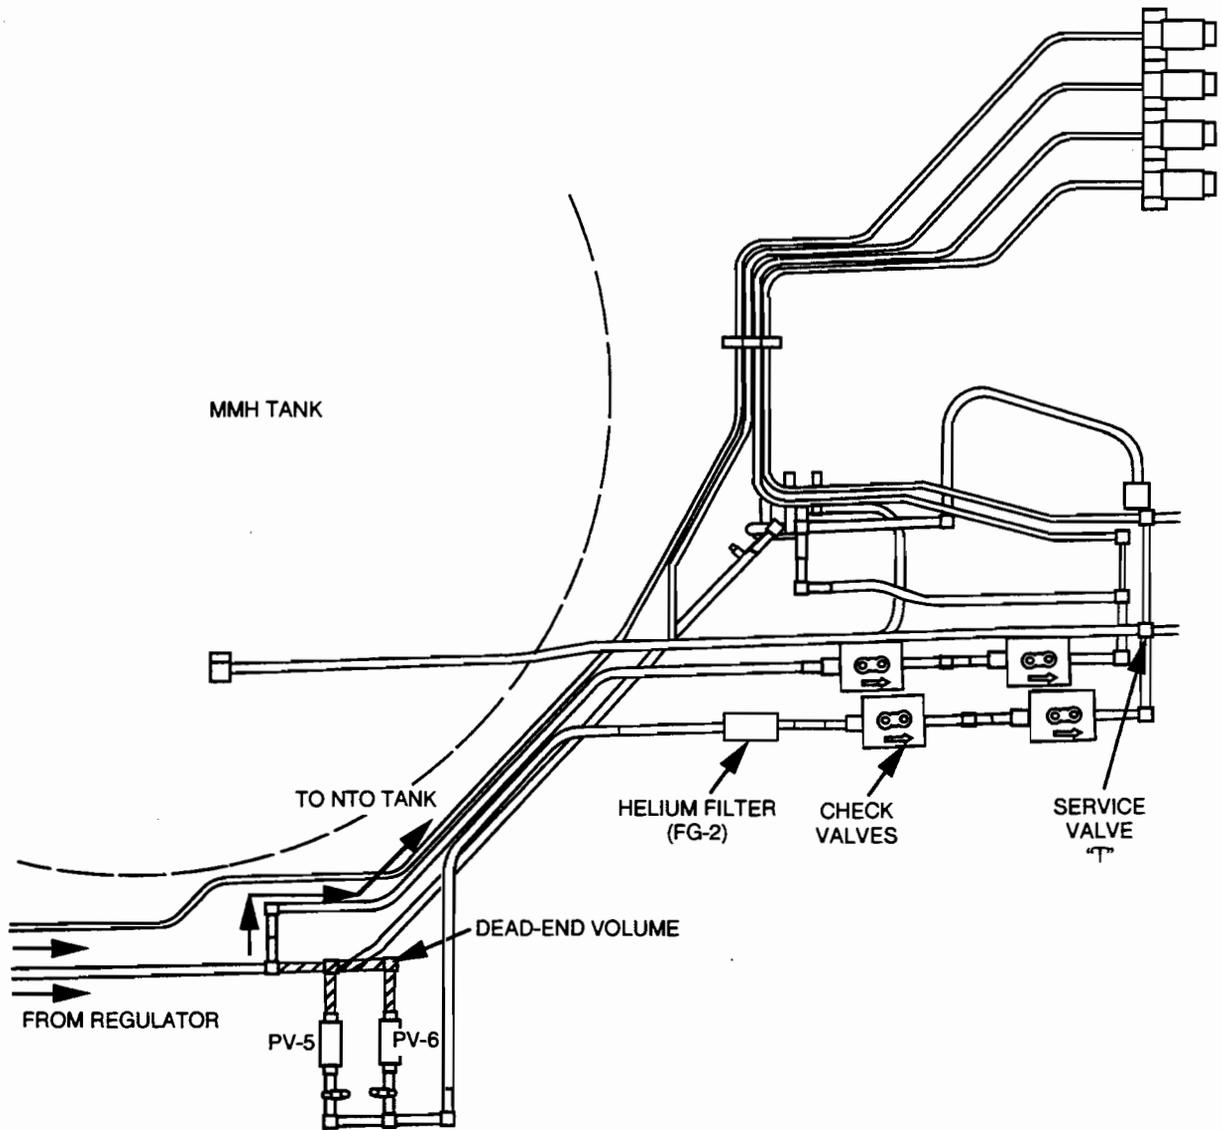
The next opportunity for the NTO ingested into the MMH Pressurization System to react with MMH is at the service valve "T" shown in Figure K-5. Because of the large temperature gradient between the MMH tank and check valves early in the mission (see

Figure K-5. Pressurization System plumbing layout.

Figure K-1), there is a significant chance that liquid MMH accumulated in large quantities in the vicinity of this "T" prior to pressurization. Therefore, the quantity of MMH which could react with the NTO in this location is not readily bounded.

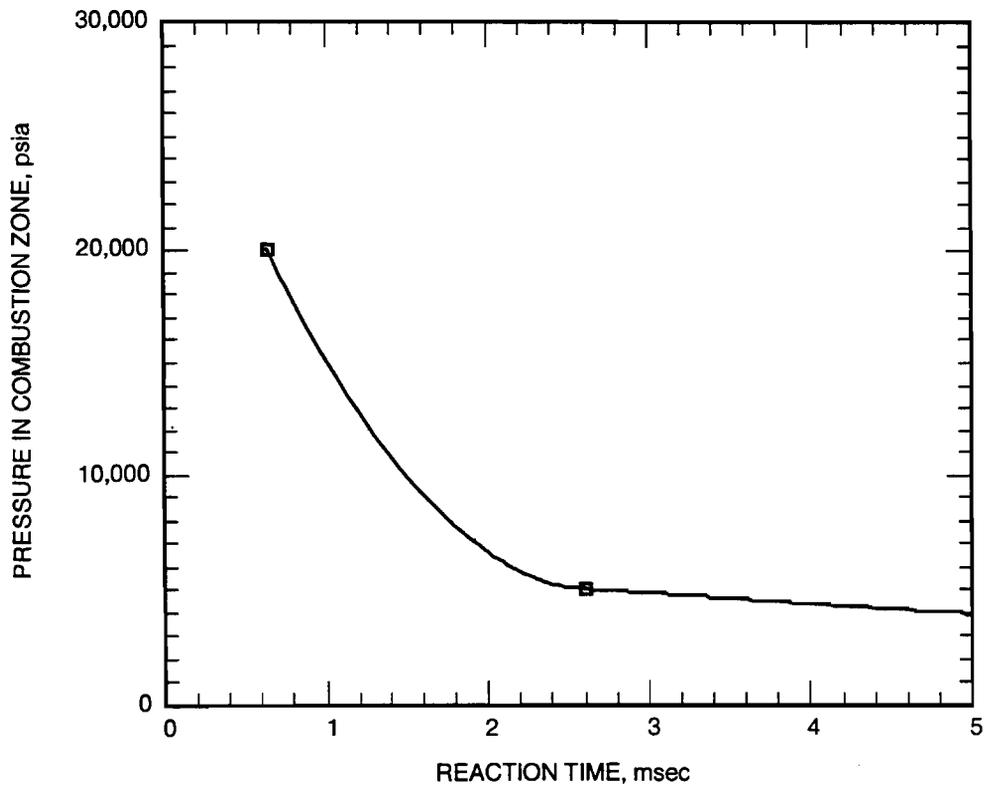
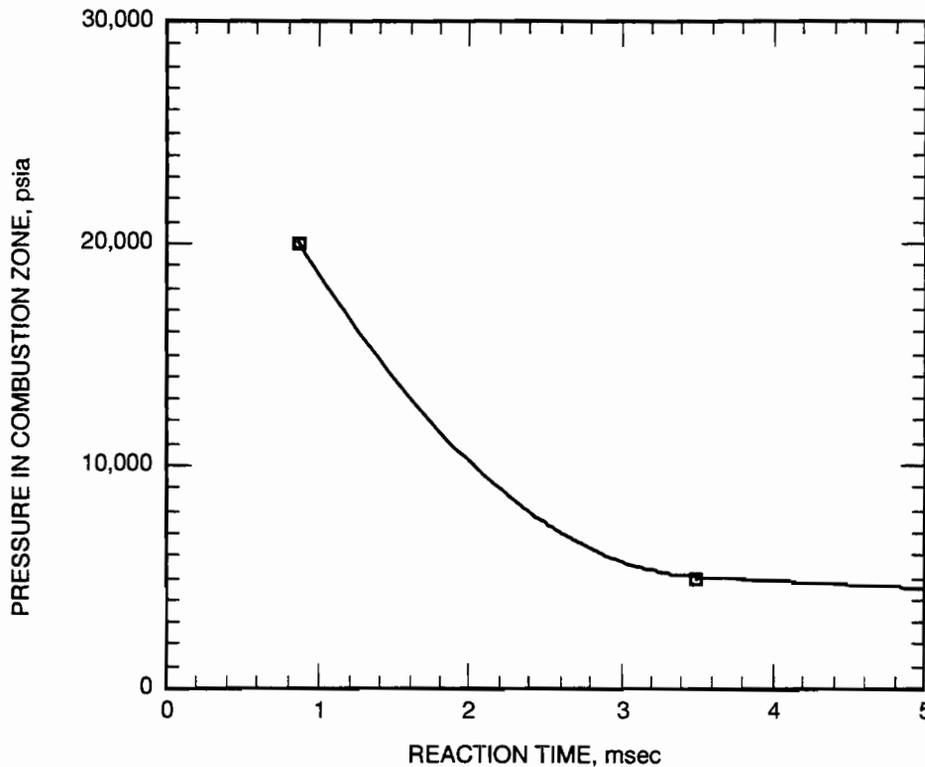
Figure K-7. Estimated line pressures for the oxidizer-to-fuel ratio = 2.5 reaction at "T" (reactants are 2.2 g NTO and 0.9 g MMH).

Figure K-8. Estimated line pressures for the oxidizer-to-fuel ratio = 1 reaction at "T" (reactants are 2.2 g NTO and 2.2 g MMH).

A comparison of Figures K-7 and K-8 reveals a fairly weak dependence of the predicted pressure on the *O/F* ratio, but indicates that the predicted pressures are highly sensitive to reaction rate. As discussed above, reaction times of the order of 1 ms are considered credible and, in the results presented in Figures K-7 and K-8, result in pressures above the theoretical burst pressure of the lines (12,000 psia) and the minimum measured burst pressures of weld samples (10,000 psia).

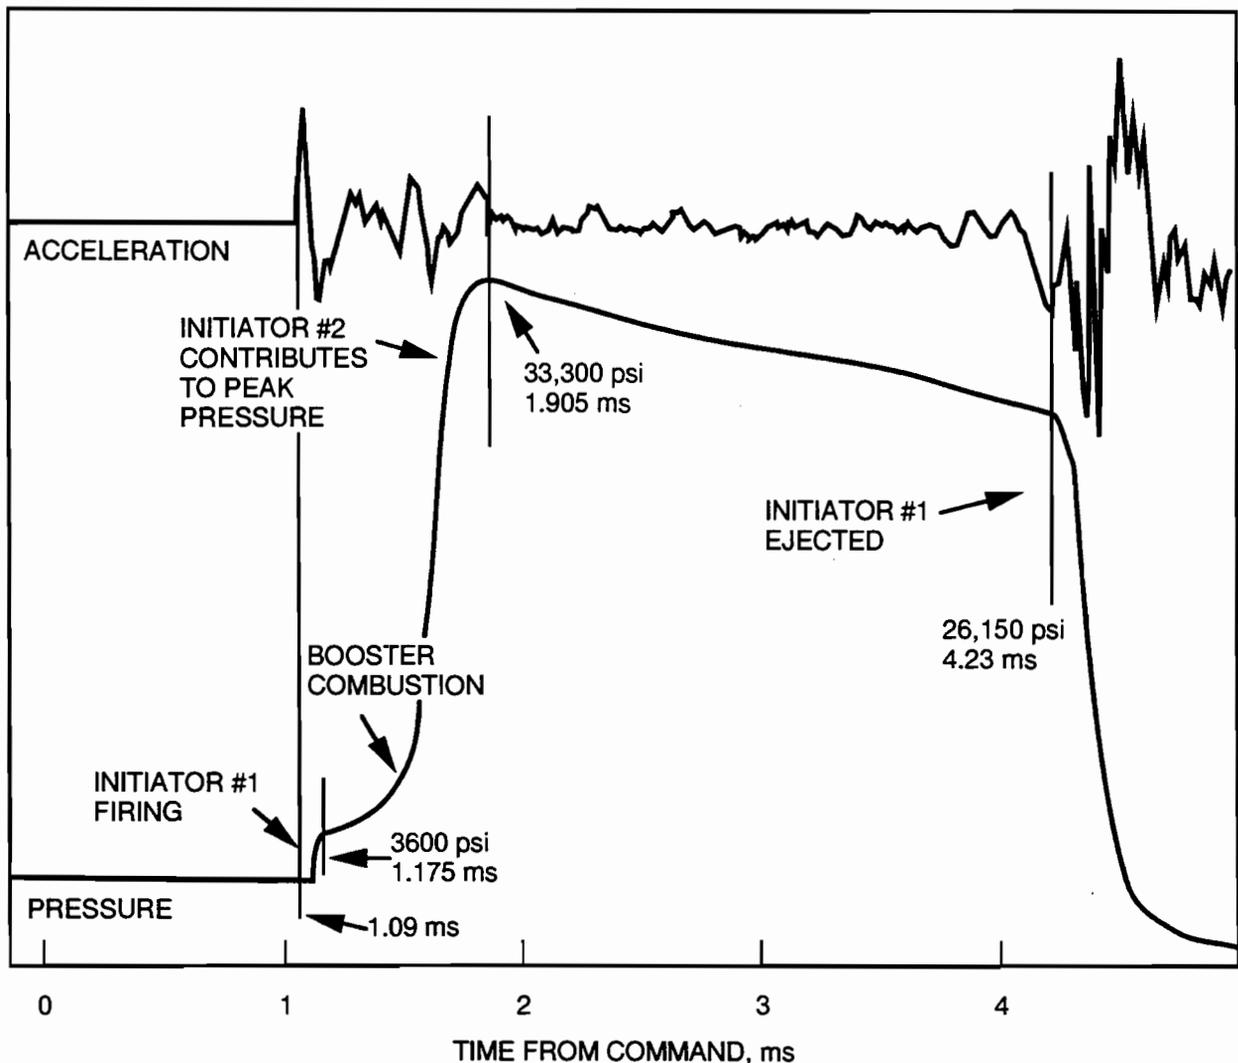
Sympathetic firing of the second initiator may be related to the failures experienced on the Cluster program. Figure P-3 shows the pressure history of the simulated pyro valve firing of October 14, 1993. About 1.09 ms after the firing signal was sent, the first initiator ignited, producing the rapid pressure rise seen in the next 85 μ s. Then the booster charge began to combust, raising the cavity to a peak pressure of 33,000 psia in another 730 μ s. Bruggemann hypothesizes that this peak is enhanced by the sympathetic firing of the second initiator during this time frame. This seems to be a reasonable hypothesis. There is certainly no evidence to suggest that firing of the second initiator took place after this peak pressure, as the pressure trace did not show a secondary peak in the following 2.3 ms. At that time (4.23 ms after the fire command) the first initiator was ejected. The ESA hypothesis holds that the ejection of the initiator is a result of the higher peak pressure induced by sympathetic firing and/or impingement of the second initiator effluent directly on the first initiator, producing enhanced erosion of the threads of the first initiator.

In each of the four incidents of initiator expulsion, the initiator that was fired electrically was expelled. However, the threads holding the other initiator were so badly eroded that it is not clear whether this (ejection of the electrically fired initiator) was a causal relationship or coincidence. One argument for coincidence is that examination of the qualification unit Cluster valves (in which the initiators were fired simultaneously) revealed significant erosion of the titanium housing—at one point the

Figure P-3. Pressure history from simulated pyro firing valve.

hot combustion gasses had eroded through over 60 percent of the housing thickness. This appears to indicate a fundamental incompatibility between the titanium housing material and the hot products of combustion. This observation leads to the speculation that these failures could have led to the ejection of either initiator. Bruggemann agreed that this was certainly possible. Unfortunately, the qualification units were not sectioned in a plane that would allow inspection of the threads which retained the initiators.

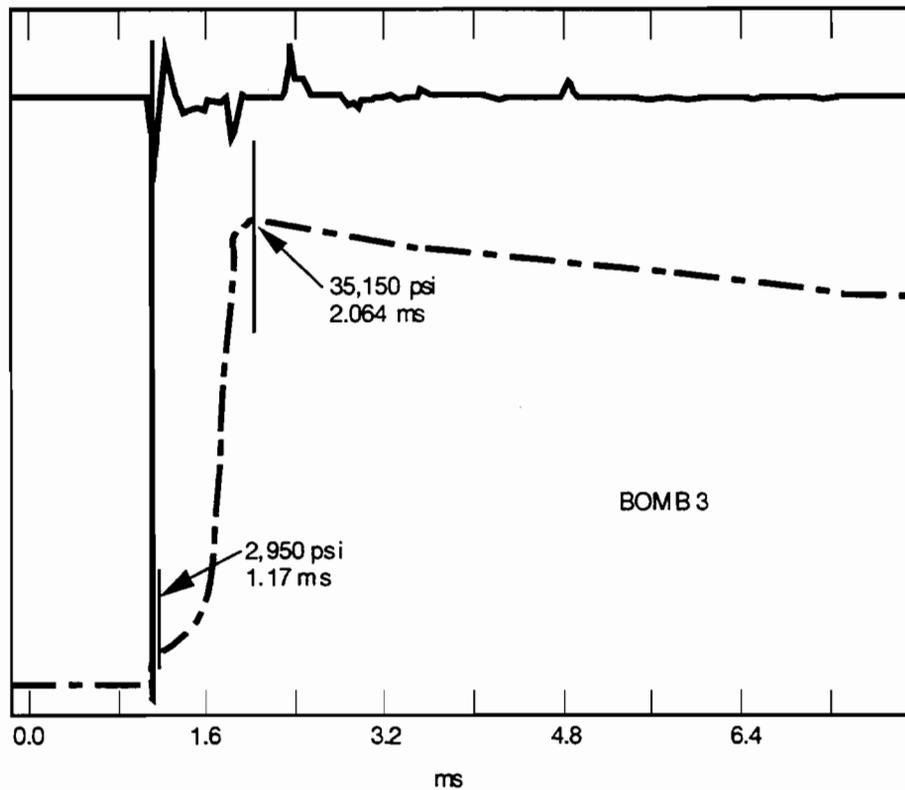
That the ejection of the initiator is not strictly deterministic is further supported by an additional test of a simulated 1467-15 valve with sympathetic firing of OEA initiators (model 4704) and a 130-percent booster charge conducted at OEA on October 15, 1993. The pressure trace of Figure P-4 shows that the peak pressure was actually higher than that of the October 14, 1993, test (and much higher than the original failures using 100-percent booster charge loads), but neither initiator was expelled.

Figure P-4. Pressure history from simulated pyro valve firing #2 using OEA initiators.

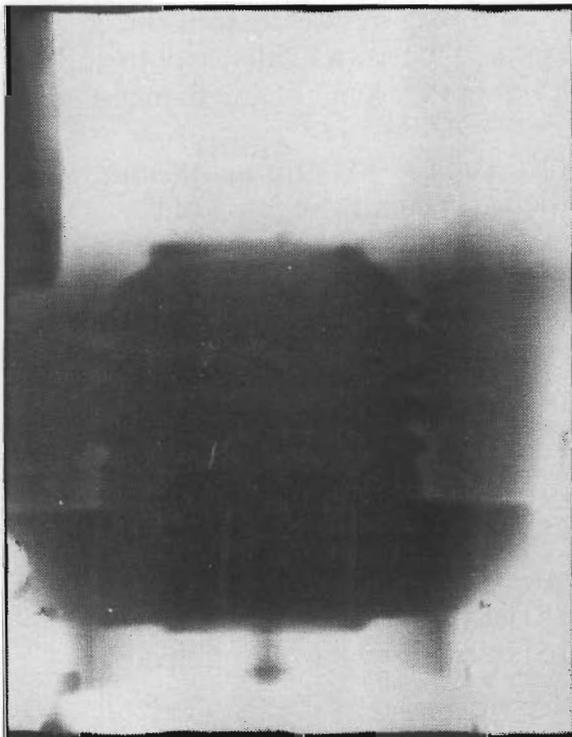
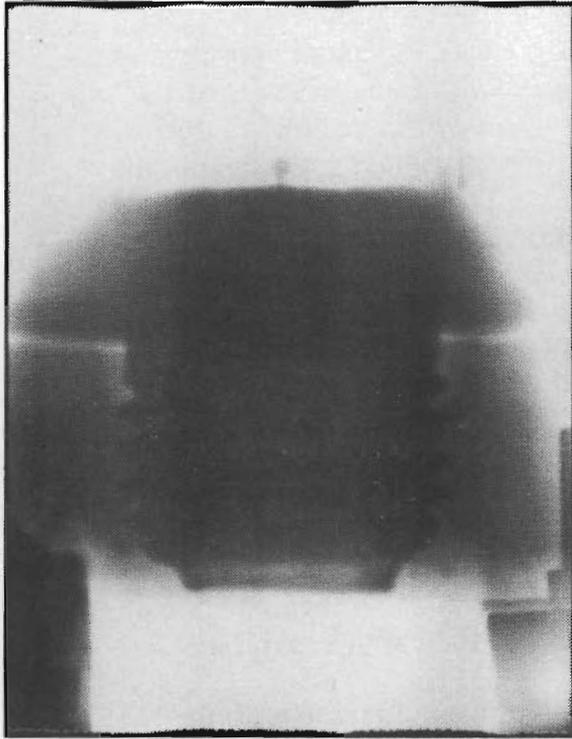
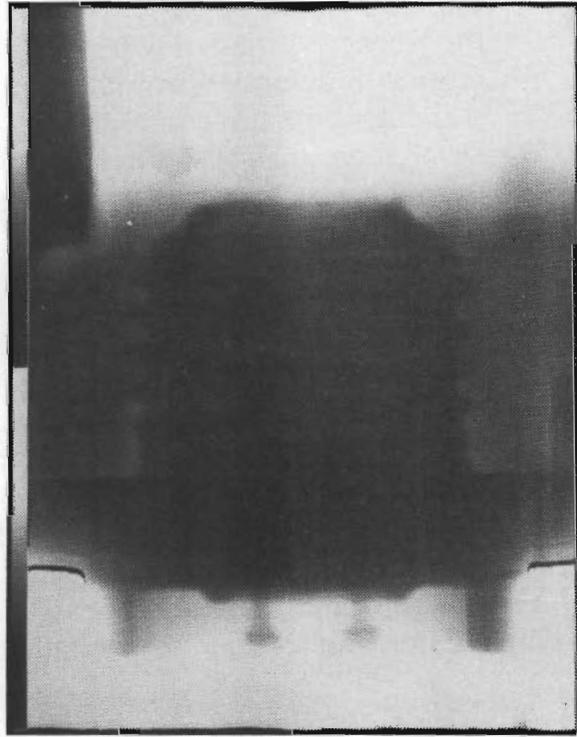
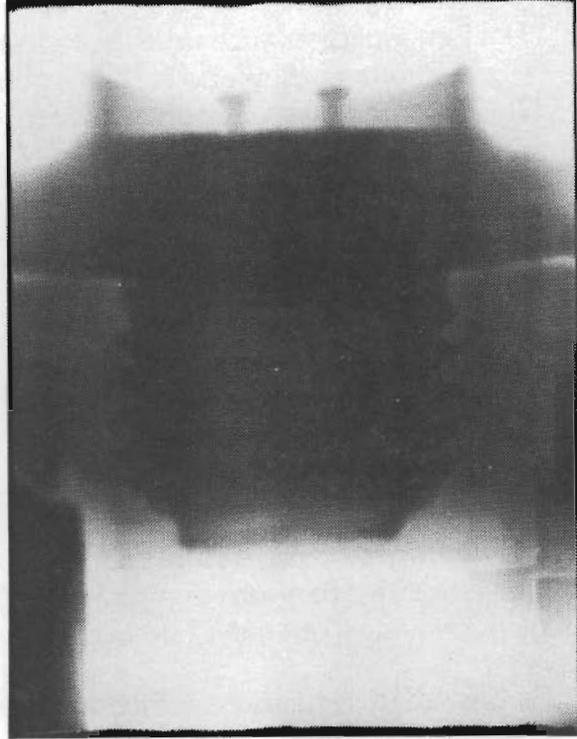
Figure P-5. X-rays of pyro valves fired in Mars Observer pyro shock tests.

X-rays of the two Mars Observer pyro valves fired during pyro shock testing were received from Astro. These photographs are reproduced in Figure P-5. They do not resolve the titanium threads very well, but there are low-density regions around the NSI threads that indicate damage to the titanium threads. Damage was fairly evident around the booster plug threads of serial number 003. Although reading of these X-rays is somewhat subjective, Lynn Lowry of the JPL Materials Laboratory thought that thread erosion was fairly clear in these photographs.

Further examination of these two valves is to include: (1) removal of all initiators and recording the torque required to loosen them, (2) visual inspection and photography of the threads on the NSIs and in the valve bodies, and (3) removal of the booster plug following similar inspection procedures. These data have not yet been received from Astro, although it has been reported that the torques required to remove the initiators were in all cases close to installation torques. This indicates that the tensile preload of the threads had not reduced significantly, which could be consistent with such damage as that shown in Figures P-1 and P-2.
